# Comprehensive Evaluation of Aluminized Steel Type 2 Pipe Field Performance

G. E. MORRIS and L. BEDNAR

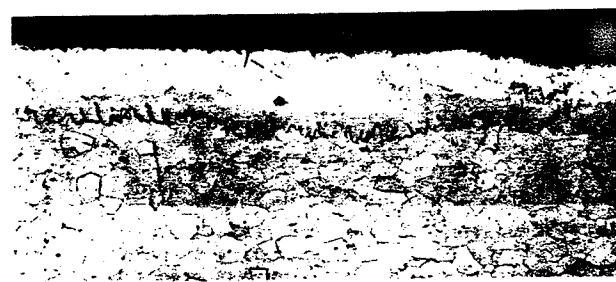
Alloy Cracking on Corrugation Crests

Alloy Cracking on Corrugation Valleys

FIGURE 5 Comparative alloy condition at corrugations on old and modern aluminized steel (192X).

nounced alloy cracking during corrugating, especially in corrugation valleys where lateral cracking occurred (Figure 5). The superiority of the old material over galvanized steel was achieved despite such cracking. A residual skin of alloy remained fully bonded to the substrate, even if lateral cracking caused spalling of the upper alloy portion (Figure 6).

Modern aluminized steel has improved coating ductility, and there is less cracking overall. At times there is no cracking tendency at all in corrugation valleys.

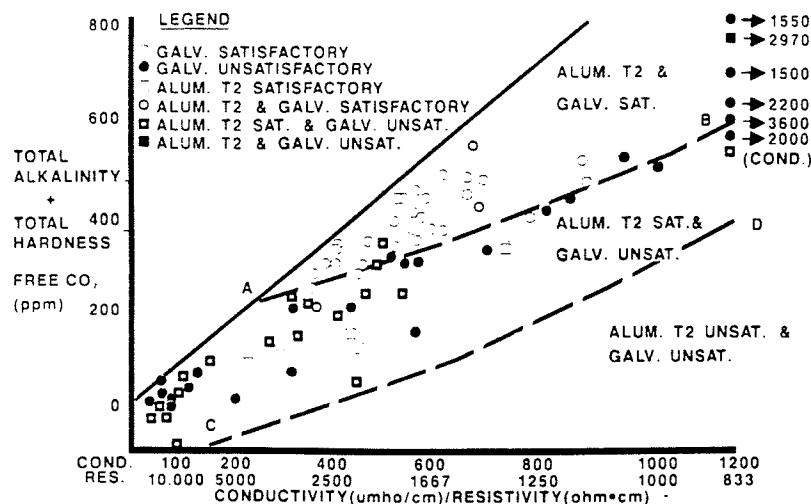
FIGURE 11 Effect of water chemistry on performance of aluminized and galvanized steel.

Line AB in Figure 11 marks the limit of increasingly severe conditions that galvanized steel normally can tolerate while providing satisfactory performance. Increasing severity is encountered from top to bottom and from left to right, and crossing line AB in either direction results in encountering problematic conditions. Traversing the graph from left to right shows the effect of constantly increasing corrosion-accelerator salt concentrations ( $\text{Cl}^-$ ,  $\text{SO}_4^{2-}$ , and so forth) at a fixed level of total inhibitors and free  $\text{CO}_2$ ; line AB marks the limit of accelerator salt tolerance at this inhibitor/ $\text{CO}_2$  level for galvanized steel. Traversing the graph from top to bottom shows the effect of decreasing inhibitor and increasing free  $\text{CO}_2$  at a fixed accelerator salt level; line AB marks the limit of inhibitor decrease or  $\text{CO}_2$  increase tolerable at this accelerator level for galvanized steel.

Consistent results with a rather well-defined boundary between satisfactory and unsatisfactory performance for galvanized steel were found. There was some overlap at the boundary, most likely caused by somewhat nonrepresentative water chemistry in a few cases, but the results are generally consistent and realistic in defining the suitability of galvanized steel.

The anticipated detrimental effects of water softness, acidity, and corrosion accelerators on galvanized steel are evident. The superior tolerance of aluminized steel for more severe conditions is also evident. Superior tolerance for soft acidic water is evident and well defined. Superior tolerance for higher corrosion-accelerator salt concentrations is suggested, as would be anticipated, but the number of pertinent data points is small at present and additional sites with high-conductivity water must be studied to help establish this.

The position of the limiting line for satisfactory aluminized performance (CD) is only tentative at present, but it is evident that the limit is considerably beyond line AB in the directions of increasing severity. The deterioration of aluminized steel was only minor at all sites with compound aluminized and galvanized steel pipe lengths, where galvanized steel performed poorly. Thus considerably more severe conditions than these would be necessary to produce the same degree of deterioration on aluminized steel in the same exposure time, and line CD must be located well beyond line AB. However, its location cannot be known accurately until the material exhibits considerable deterioration.

pipe life. In its present form, the graph provides a useful guideline for pipe performance, although it is expected to be conservative. It is extremely conservative for drier climates because the graph is based on data from wetter climates. It is also conservative in that the worst portion of a pipe length was used to designate the pipe condition. In addition, it is conservative for stagnant-water sites because lower dissolved oxygen contents in such water produce lower overall corrosion loss (when acidity is not extreme); most of the wet sites in this study had flowing water. The graph is very conservative for material thicker than 16 gauge and for situations that do not require 50 years of maintenance-free life for 16-gauge material.
