## Applications of Permanent Precast Polymer Concrete Forms for Concrete Rehabilitation

DOUGLAS BARNABY and JAMES T. DIKEOU

### ABSTRACT

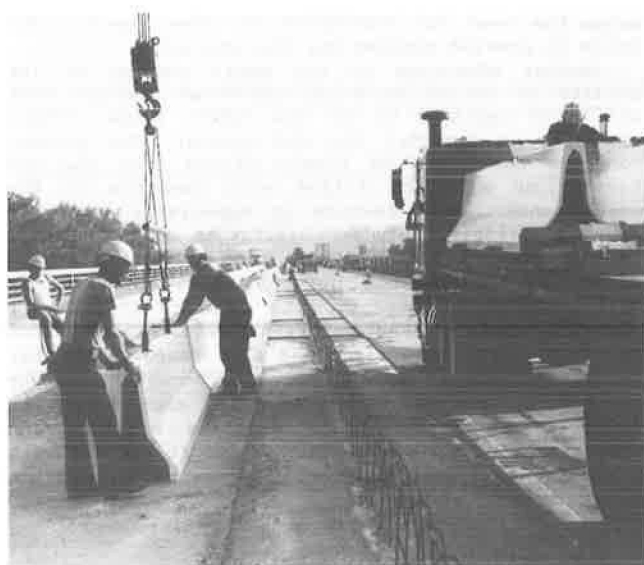
FIGURE 5 Pennsylvania Turnpike: Erection crew unloading polymer concrete shells prior to setting over reinforcing bars.

Erection of the shells began as soon as the trailer load of 12 20-ft sections arrived. (The ability to transport a large number of sections per trailer load minimized the size of the staging area.) The shells were then unloaded by a three-man crew and placed in their approximate location--plus or minus a few inches. After the shells were unloaded, the same crew dropped back to align and anchor them to the roadway with anchor bolts set through clip angles at the base of the sections (Figure 3). After anchoring, they were ready to be filled with 3,000 psi concrete through-holes provided at the top of each section. Figures 5 and 6 show photographs of the erection process.

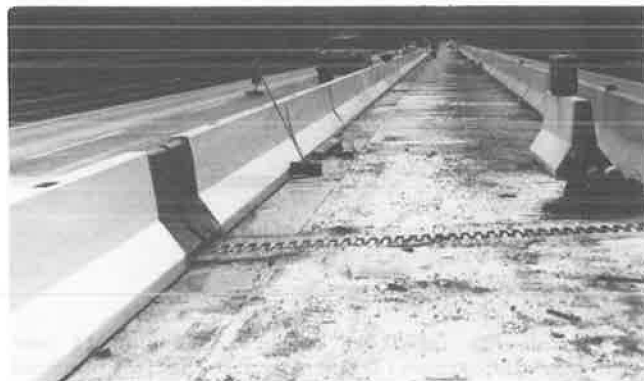
FIGURE 6 Pennsylvania Turnpike: Polymer concrete shells installed and awaiting placement of infill concrete. (Note the pour holes at the top of the barrier and the splice section to the right).

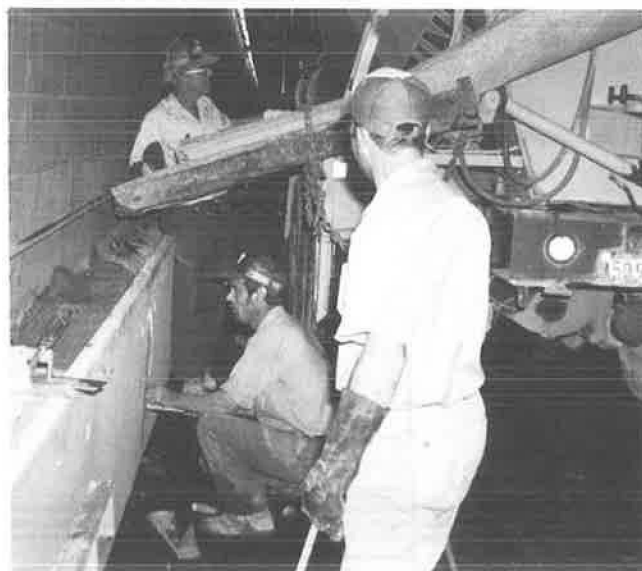
FIGURE 9 Sumner Tunnel, Boston: Work crew places conventional portland cement concrete with a superplasticizer additive between the polymer panel and the existing sidewall concrete.

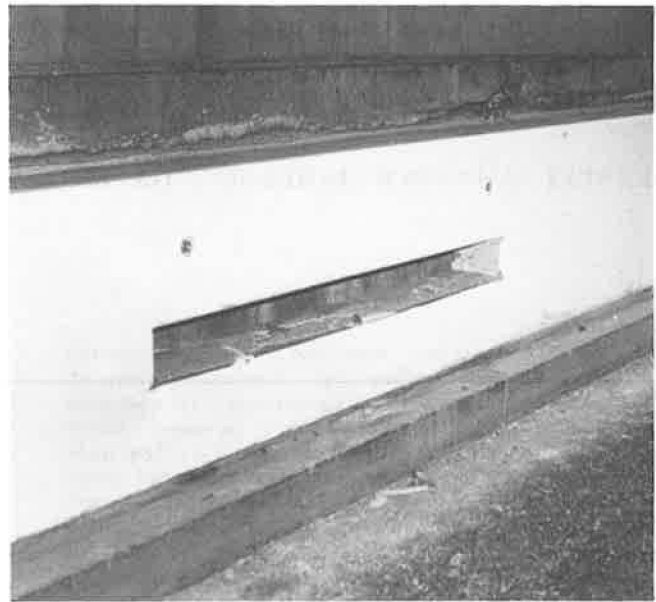
FIGURE 10 Sumner Tunnel, Boston: Completed bench wall repair showing contrast of old and new. Anchor holes were filled with a matching plastic plug to create a uniform smooth surface.

Because both lanes of the tunnel must be operational during the day to handle the estimated 80,000 car-per-day volume, construction was begun at midnight and continued through 5:30 a.m. A crew of 12 men placed and anchored approximately 36 15-ft panels per shift. The erection operation on a given shift began by bringing into the tunnel a flatbed trailer with enough panels to be set that evening. The trailer was equipped with a boom device that lifted the panels off the trailer and set them into predrilled holes in the sidewalk to receive anchors that were cast into each panel. Figure 8 shows the anchoring system for the panels. An alignment crew followed up the unloading operation by anchoring the panels to the sidewall. Vent openings were sealed off to prevent backfill concrete from coming out. A modified concrete mix with a superplasticizer was then placed behind the panels (Figure 9). The vertical joints between the panels were sealed and the contractor plugged the anchor holes with a special plastic plug to create a smooth uniform surface. Figure 10 shows the completed bench wall repair. All work had to be completed before the morning rush hour.
