Close-Range Photogrammetry for Bridge Measurement

FRED B. BALES

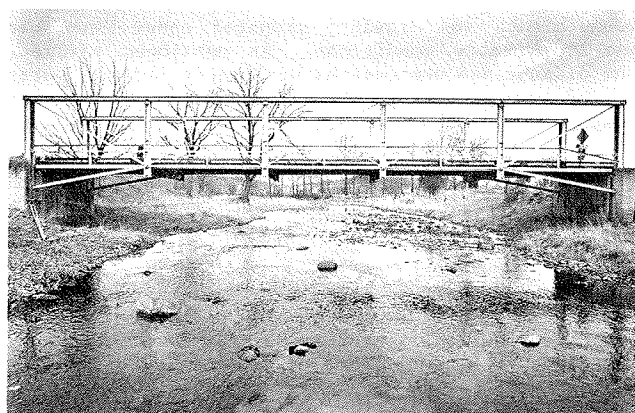
FIGURE 8 Pony truss bridge, Augusta County, Virginia.

The two structures selected for inclusion in this paper to show historic documentation illustrate measurements and drawings prepared under favorable and unfavorable conditions. As mentioned earlier, the close-range photographs were taken under a variety of weather and lighting conditions. A bedstead pony truss bridge was photographed under overcast skies in a drizzling rain with a fairly large object-to-camera distance (Figure 8). This is the type of condition to be avoided if at all possible. The drawing of this bridge, a side elevation, was prepared to a scale of 1 in. = 3 ft (Figure 9).

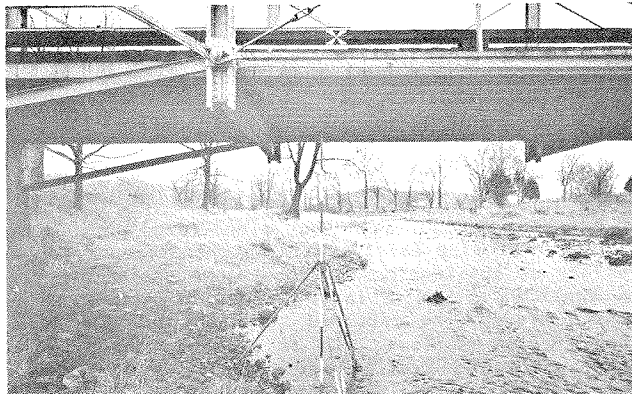
FIGURE 10 Pony truss bridge: joint detail.

Results similar to those for the overall elevation of the bedstead pony truss were experienced in checking the elevation of the joint detail of this bridge (Figures 10 and 11). The results were better, in most part because of a shorter object-to-camera distance. From a percentage standpoint, 67 percent of the errors in measurement were less than 1/16 in. and 92 percent were less than 1/8 in. (Tables 4 and 5).
