Cathodic Protection of Reinforced Concrete by Using Metallized Coatings and Conductive Paints

JOHN A. APOSTOLOS

ABSTRACT

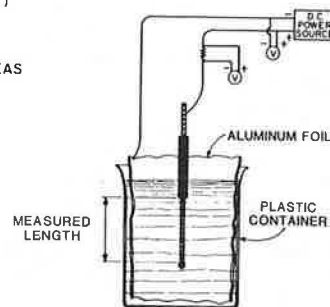
FIGURE 1 Schematic--wire consumption test.

All metals in wire form were tested in the circuit shown in Figure 1. A measured and weighed length of each wire was immersed in a container of salt water (3.5 percent NaCl solution by weight). The wire was partly coated with wax so that a length of 2.5 in. would be in contact with the water. An external power supply created a potential in the range of 1 to 2 V between the wire and the aluminum foil lining of the container. This caused the wire to discharge current into the water and thus consume itself. Testing was ended when a significant portion had been consumed, but before the wire broke at its thinnest point. Subsequent weighing and computations provided values for consumption rates (Table 1).

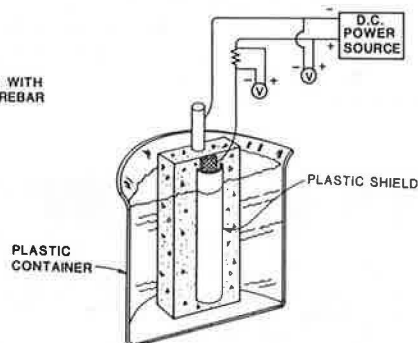
FIGURE 2 Schematic--CP current delivery to reinforced-concrete specimen.

shown in Figure 2. Each material was painted or sprayed in the form of stripes on the surface of all reinforced-concrete test specimens. Applied quantities were estimated, but because of the small areas involved, the precision of these values was low. The main usefulness of this test was to imitate real-life conditions (with the exception of current density) and establish whether or not some coatings (especially the metals) would lose bond or quickly develop a poorly conductive oxide layer between themselves and the concrete.

The concrete specimens measured 2.25 x 4.5 x 15.0 in. and each contained a 0.5-in.-diameter embedded reinforcing bar. Because most real-structure CP applications would be retrofitted on already salt-contaminated structures, the reinforced-concrete specimens were selected from a stockpile that had been previously exposed to months of immersion in saturated salt water.

The reinforced-concrete specimens were immersed in a container of tap water. As water was absorbed into the concrete, it reactivated the salt within and thus provided resistance values that were closer to real-life structures during wet periods.

To ensure that CP current would be discharged directly from the conductive coatings to the concrete, the exposed surface of the coatings had to remain dry. This was accomplished by a plastic shield epoxied around the conductive material and sealed at the bottom. Being "in the dry," the coatings could not discharge current into the water, but acted in a manner that simulated real-life conditions.

An external power supply created a constant potential of 12 V between the conductive material and the embedded steel. This caused the coating to discharge current into the concrete and thus consume itself. In most cases the current delivered to the steel was considerably in excess of that needed to provide full cathodic protection; the aim of the test was to consume the coating at a rapid rate.

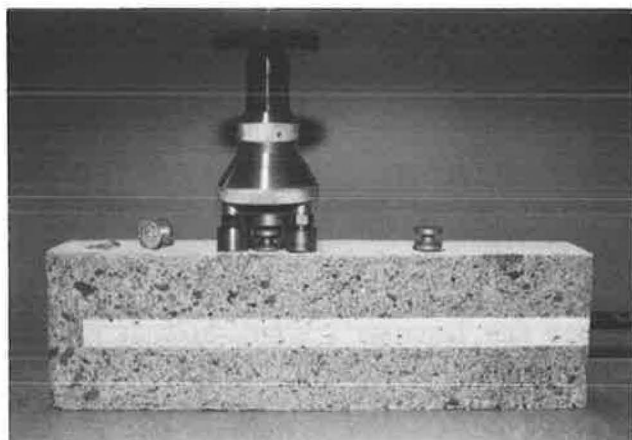
FIGURE 3 Adhesion tester and dollies on coated concrete.

Pullout bond tests were conducted by using a 0.75-in.-diameter aluminum dolly epoxied to the coating surface. The epoxy is allowed to cure, and the dolly is then pulled with a calibrated device until bond failure occurs (Figure 3). The tensile stress at failure, in pounds per square inch, is directly read from the device (an Elcometer Adhesion Tester Model 106).

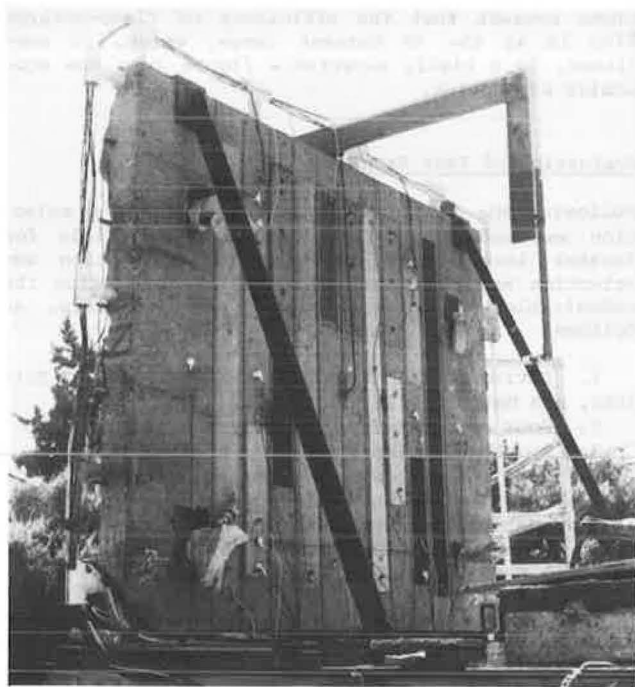
FIGURE 4 Reinforced-concrete slab with coated stripes.

For this test the slab was sandblasted and mounted vertically, thus simulating a wall. Vertical stripes (4 x 60 in.) of conductive materials were applied to the smooth (formed) face of the slab. Smaller stripes (4 x 20 in.) were also applied as reserves (Figure 4).

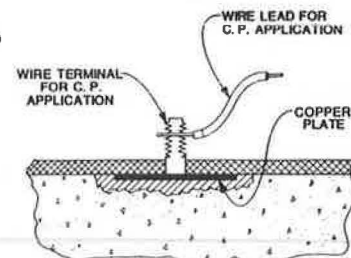
FIGURE 5 Schematic—electrical connectors.

nection devices (Figure 5) were fastened flush with the concrete surface by using epoxy. These connectors consisted of a 2 x 2 x 0.03-in. copper plate, which received a coating along with the concrete, and a binding post to which the conductor carrying the CP current was connected. The epoxy (a dielectric) prevents the current from being discharged directly from the copper plate to the concrete. Instead, the current flows to the conductive coating and is distributed over the entire coated surface.

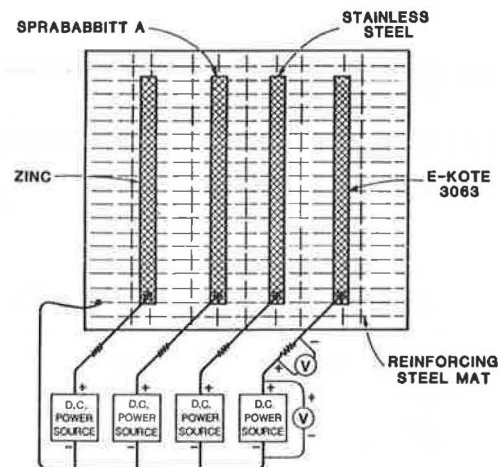
FIGURE 6 Schematic—CP current delivery to reinforced-concrete slab.

All four materials were tested in the circuit shown in Figure 6. The external dc power supplies were adjusted to deliver a constant current of 0.050 amperes (30 milliamperes per square foot of coating) up to the point where the circuit resistance required a maximum of 30 V. Current and voltage were continuously monitored with automatic data-recording devices. It should be noted that the current density being applied was considerably higher than the expected value in an operational system. This was done to obtain useful data in a period of months, rather than years. Figure 7 presents the test record to

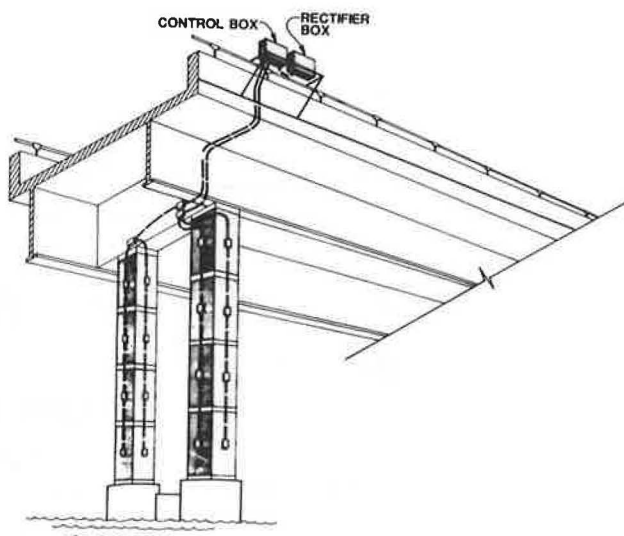
FIGURE 8 Pier 4, Richmond-San Rafael Bridge.

The structure is pier 4 of the Richmond-San Rafael Bridge, located in the northern half of San Francisco Bay. Each pier consists of two reinforced-concrete columns (3.5 x 3.5-ft cross section) of varying height. Pier 4 columns are 20 ft high and their base is cast monolithically onto 6-ft-diameter solid reinforced-concrete shafts. The column bases are about 10 ft above high tide and are subject to a combination of salt air, fog, rain, and wave action. The resulting corrosion distress has been severe enough to necessitate replacement of entire columns in nearby piers.

One column was coated with zinc and the other with Sprababbitt A. Before coating, the concrete was sandblasted and copper and stainless-steel electrical connections (Figure 5) were epoxied onto the concrete surface. To study the distribution of current, the metals were applied in four horizontal bands on each column, with 6-in. bare gaps between them, as shown in Figure 8. The bare gaps were used as locations for taking electrical potential measurements.

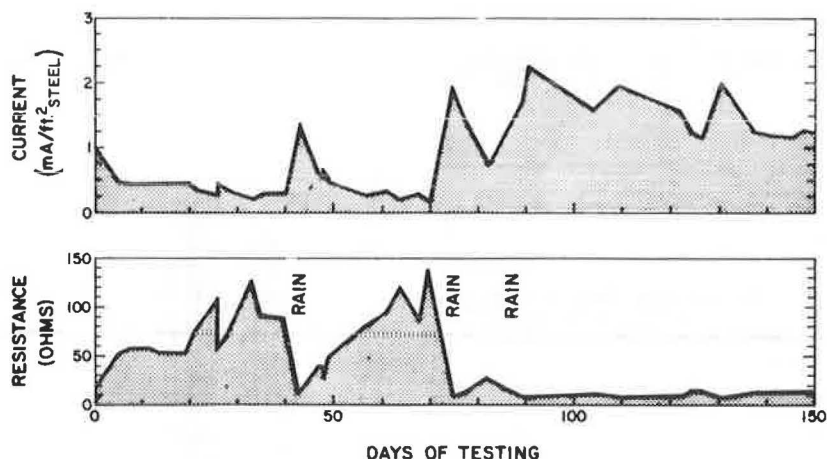
FIGURE 9 Record of zinc-coated column—pier 4, Richmond-San Rafael Bridge.

Because of the changing environment (temperature, wind, tides, fog, rain, and so forth), the current densities varied, as expected, averaging to date 0.98 and 0.84 milliamperes per square foot of steel for Sprababbitt A and zinc, respectively, with peaks approaching, and at times exceeding, 2 milliamperes per square foot during wet weather (Figure 9).

It is too early to evaluate the results on the pier. At this time, both coatings are performing well. It is estimated that, at the present average current densities, the coatings will theoretically last 17 years for Sprababbitt A (estimated coating = 0.29 lb/ft²) and 21 years for zinc (estimated coating = 0.30 lb/ft²). Allowing an efficiency factor (estimated at this time to be 50 percent) the Sprababbitt A should provide CP for about 9 years and the zinc for about 10 years.
