TRANSPORTATION RESEARCH RECORD 962

# Bridge Maintenance Management, Corrosion Control, Heating, and Deicing Chemicals

TRANSPORTATION RESEARCH BOARD  
NATIONAL RESEARCH COUNCIL

WASHINGTON, D. C. 1984

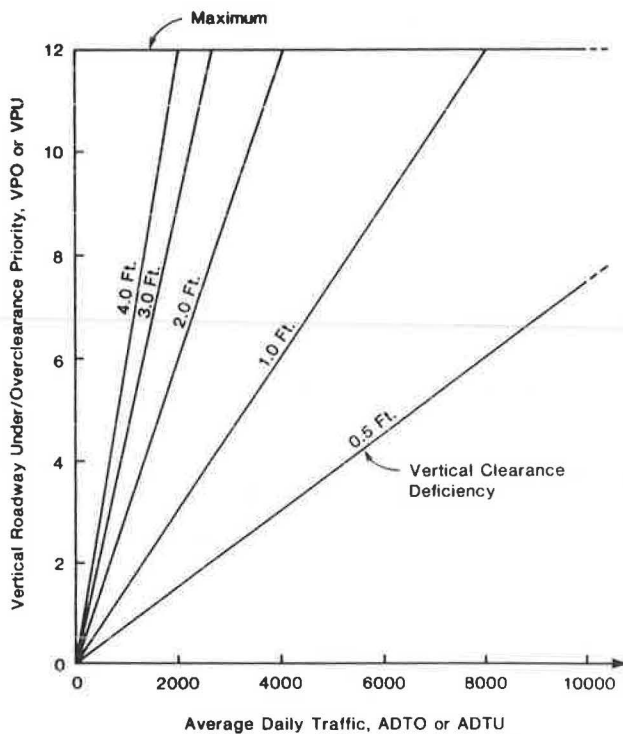
FIGURE 4 Clearance priority versus ADT and clearance deficiency.

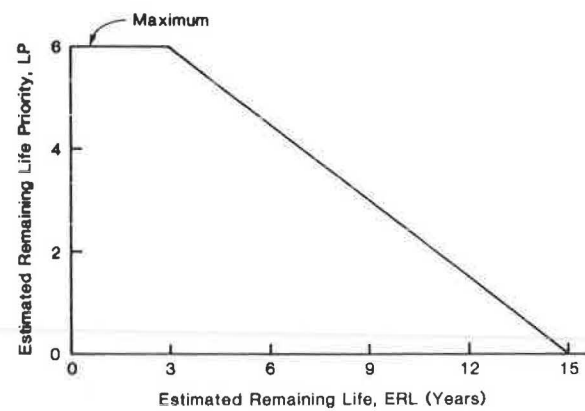
FIGURE 5 Remaining life priority versus estimated remaining life.

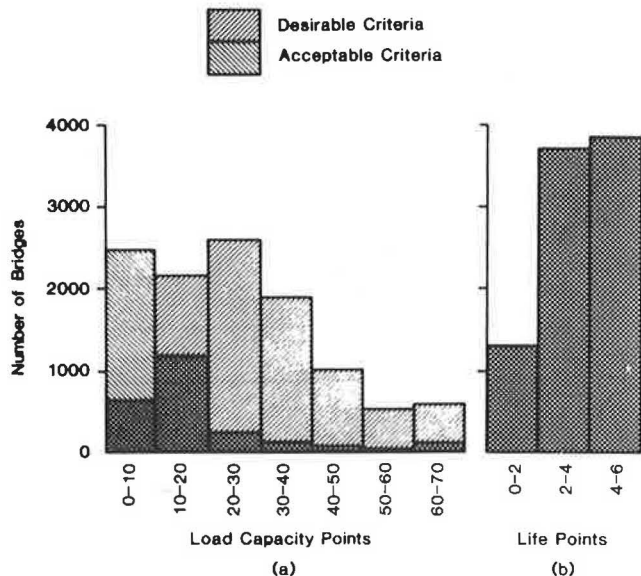
FIGURE 6 Distribution of deficiency points due to load and remaining life.

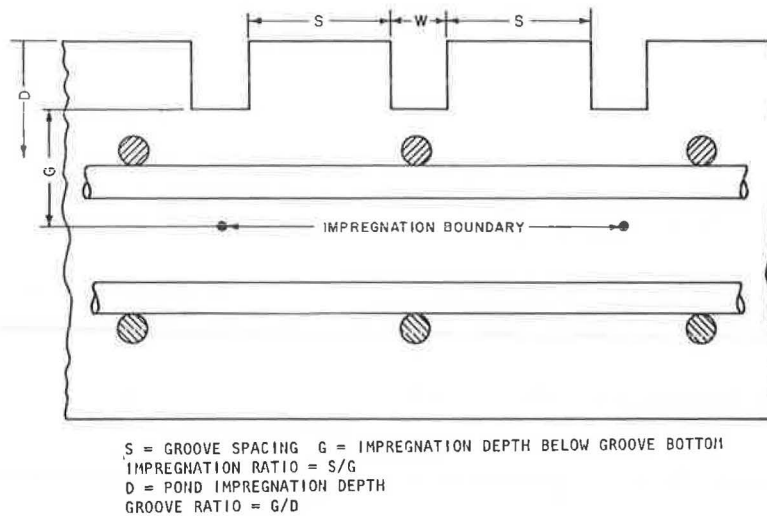
FIGURE 2 Impregnation ratio and groove ratio.

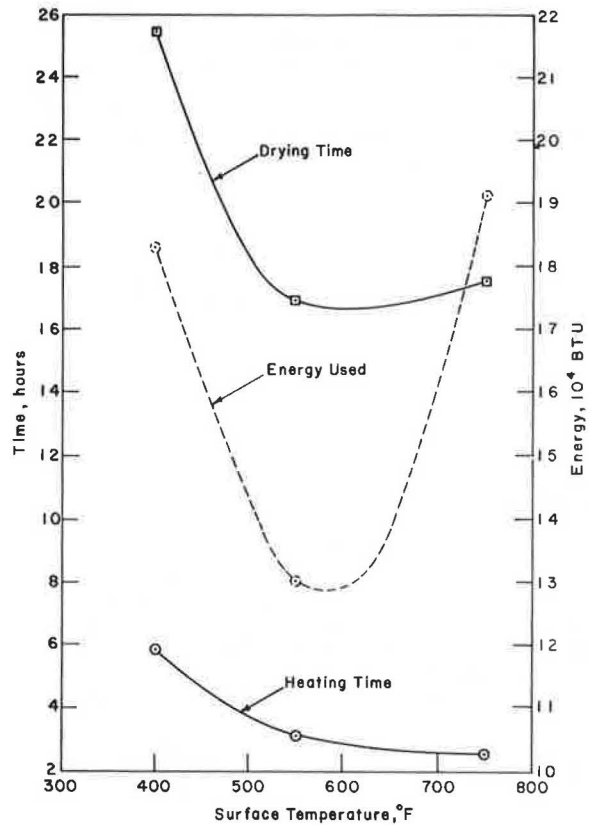
**FIGURE 6 Drying and heating time and energy.**

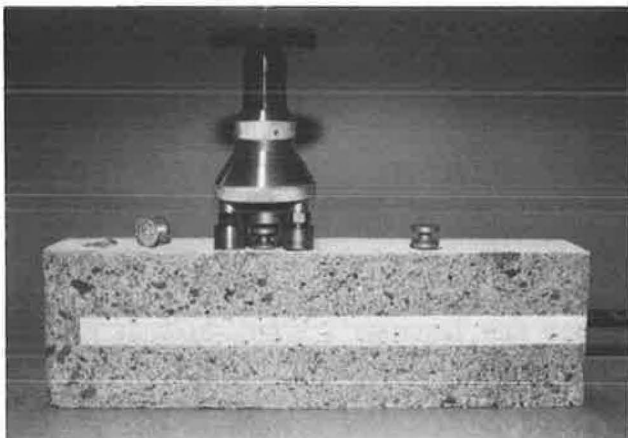
FIGURE 3 Adhesion tester and dollies on coated concrete.

Pullout bond tests were conducted by using a 0.75-in.-diameter aluminum dolly epoxied to the coating surface. The epoxy is allowed to cure, and the dolly is then pulled with a calibrated device until bond failure occurs (Figure 3). The tensile stress at failure, in pounds per square inch, is directly read from the device (an Elcometer Adhesion Tester Model 106).

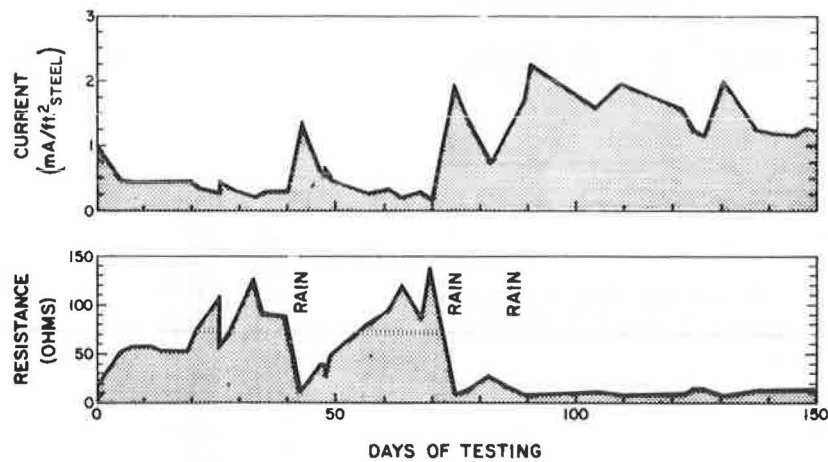
FIGURE 9 Record of zinc-coated column—pier 4, Richmond-San Rafael Bridge.

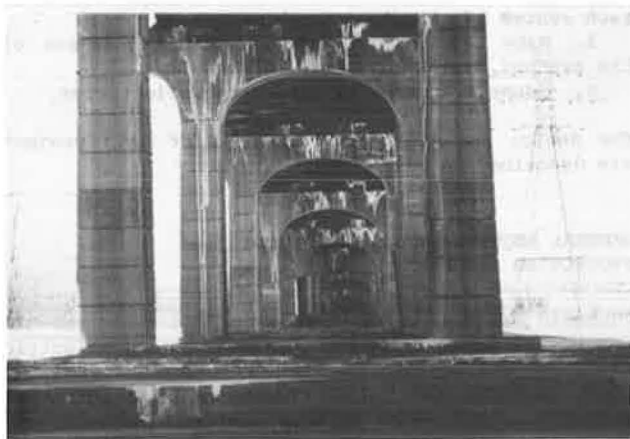
FIGURE 1 Salt staining on pier bents, Burlington Bay Skyway.

The Burlington Bay Skyway Bridge, which is a multiple-span, high-level structure over the entrance to Hamilton Harbour in southern Ontario, was selected for the installation of the test systems. The rectangular columns of the structure are exposed to surface run-off from leaking expansion joints and roadway drains. Salt-staining is frequently visible in the winter months, as shown in Figure 1. The condition of the columns is a function of the exposure

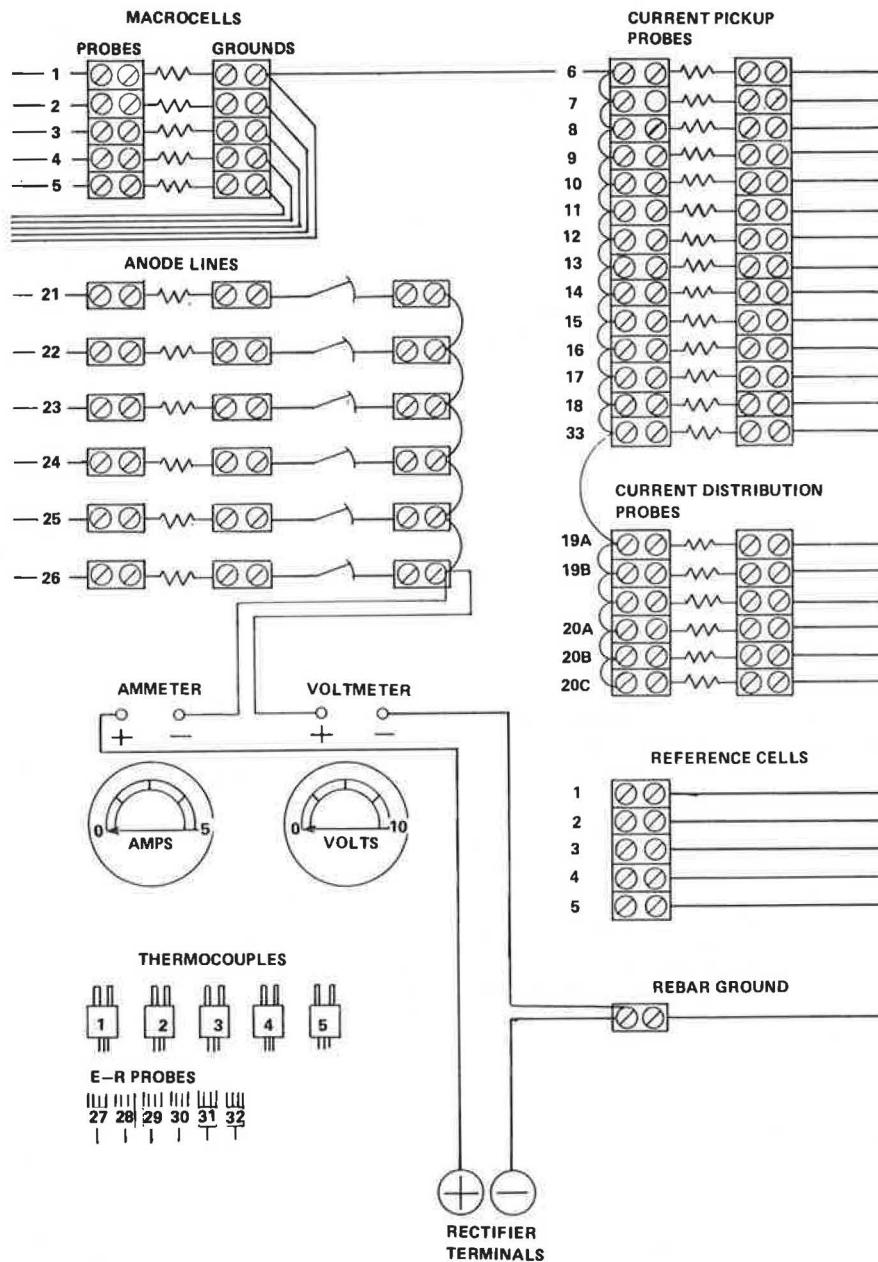
FIGURE 5 Terminal box layout (System 3).

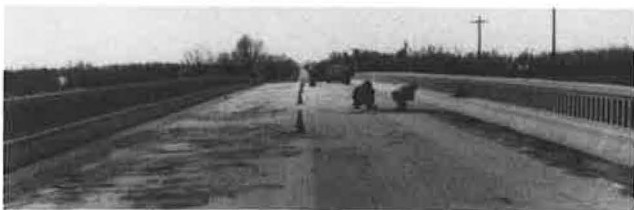
FIGURE 1 A 16-year-old polypropylene fabric membrane covering part of the deck in right foreground.
