A Geogrid-Reinforced Soil Wall for Landslide Correction on the Oregon Coast

THOMAS SZYMONIAK, J. R. BELL, GLEN R. THOMMEN, and EDGAR L. JOHNSEN

ABSTRACT

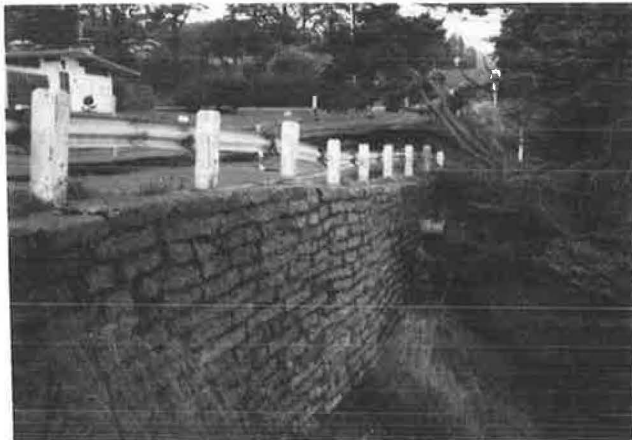
FIGURE 2 Site before construction.

rubble wall, and forced the closure of the main entrance to the popular Devil's Punch Bowl State Park. Figure 2 shows the original concrete rubble wall and the extent of the slide failure.

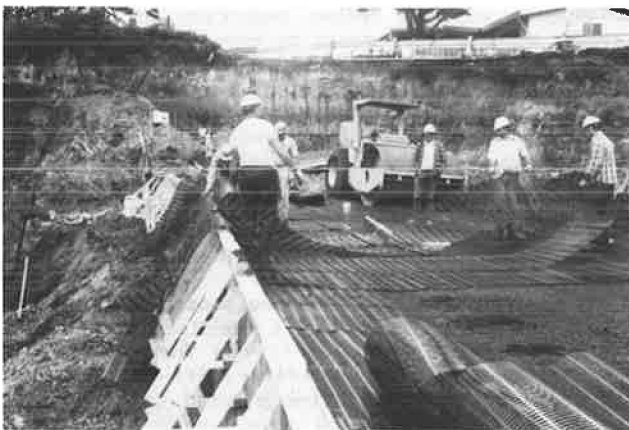
FIGURE 15 Modified forming system.

The contractor's solution to the forming problem is shown in Figures 15 and 16. Figures 15 and 16 show the modified forming system and the new forms. The forms employed by the contractor were stiffened with 2 x 4-in. lumber and braced against a 2 x 4-in. support extending 4 ft into the backfill to provide an anchor. The protruding end of the horizontal anchor was supported by a vertical member and an 8-in. spike was driven at the end of the support into the lower layer. The bottom of the 3/4-in. plywood form was held in place by 2 x 4-in. lumber nailed to the anchor support. At least three braces were used on each 8-ft forming unit. The new forming system required considerably more time to construct but did provide a stable face against which to build.
