Development of Proposed Height Standards and Tolerances for Light-Post Traffic Barriers

JAMES E. BRYDEN

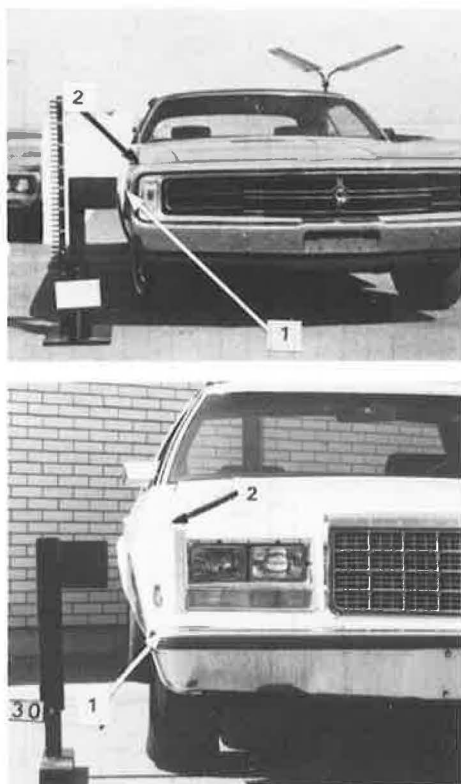
FIGURE 1 Guiderrail override (1) and underride (2) points on 1969 (top) and 1981 (bottom) Chrysler sedans.

The data in Table 3 give geometric characteristics for a sample of vehicles from that period, with two specific measurements provided: first, the height to a point on the bumper that can lead to vaulting if that point reaches the top of a barrier, and second, the height to a point on the hood that can result in underriding if this point gets below the bottom of the rail. Examples of 1969 and 1981 vehicles with these points marked are shown in Figure 1.

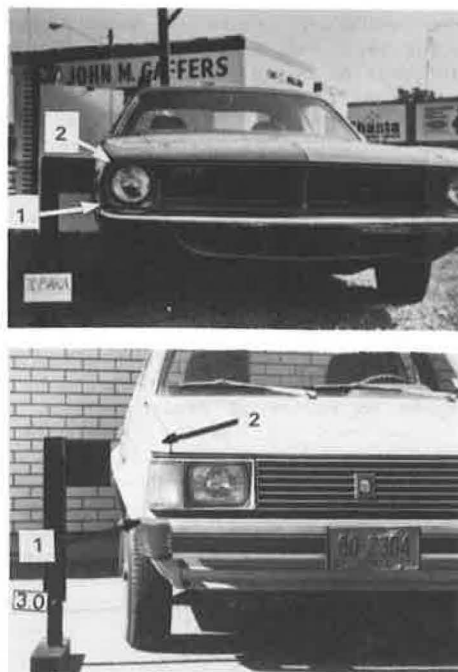
FIGURE 3 Box-beam override (1) and underride (2) points on 1970 (top) and 1980 (bottom) popular small sedans.

high. Figure 3 shows examples of 1970 and 1980 small vehicles adjacent to a box-beam mounted at 30 in., which presents a risk of underriding.

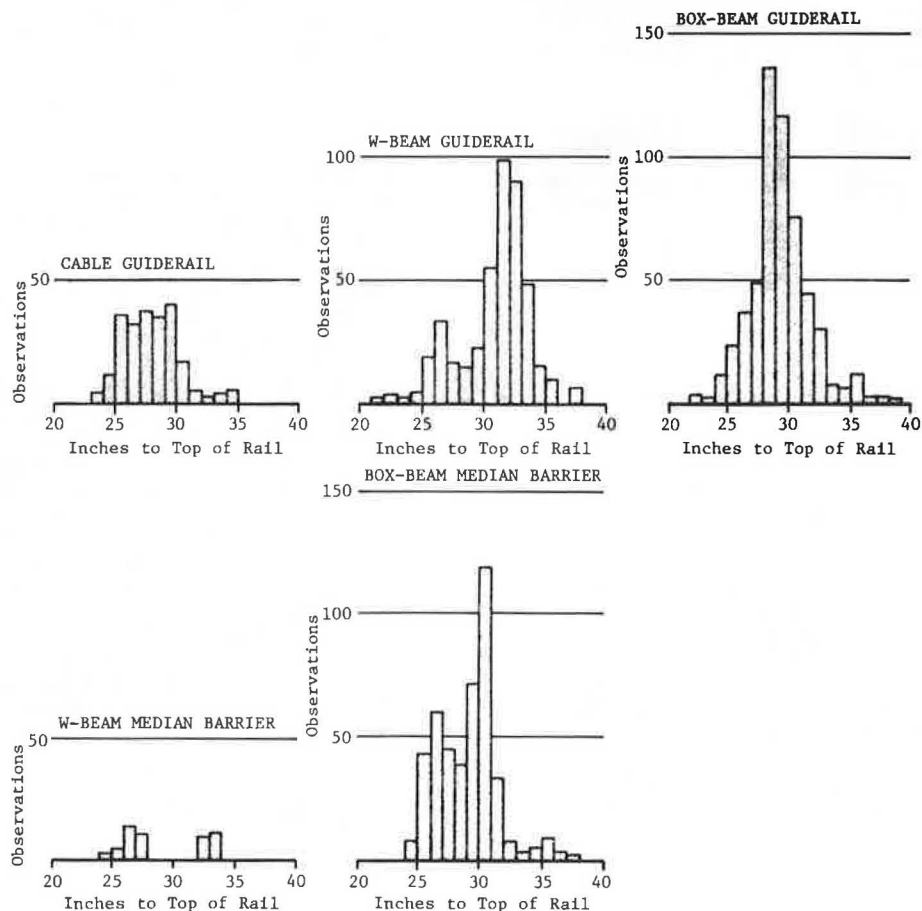
FIGURE 6 Distribution of rail mounting heights on 47 New York State contracts (1969-1971).
