Construction and Difficult Geology: Karstic Limestone, Permafrost, Wetlands, and Peat Deposits

TRANSPORTATION RESEARCH BOARD
NATIONAL RESEARCH COUNCIL

Transportation Research Record 978
Price \$10.80

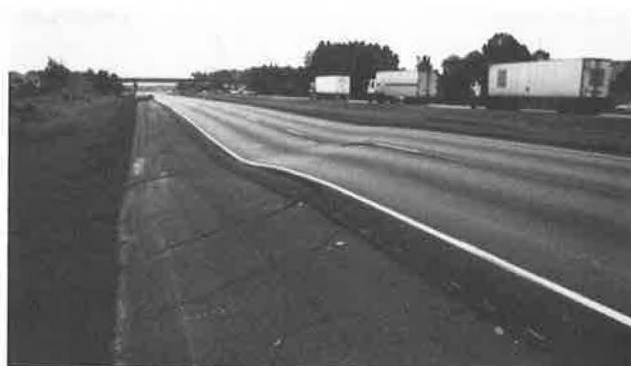
FIGURE 2 Subsidence on I-75 near Alachua, Florida.

subsidence that was located in a topographic low. The southbound lanes of I-75 were closed because of concern about the possibility of a collapse after a depression and cracking occurred in the pavement (Figure 2).

The distressed area extended from the western portion of the median, west across the pavement, and about 30 ft (9 m) beyond the right-of-way to surface cracks, which were displaced vertically about 5 in. The observed cracks did not form a continuous circular shape but, when mapped (as shown in Figure 3), they revealed an elliptical pattern approximately 140 ft (43 m) wide that was estimated to be more than 180 ft (55 m) long. Borings down to 75 ft (23 m) indicated sandy soils with isolated clayey soil lenses. The water table was not encountered at this depth, even though there had been considerable rainfall for several months preceding the subsidence.

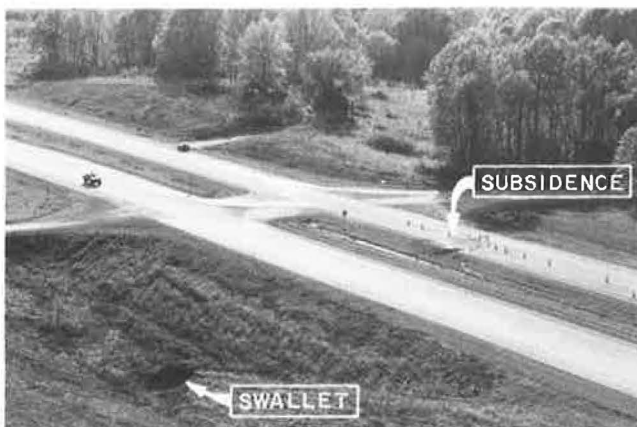
FIGURE 1 Subsidence caused by piping from water introduced into a sinkhole along TN-76.

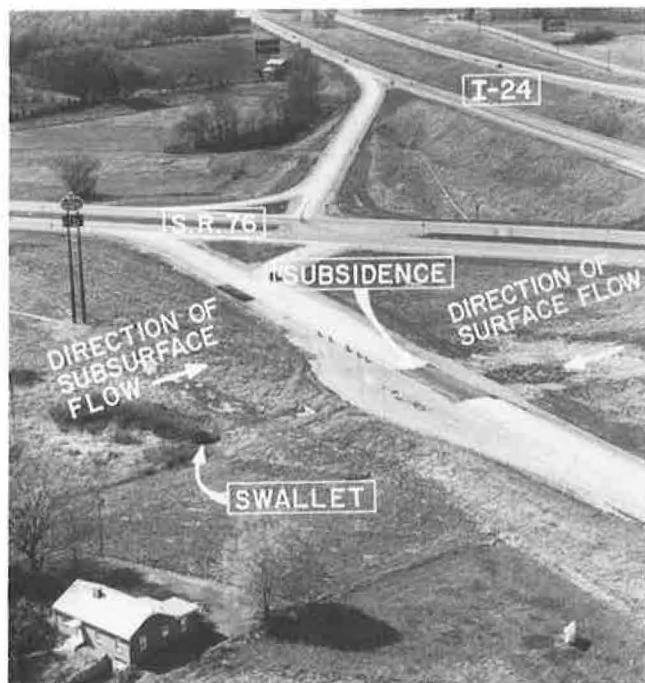
FIGURE 5 Subsidence of the I-24 eastbound on-ramp as viewed in April 1980.

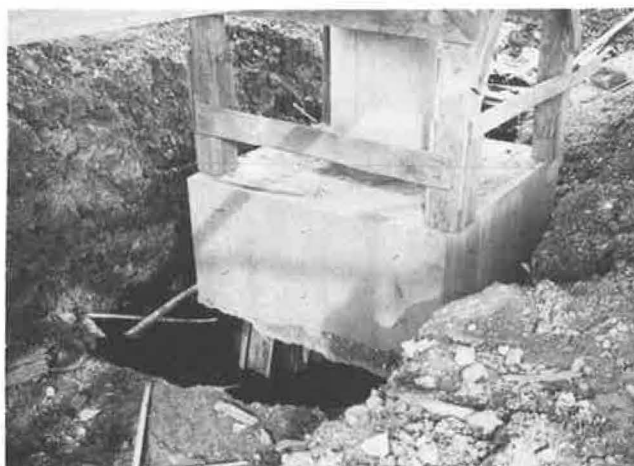
FIGURE 7 Close-up view of the collapsed condition shown in Figure 6.

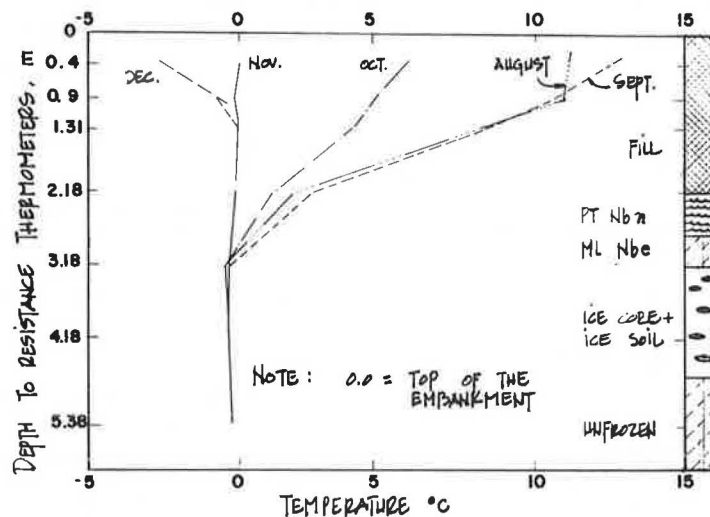
FIGURE 5 Thermal regime of a palsa: test embankment, access road to GB-1, 1981.

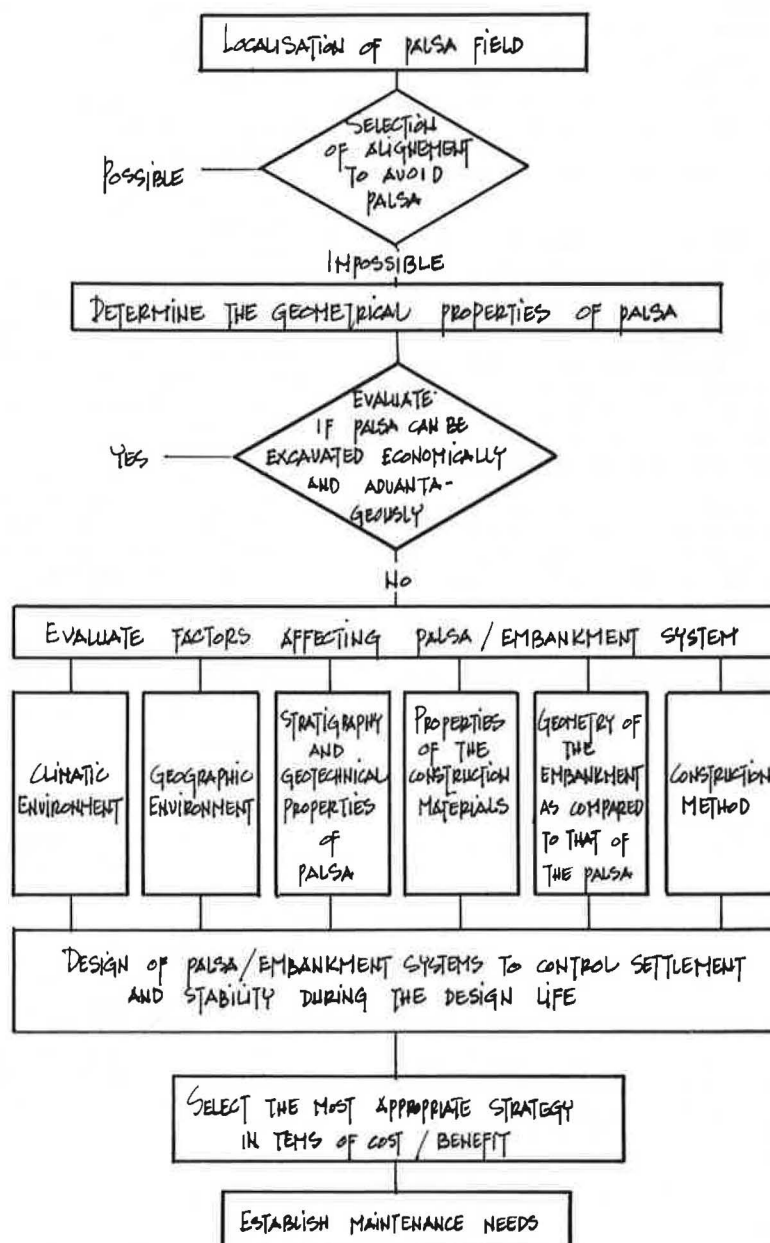
FIGURE 16 Steps involved in the design of embankment over palsa.

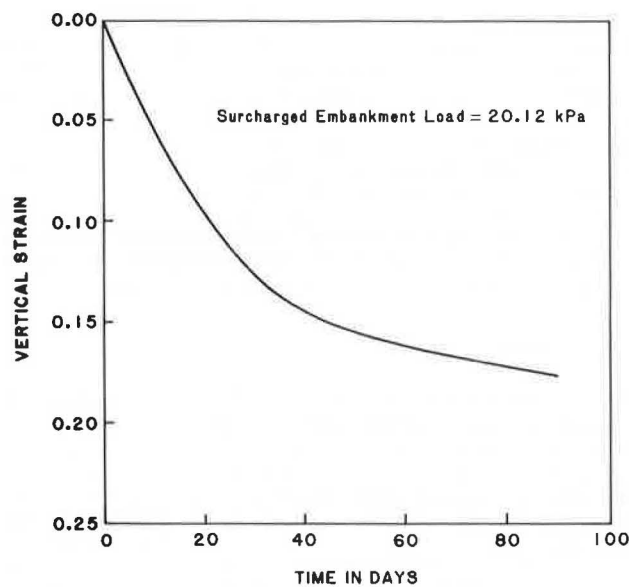
FIGURE 1 Settlement data from plate 89.

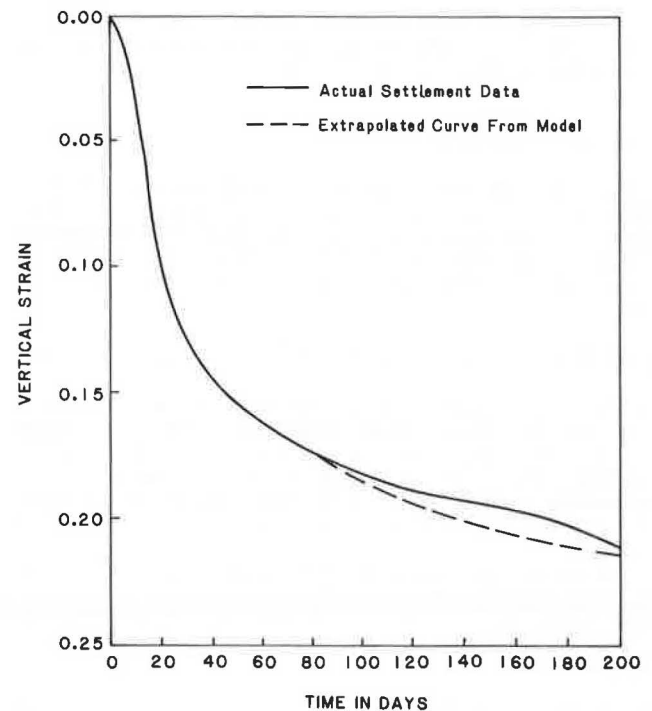
FIGURE 3 Actual and estimated settlement behavior.

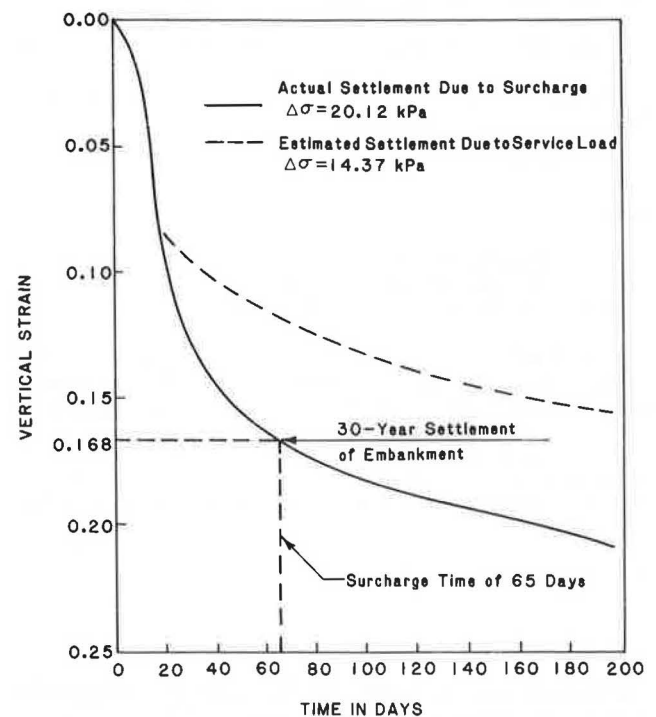
FIGURE 4 Actual field settlements and anticipated settlement due to service load only.

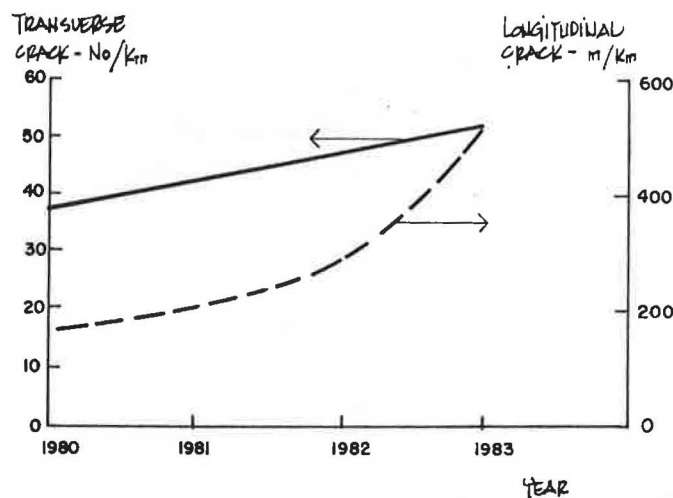
FIGURE 7 Progression of cracking of pavements built over peat deposits, James Bay access road.

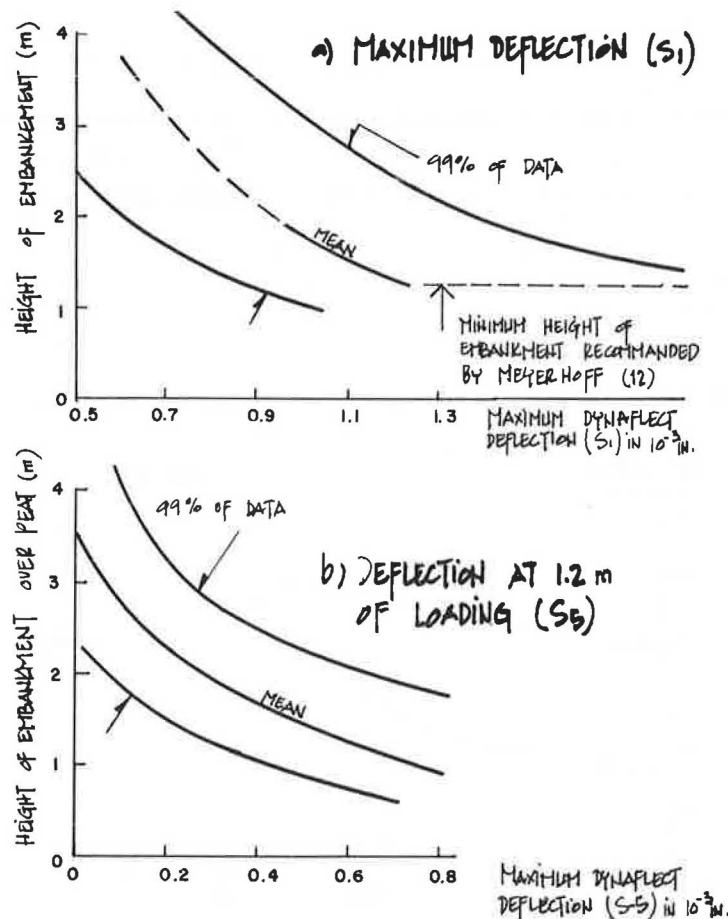
FIGURE 8 Influence of the height of embankment on maximum Dynaflect deflection and deflection at 1.2 m when the thickness of peat is at least 1.5 m.
