Deterioration of Bituminous Pavement Surfaces by Growth of Alum Crystals

JAMES R. DUNN

Some 1.5-in. bituminous pavements in Stafford County, Virginia, have developed numerous small domes from 2 to 4 in. in diameter and about 1 in. high. Each dome has a core of white, astringent-tasting crystals that are under the bituminous pavement and at the top of the subbase. The crystals appear to be closest in composition to pickeringite, a magnesium alum, which commonly results from the weathering of pyritic schists. The domes were observed primarily between vehicle wheel tracks and in areas of poorest drainage. The aggregate in the bituminous pavement is quartz sand and gravel and does not appear to be casually involved in the deterioration. The subbase aggregate is largely crushed biotite schist and granite and is from a quarry near Culpeper. Analyses of water in the quarry and of salts leached from stone piles indicate that the quarry is the probable source of the alum, and that the salts are in the subbase stone. It appears that salts concentrate under the bituminous pavement because water without the contained salts moves through the bituminous pavement, which appears to act as a semi

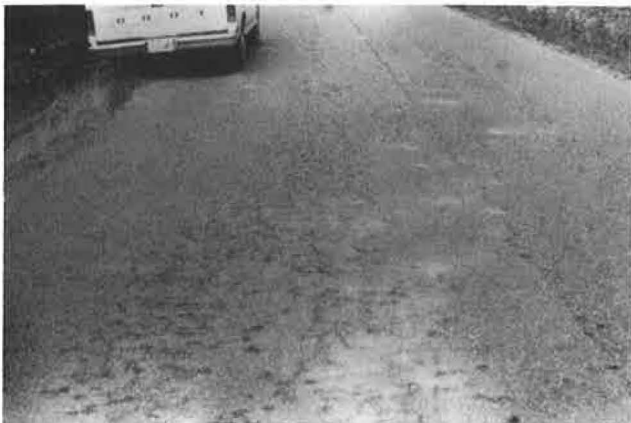
FIGURE 1 Distribution of deterioration domes in pavement.

The deterioration consists of roughly circular domes in bituminous pavements. The domes are from 2 to 4 in. in diameter and are up to about 1 in. high. Usually some tension cracking has occurred at the top of the domes, apparently because of stretching of the pavement when it is domed upward. The domes tend to occur in groups, with the individual domes from a few inches to about a foot apart (Figure 1). (Note the tendency of the domes to occur in between the areas of the maximum number of wheel passes. Tension cracks occur at the top of the domes.) In

places, the domes coalesce and the deterioration becomes general. The domes tend to occur toward the middle of pavement areas and where vehicle wheels do not make many passes.

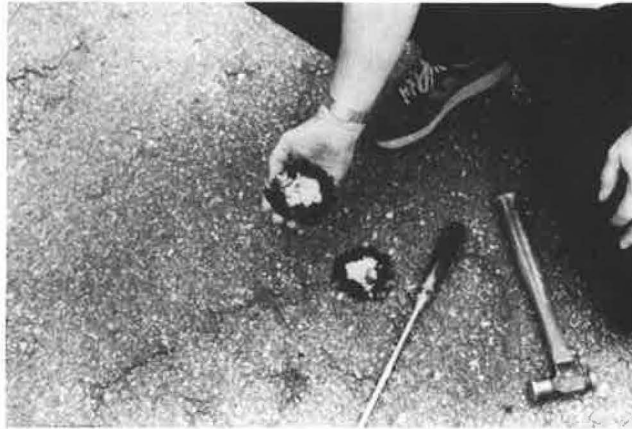
FIGURE 2 Typical dome pried out of the pavement.

At the center of each mound (mostly beneath the pavement, but in some cases working up into irregularities in the pavement) is a mass of fine-grained, white, crystalline salt with an astringent taste (Figure 2). (Note that the white salt is in the center of the dome, and none gets into the pavement.) Where the mounds coalesce, the crystalline material is more or less continuous (Figure 3). Where there were no salt domes, no white crystals were observed under the pavement.

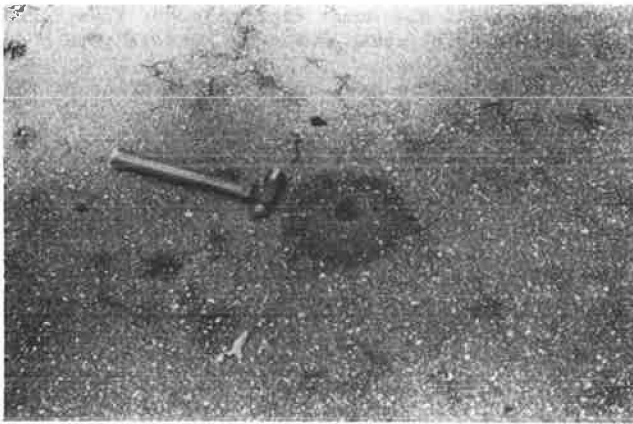
FIGURE 4 Breached dome from which salts apparently erupted to form a damp-appearing halo.

At two locations breached domes were observed (Figure 4). (Note that more typical unbreached domes occur around the breached dome.) Saline solution apparently had leaked through the dome, perhaps because of hydrostatic pressure from below. In each case a whitish concentration of salt was visible immediately around the dome and a damp-looking area about 6 to 8 in. in diameter ringed the dome.

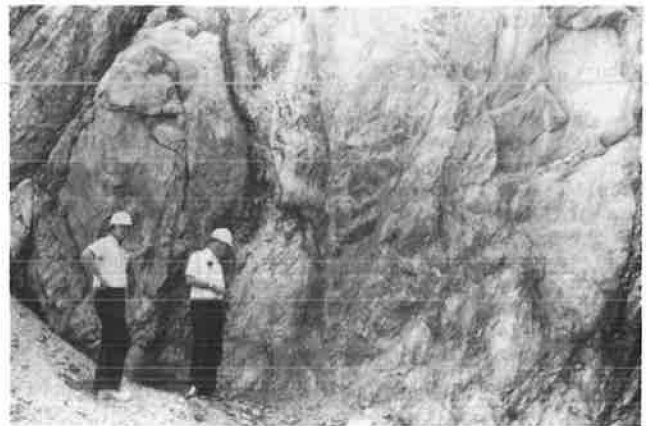
FIGURE 5 Salt efflorescence around water course, upper lift, Spotsylvania quarry.

Seepages of water along fractures in the rock were observed in several areas, and salts that varied from white to brownish were precipitated around the seeps (Figure 5). The seeps were most obvious at the upper two lifts, but some seepage was noted at the lowest lift. The sump pump operates intermittently at the rate of about 600 gal/min, averaging about 50,000 gal/day. The water is pumped to a surface pond that empties into a local stream. The quarry is closed during winter months, during which time the water rises to a depth of 15 to 20 ft.

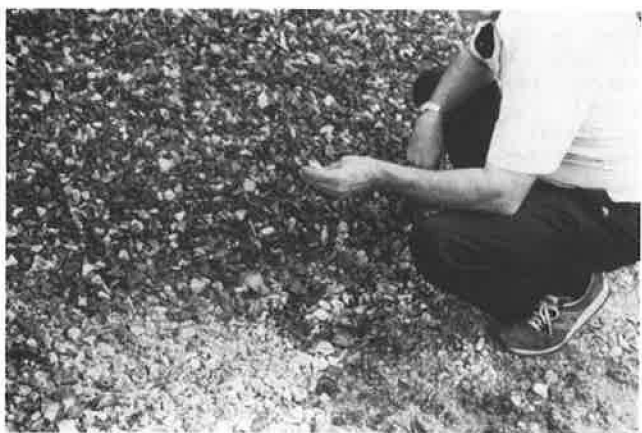
FIGURE 6 Alum salt-covered Virginia size No. 19 aggregate particles, base of relatively fresh appearing aggregate pile, laid down 2 years, south of maintenance shop.

Another pile of crushed stone was observed south of the maintenance shop. The pile, which had been in place for about 2 years, showed little tannish or brownish stain and was primarily a medium to dark gray. Biotite schist was abundant, comprising about 75 percent of the pile in local areas. Abundant salts were observed around ponded areas, and the salts cemented much of the interior of the pile,

particularly at the lower one-third (Figures 6 and 7). The salt crusts had an astringent taste. Some particles of biotite schist at the base of the pile were partially disintegrated.

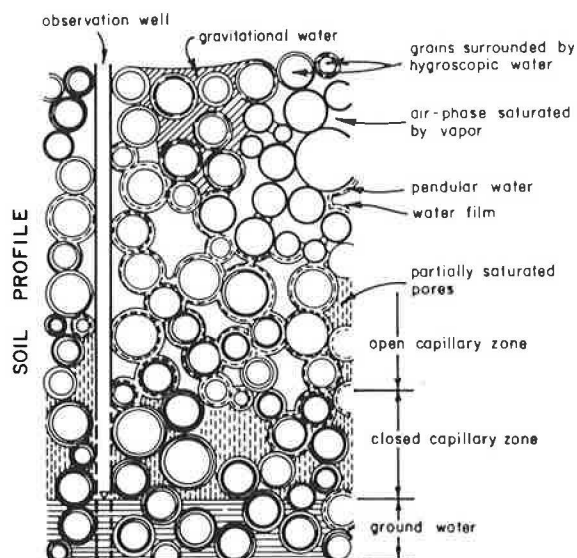
FIGURE 8 Types of water in soils.

Because water gets through the blacktop but salt does not, the pavement is apparently acting as a semipermeable or relatively impermeable membrane that transmits water but not its contained salts. When water moves to the surface of the pavement to evaporate, the salt apparently cannot get through, is left behind, and concentrates. Very probably the particles of mica schist start deteriorating before the salts saturate, and these particles are reduced to sand-size debris. The virtual absence of mica schist particles below the salt crystals is an indication of the probable efficiency of the deterioration process. The zones where such particles existed then become zones where capillary water is pulled to the top of the subbase after the water level has lowered around these sandy debris zones. Kovacs (4) calls such a zone the open capillary zone. Figures 8 and 9 show how the process of deterioration may operate.

In Figure 8 note the nature of water in the soil-moisture zone (4). The critical area during salt concentrations in subbase road conditions appears to be Kovacs' open capillary zone, where concentrations of finer materials cause water to move upward more readily. Figure 9 shows that when the

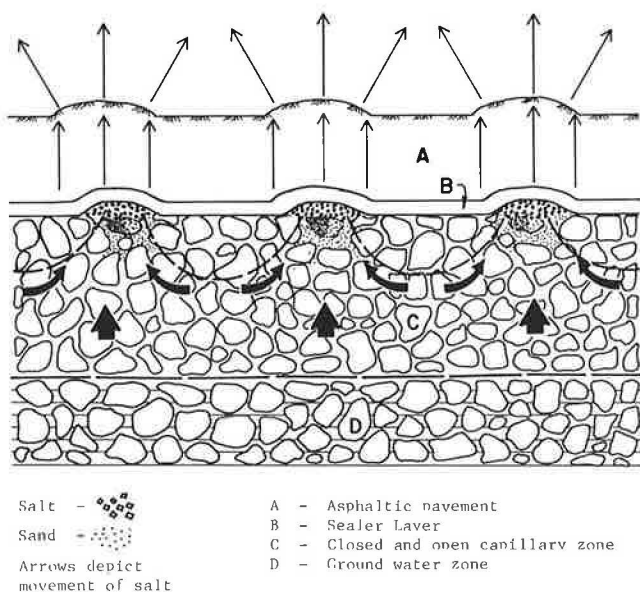
FIGURE 9 Mechanism of salt doming.

unsound particles under the pavement have disintegrated, they become, effectively, zones of fine sand within the subbase. During dry seasons when the level of groundwater drops to zone D, these sand patches become open capillary zones (see Figure 8) at the top of the closed capillary part of zone C. Evaporation off the surface of the pavement is apparently concentrated above these zones. Salt begins to precipitate directly under the seal as water without salt is pulled through the pavement to evaporate from the surface. The growing salt crystals dome the pavement upward.]

becomes supersaturated and the contained alum salts precipitate. Cooling at night may possibly be a factor that starts the initial crystallization. The original points or zones of supersaturation appear to be above what were micaceous particles. Thus crystallization appears to begin at the top of the particles where they are in contact with the pavement where the salts, in effect, are filtered from the water. Once crystals begin to grow, they grow upward as water evaporates from the top of the pavement. This process presumably continues until all available salt in the base material is used up.
