Rigid Pavement Joint Resealing: Field Application, State of the Art

JOHN W. BUGLER

ABSTRACT

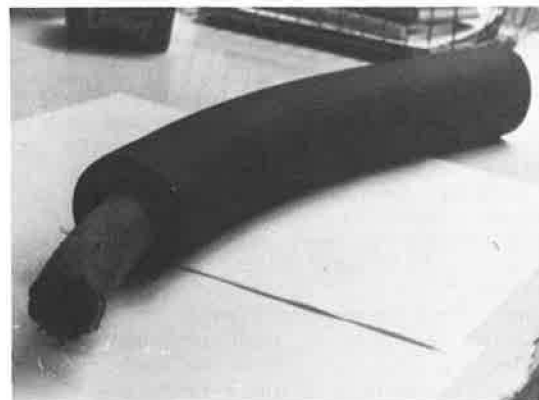
FIGURE 3 Section of insulated hose.

The hoses are usually 15 ft long, and the applicator wand is 4 ft long. The heat losses from the hoses and the wand are significant if they are not insulated. In the field heat losses of 20°F, at ambient temperatures near 70°F, have been experienced.

The problem was solved by amending the specification to read: "The hoses and the applicator wand shall at all times be insulated. The material and method of insulation shall be in compliance with the recommendations of the joint seal apparatus manufacturer and meet with the approval of the Engineer. The material and methods shall be submitted to the Engineer for his approval, two weeks prior to the commencement of joint sealing operations."

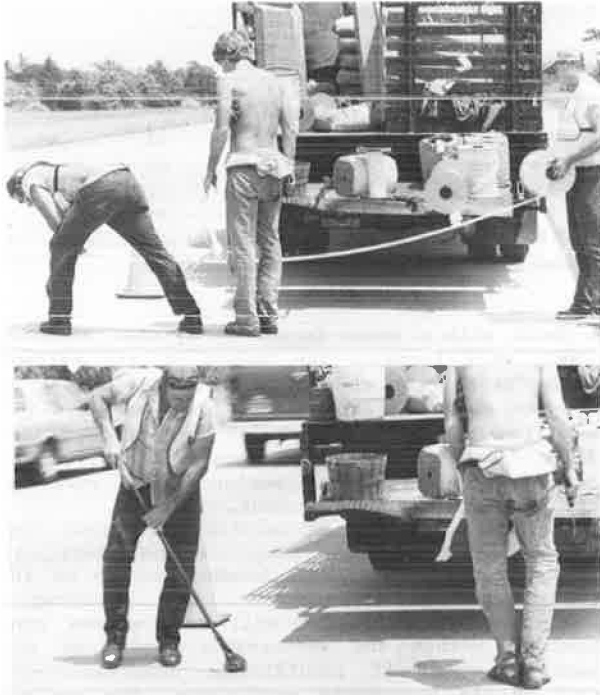
Because joint widths vary due to moisture, temperature, and degree of infiltrated incompressibilities, it may be necessary to have on hand cord, the diameter of which is not readily available; thus the contractor may have to make a special order. The readily available cord diameters are 0.375, 0.5, 0.625, 1, and 2 in. Special orders take 3 weeks to execute. Figures 9 and 10 show how the cord is inserted and how it should look when it is in place.

FIGURE 9 Placing stitched cotton piping cord.

tion. Inspectors were advised to check the diameter of the stitched cotton piping cord used in the joint and compare it with the width of the joint. They were also advised that the diameter of the cord should be approximately 25 percent greater than the width of the joint.
