TRANSPORTATION RESEARCH RECORD 990

Sealing Bridge and Pavement Joints

TRANSPORTATION RESEARCH BOARD
NATIONAL RESEARCH COUNCIL

WASHINGTON, D.C. 1984

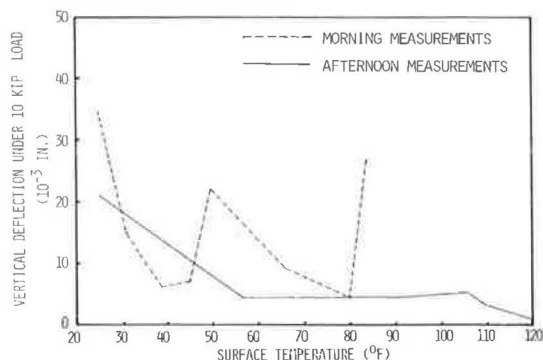
FIGURE 8 Vertical deflection versus surface temperature, group 6.

The surface temperature of the slab was measured at the same time as the vertical deflections. An attempt to correlate surface temperature and deflection was unsuccessful. Figure 8 is a typical plot of vertical deflection versus surface temperature. It is obvious from the plot that there is no direct relationship. Vertical deflection is a function of the shape of the slab, which depends on both top and bottom temperature of the pavement. The vertical

movement is a function of the temperature gradient across the depth of the slab.

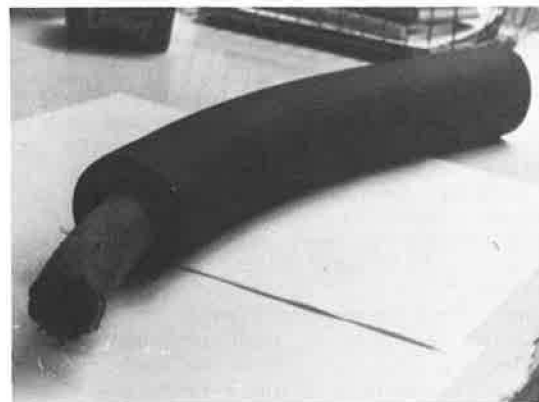
1. The cut-off valve was located 6 in. from the discharge tip, and
2. The applicator wand discharge tip was redesigned to include a set of wings (Figures 2-4), thereby allowing the operator to glide the applicator wand along the joint as he made his pass.

FIGURE 2 Posh field extruder with insulated hose and insulated applicator wand.

FIGURE 3 Section of insulated hose.

FIGURE 4 Wing tip.

These improvements gave one additional benefit: time. The time needed to seal a 12-ft joint was reduced by one-half.
