## Design and Construction of Highway Underpasses Used by Mountain Goats

FRANCIS J. SINGER, WALTER L. LANGLITZ, and EUGENE C. SAMUELSON

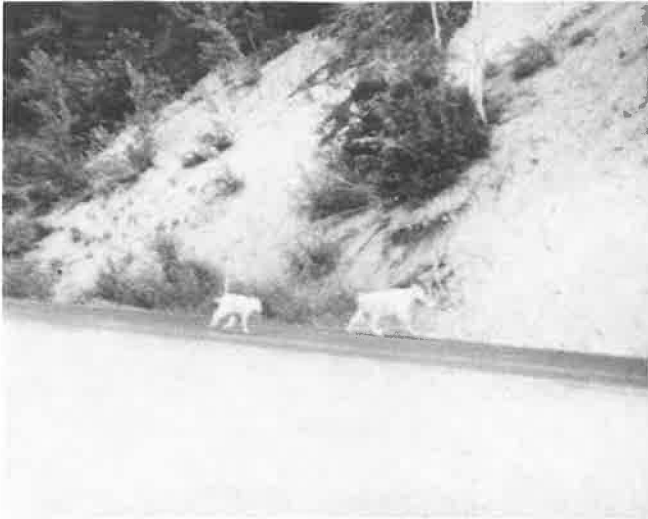
FIGURE 1 Goats crossing highway surface before reconstruction of US-2 in Glacier National Park, Montana.

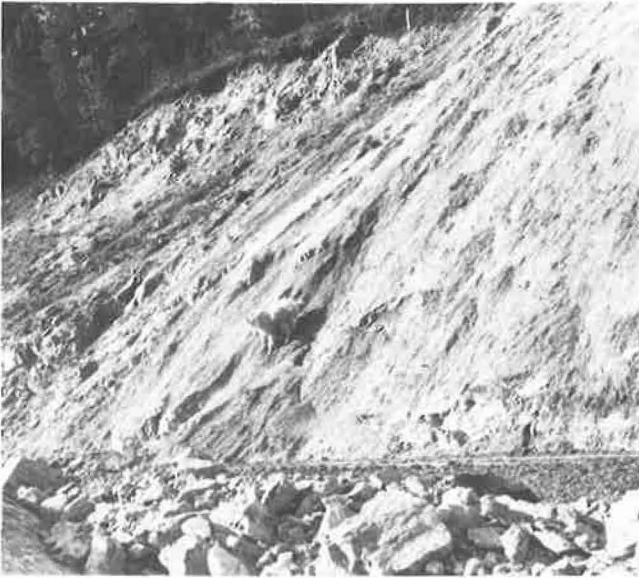
FIGURE 3 Goats crossing the more exposed and steeper Route 3.

project area was checked for goats before equipment start up; (f) passing traffic was stopped by flag people to allow goats to cross the highway; (g) because of the open crossing route left near the Goat Bridge, construction on the Snowslide Gulch Bridge was not terminated because of the presence of goats (6). A National Park Service wildlife biologist (F. Singer) monitored the highway project for any serious disruptions or injuries to the goats and to warn the contractor and flag people of any impending goat crossing. During construction goat disturbances actually decreased as a result of less visitor activity and slow speeds of automobiles. Consequently, goat route preferences changed and the more exposed but steeper Route 3 received greater use by goats (see Figure 3).

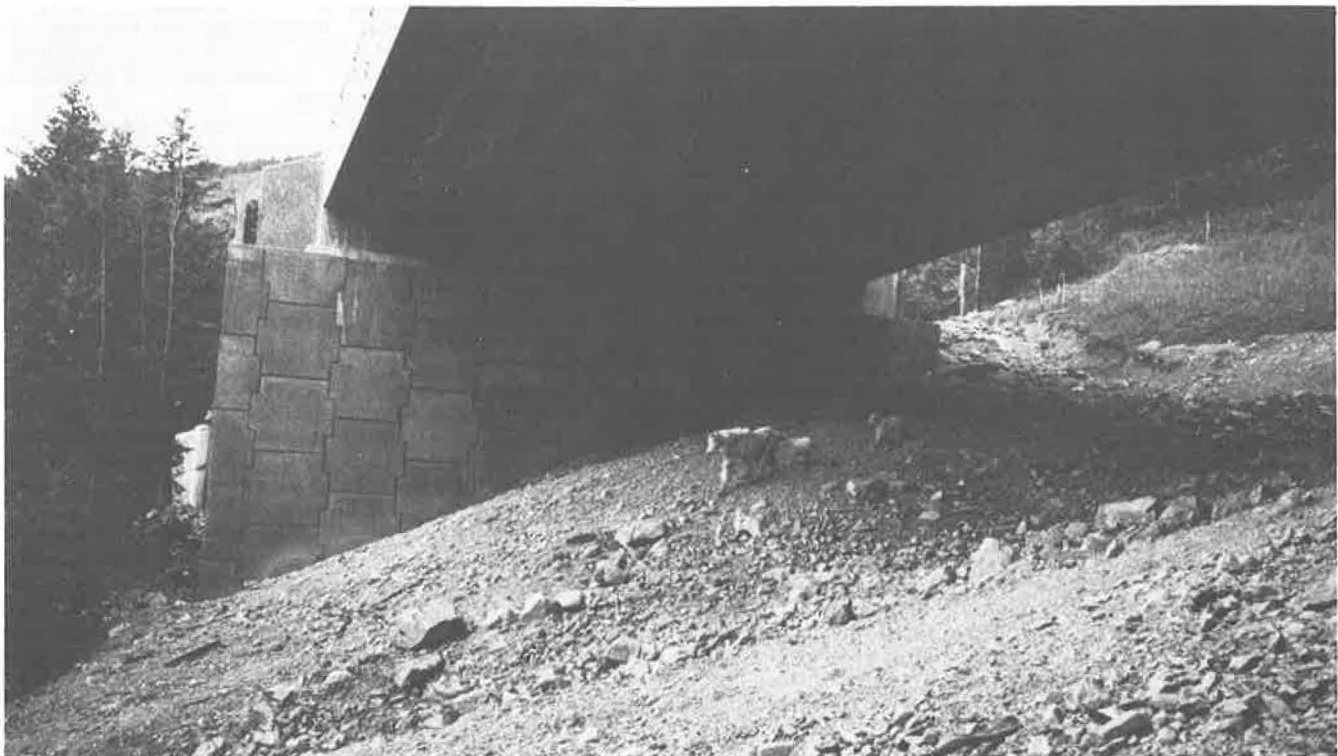
FIGURE 4 Nanny with twins at side passing under the Goat Bridge of US-2, Glacier National Park, Montana.

After completion of the goat underpasses, 99.4 percent of 924 observations of mountain goats crossing the highway were under either of the two bridges (see Figure 4). Only 0.6 percent of the goats passed around either end of the structures and fencing to cross the highway surface (7). Physical contact was made initially (charges, head butts, stand on hind legs) against the fencing, but goats rapidly adapted
