The Connecticut Impact-Attenuation System

JOHN F. CARNEY III, CHARLES E. DOUGAN, and MARTIN W. HARGRAVE

ABSTRACT

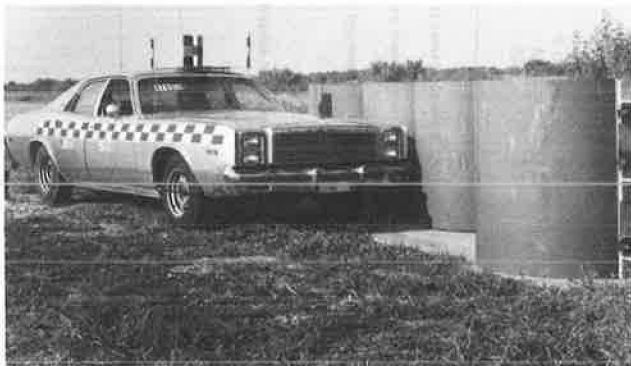
FIGURE 5 Vehicle alignment before Test 6.

b. Test vehicle: A Plymouth Salon (1978) impacted the Connecticut attenuator at 58.0 mph and 15 degrees, directed at the rear corner of the system (Figure 5). The vehicle weighed 4,500 lb with 2,482 lb on the front axle and 2,018 lb on the rear axle.

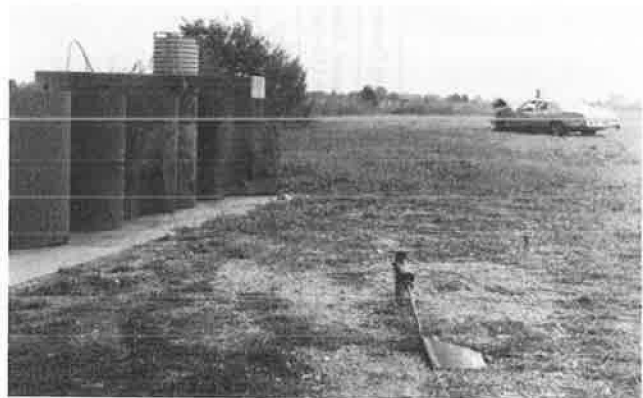
FIGURE 8 Side view of CIAS showing test vehicle after Test 6.

c. Test results: The crash cushion smoothly redirected the vehicle. Figures 6-8 show the CIAS and the vehicle after Test 6 (see Table 1 for measured decelerations). This test demonstrated that the tube-stiffening system provides the lateral resistance required to redirect a vehicle under these severe test conditions.

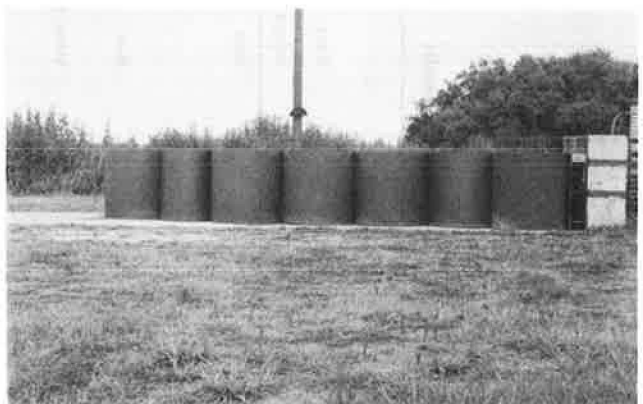
FIGURE 9 Side view of CIAS before Test 7.

b. Test vehicle: A Plymouth Salon (1978) impacted the attenuator at 61.4 mph and 0 degrees. The vehicle weighed 4,500 lb with 2,460 lb on the front axle and 2,040 lb on the rear axle. Views of the test vehicle and the CIAS before the test are shown in Figures 9 and 10.

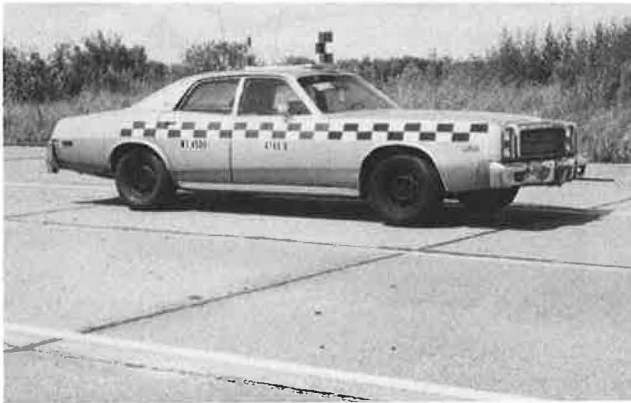
FIGURE 10 Test vehicle before Test 7.

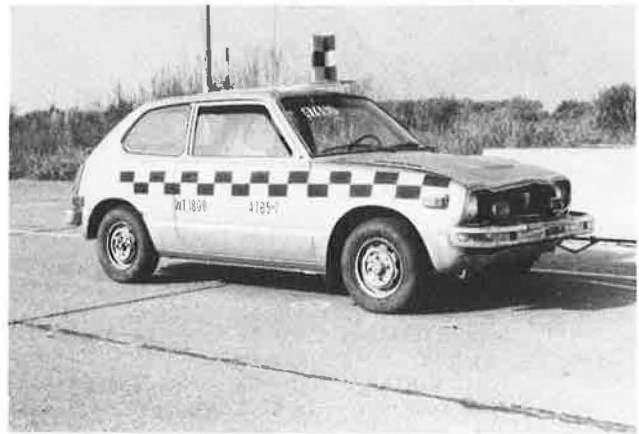
FIGURE 13 Test vehicle before Test 8.

b. Test vehicle: A Honda Civic (1977) impacted the attenuator at 60.9 mph and 0 degrees. The vehicle weighed 1,800 lb with 1,069 lb on the front axle and 731 lb on the rear axle (Figure 13).

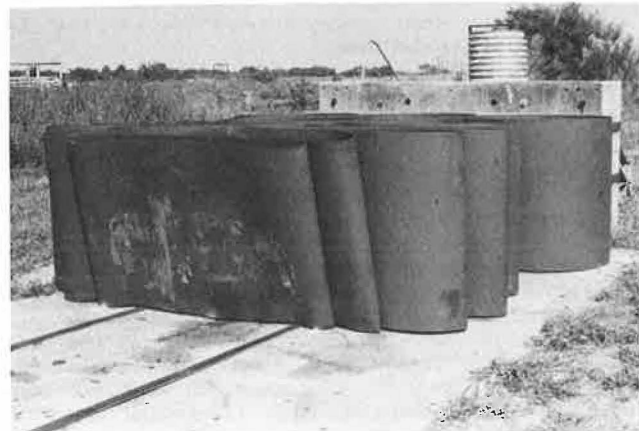
FIGURE 14 Side view of collapsed system, Test 8.

c. Test results: The vehicle fully collapsed the first five rows of the attenuator, but the back two rows of the system were deformed only

slightly (Figures 14 and 15). The front end of the vehicle sustained an average crush of 9 in. (Figure 16). Two occupant impact velocities are reported in Table 1 for this test. As in Test 2, they correspond to occupant travel distances of 1.25 and 2.0 ft.

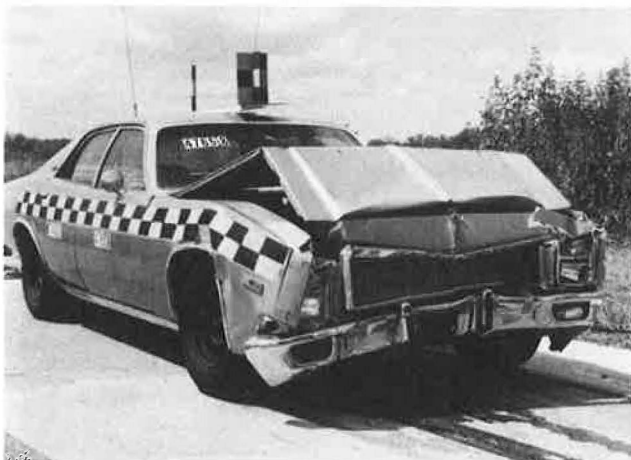
FIGURE 12 Frontal damage sustained by vehicle in Test 7.

c. Test results: The vehicle collapsed the attenuator almost completely, as shown in Figure 11 (see Table 1 for measured decelerations). The front end of the car sustained an average crush of 13.5 in. (Figure 12). All occupant risk values in this test were well below the guidelines of both TRC 191 and NCHRP Report 230.

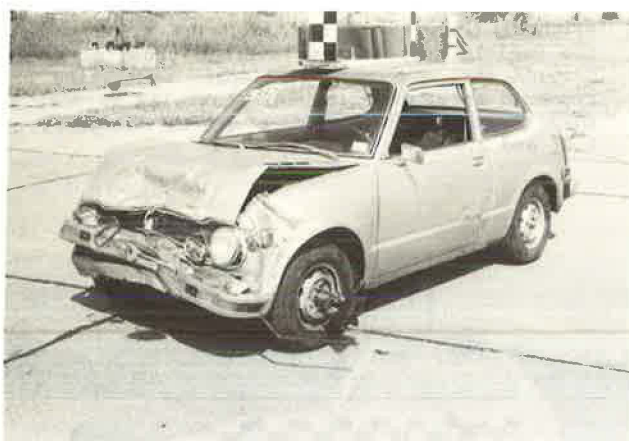
FIGURE 16 Damage sustained by vehicle, Test 8.

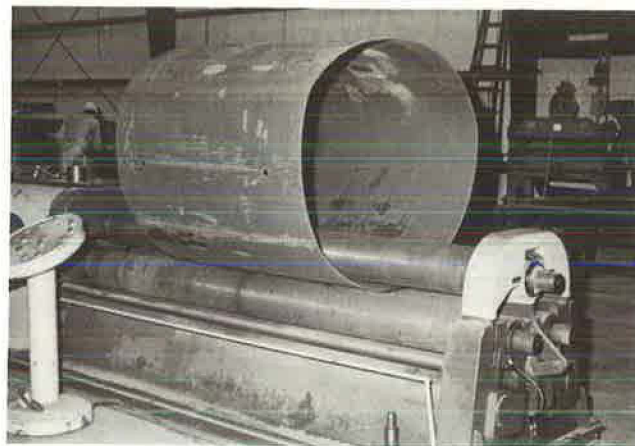
FIGURE 17 Tube A mounted in rolling mill.

pipes and straps were removed and it was rerolled from the existing semiround shape. Figure 17 shows Tube A mounted in a rolling mill before it was rerolled. After 1.5 hr of rerolling, new pipes and straps were added to the tube.

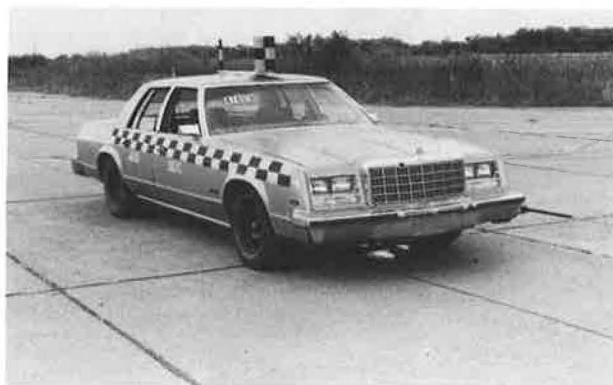
FIGURE 21 Before Test 9: test vehicle (top) and top view of CIAS (bottom).

It can be seen from Figures 21 and 22 and Table 1 that the system's response in Test 9 was essentially identical to that in Test 7. The only discernible difference to be reported concerns the relative stiffness of the front ends of the test vehicles employed in Tests 7 and 9. The Chrysler Newport was significantly stiffer than the Plymouth Salon used in Test 7, sustaining an average crush of only 8 in. This very successful test proves that collapsed tubes can be economically restored and used again in the CIAS without affecting system performance.
