The Concrete Resurfacing of Existing Asphalt on I-30 in Rockwall County, Texas

LONNY G. TRAWEEK

Portland Cement Concrete Pavement Overlay Over a Bituminous Pavement

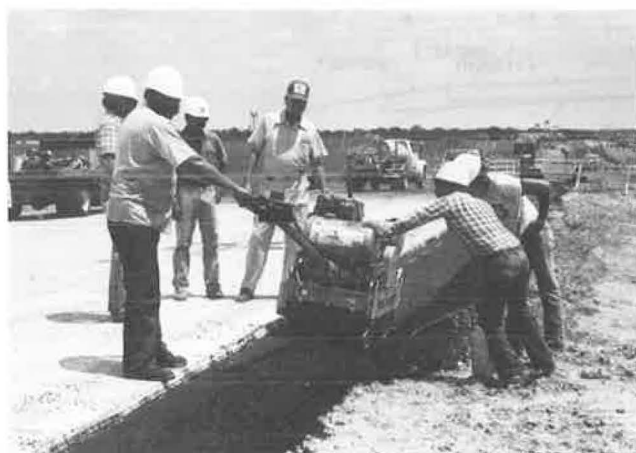
FIGURE 5 Small roller.

slope will not allow normal rollers to be used. A small vibratory roller and a modified tractor (Figures 5 and 6, respectively) were used on the lower lifts with the addition of a pneumatic roller finishing the top lift. The speed of the small roller was slow because the steep cross-slope required lateral support. Normally, two workmen were required to maintain its position on the asphalt.

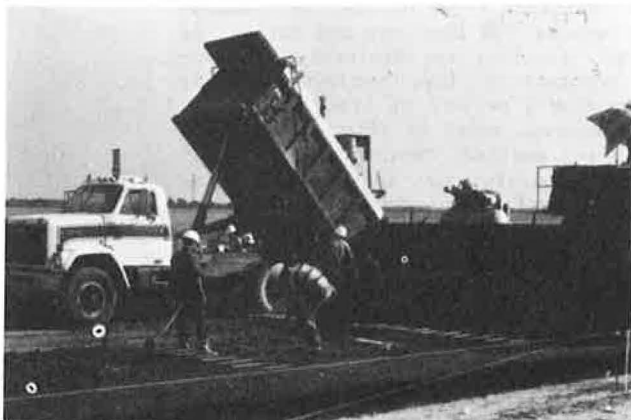
FIGURE 8 Placing operation.

The H.B. Zachry Company constructed a central-mix concrete plant within the project limits. A paving train with a 50-ft Gunter-Zimmerman slipform paver was brought in and modified to handle the cross-slope break at each shoulder edge. This modification would enable it to place the concrete pavement the full 38-ft width in one pass. The placing operation began by leaving out the center section of the dowel baskets to leave room for the dump trucks to back up and discharge (Figure 8). The final dowel basket was placed after sufficient concrete was ahead of the paver to pass that particular transverse joint (Figure 9).

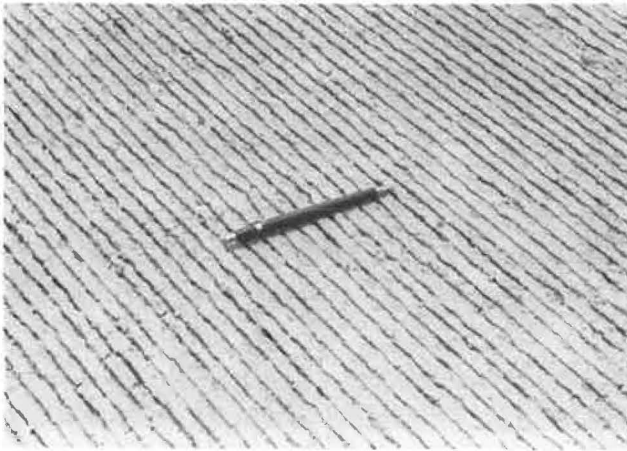
FIGURE 11 Finished texture.

approximately .188 in. When these depths were reached, a harsh surface developed because of pulled aggregate. Statewide research was ordered. After the result of this research was analyzed, the texture depth was lowered by field change to produce a texture similar to Figure 11.

This type of texturing would increase skid resistance and reduce hydroplaning by allowing the water to drain across the pavement inside the grooves. To produce the desired texture required by the specifications, the average depth of the grooves would have to be nearly .250-in. deep with a minimum depth of
