## Bridge Deck Rehabilitation by Using Cathodic Protection with a Low-Slump Concrete Overlay

ANDREW D. HALVERSON and GLENN R. KORFHAGE

The design and construction of a state-of-the-art cathodic protection system for a reinforced-concrete bridge deck by the Minnesota Department of Transportation is described. The bridge selected was the 42nd Street Bridge (Bridge 9616) over I-35W in South Minneapolis. The system selected was a distributed-anode system with a low-slump concrete overlay as a wearing surface. The system was constructed in the summer of 1983. The cathodic protection system has primary and secondary anodes for current distribution. A primary anode system of platinized niobium wire placed transversely across the bridge feeds a secondary anode system of carbon strands placed longitudinally on the bridge. Both the wire and the strands are covered with conductive polymer concrete. Power from a rectifier is supplied to the anodes through a conduit running along the north crash rail of the bridge. Rehabilitation of the bridge was completed in 30 working days, and the system was activated in December 1983.

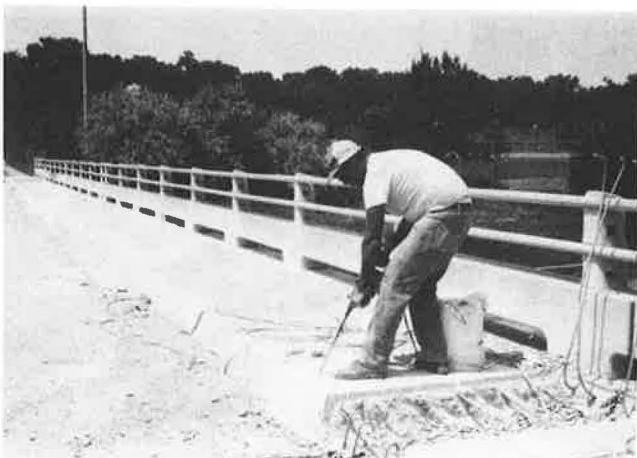
FIGURE 7 Drilling hole through curb for primary anode wire.

forcing steel in the deck. A hole was also drilled from the primary anode slot in the sidewalk through the curb to the bridge deck (Figure 7). This was done to lead the platinum wire from the sidewalk slot to the deck surface and back to the sidewalk slot on the other side of the bridge. By doing this, the contractor did not have to saw the face of the curb.

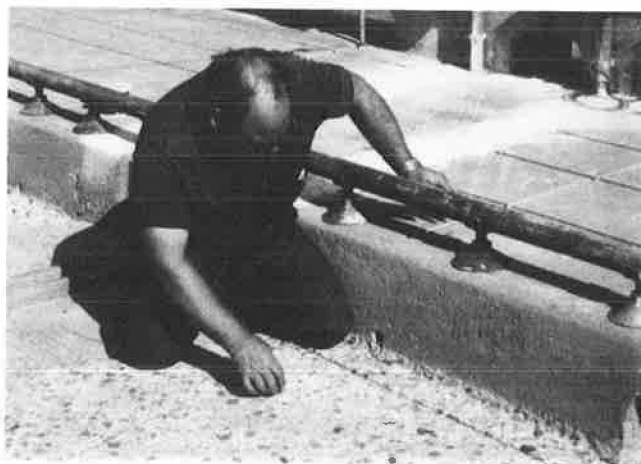
FIGURE 10 Passing platinum wire through curb.

Figure 10 shows the beginning of work on the distributed-anode system on August 11. The electrician is leading the platinized niobium wire from the sidewalk slot through the hole in the curb to the bridge deck and across the deck. Behind the electrician are wooden pegs placed in holes that were drilled in the bridge deck. The pegs are either 1 or 1 1/2 ft apart depending on the required spacing of the carbon strand secondary anodes. The carbon strand was strung out on the deck from one end of a zone to the other, wrapped around two pegs, and strung back to the other end. Wrapping the strand

around these pegs allowed it to be pulled tight and the proper spacing of either 1 or 1 1/2 ft between the strands could be maintained until the PC ribbons were placed. After the PC was cured, the pegs were pulled and the excess carbon strand was removed.

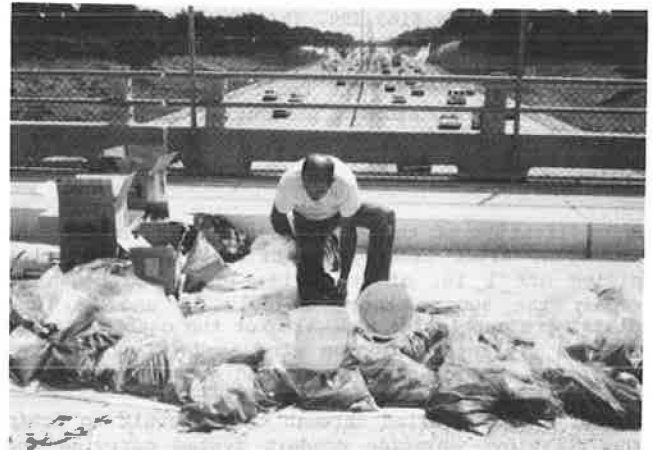
FIGURE 11 Mixing resin, hardener, and coke.

The resin and hardener were then added to a heavy-duty plastic bag containing a preweighed amount of conductive coke. The liquids and coke were mixed in the plastic bag by using a rolling motion; this was carried out on a plastic-covered piece of plywood (Figure 11). The mixed PC was transferred to a pail and then to a hand-made hopper and extruder (Figure 12). After the conductive PC ribbon was placed, it was sprinkled with dry coke, which was beneficial to the cure of the PC.

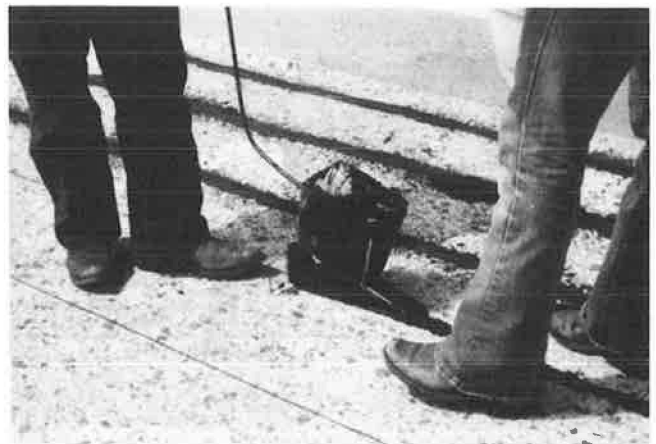
FIGURE 12 Placing PC ribbon.

The first plexiglass hopper and extruder was supplied by the designer of the cathodic protection system and was copied by the electrical subcontractor. Several of these plexiglass devices were used. With time, the PC would bond to the plexiglass

and start to clog the hopper and the extruder. This made for slower production and for a smaller ribbon. Specifications called for the ribbon to be 1 to 1 1/2 in. wide and 3/8 to 5/8 in. thick. It took a total of 14 hr to complete the first half of the bridge deck. The second half of the bridge was completed in about 8 hr. The first half of the low-slump overlay was placed August 12, the day following completion of half of the cathodic protection system and 1 month after work had begun.

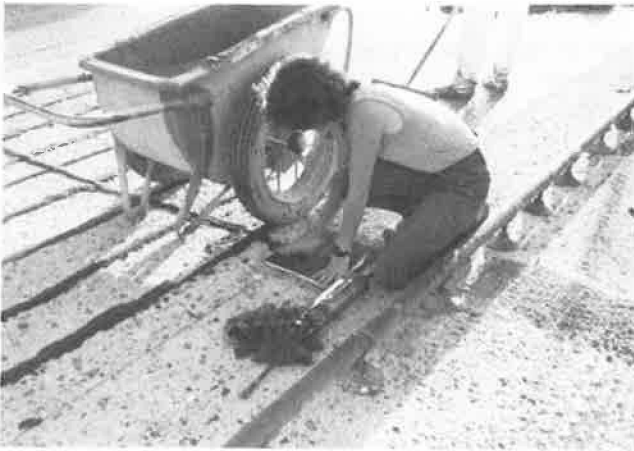
FIGURE 13 Plate covering platinum wire.

The platinum wire for the second half of the protective system was coiled underneath a greased steel plate, which was paved over (Figure 13). Later a saw cut was made to provide a sharp vertical edge against which the remainder of the overlay was to be placed. When the excess concrete was removed, the steel plate was exposed, and the cathodic protection system was placed on the remaining behalf of the bridge deck.

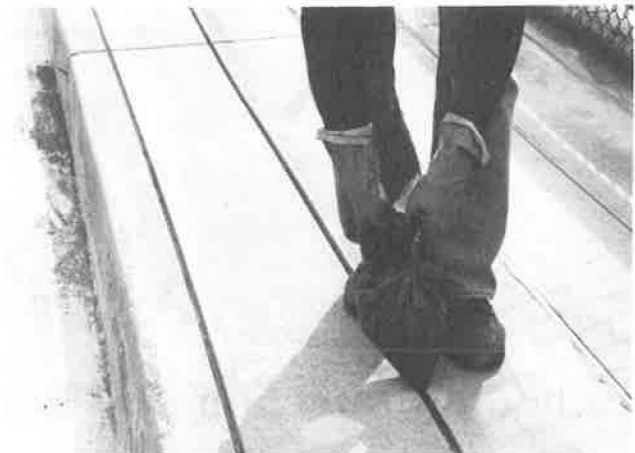
FIGURE 14 Placing conductive PC in sidewalk slot.

The hardener and resin were combined and then mixed together. These were then added to the conductive coke material and mixed in the same manner as the ribbon material on the bridge deck. The corner was cut off the mixing bag, and the conductive PC was placed directly into the slot from the bag (Figure 14). Silica sand instead of coke was placed on the fresh polymer sidewalk because sand is lighter in color but still helps both curing and traction. It took three working days to prepare and complete the sidewalks of the bridge. It took a total of about 6 hr to place the conductive PC on each side. At the same time, the approaches were paved, and the bridge was opened late in the evening of August 24, 45 days after construction began. The remaining work on the conduit runs and junction boxes was done while there was traffic on the bridge deck.
