Cathodic Protection of a Four-Lane Divided Continuously Reinforced Concrete Pavement

ANDREW D. HALVERSON and GLENN R. KORFHAGE

The design and construction in 1982 of a second cathodic protection system for continuously reinforced concrete pavement by the Minnesota Department of Transportation is described. Corrosion of the reinforcing steel in this type of pavement has been a severe maintenance problem. An initial cathodic protection research project was successful in retarding this corrosion, so the department contracted for the design of a second system. This resulted in three separate designs, each 1,800 ft long, with separate power sources. They are (a) a trench system with the anodes placed in a trench 4 ft deep by 1 ft wide (b) a shallow-post-hole system with the anodes placed in augered post holes 12 ft deep, and (c) a deep-post-hole system with the anodes placed in augered post holes 15 ft deep. The pavement is grounded every 200 ft of each roadway by attaching wire to the reinforcing steel. Construction began in October 1982 and was completed in 1983. The systems were activated in December 1983 at current levels determined by E log I tests. Initial testing of the systems

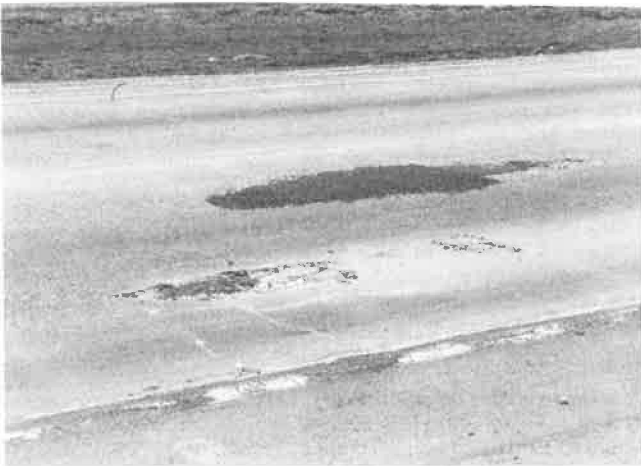
The distress in CRCP is visible throughout the year in the form of old patches on the pavement surface, and the spalls and potholes are a particular problem in the spring (Figure 1).

FIGURE 1 Deterioration of CRCP.

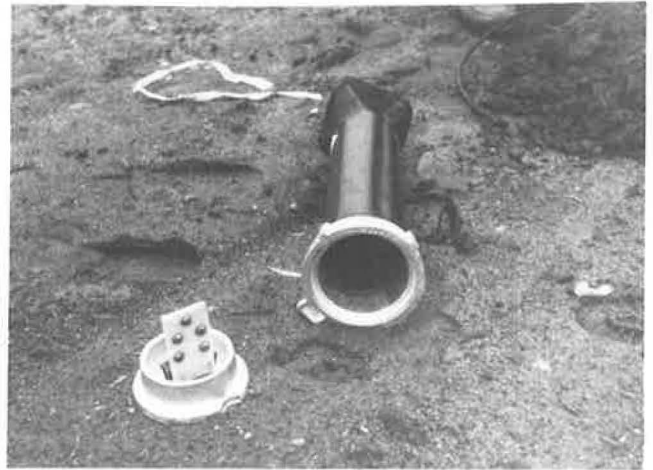
Each collector trench also contained three number 12 twisted wires, to be used as test leads for potential readings. The leads terminated in test stations buried along the shoulder (Figure 12), which made it possible to take electrical potentials on the surface of the pavement without running long lead wires and without running wires across the pavement.

FIGURE 12 Test station.

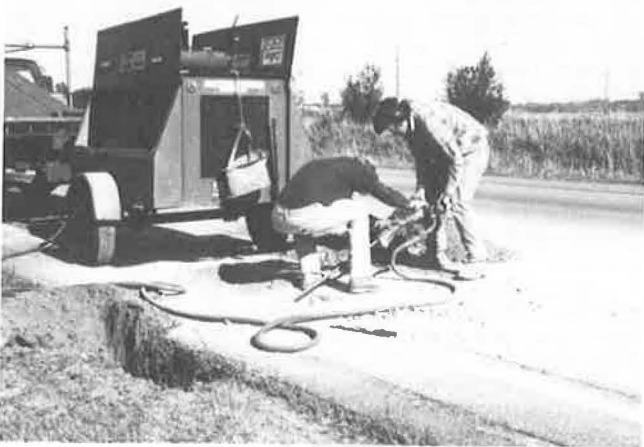
The contractor first established the system grounds, which were made to the reinforcing steel at 200-ft intervals. A cable locator was used to find the transverse steel. A small milling machine was then brought in to grind the concrete to the depth of the steel (Figure 9). Jackhammers were used to further expose the steel, which was cleaned by using an electric drill with a wire brush. A number 8 stranded copper wire was cadwelded to the longitudinal and then the transverse reinforcing steel, and each cadweld was tested for soundness with a hammer. A hole was drilled through the soil and under the 4-ft-wide bituminous shoulder on the median side of each roadway to an 18-in.-deep collector trench (Figure 10). The trench was originally opened up with a backhoe at each ground connection and later completed with a trenching machine. The ground wire could then be passed under the shoulder without damage to the shoulder. A 9-in. section of 1/2-in. polyvinylchloride conduit was placed around the wire to counteract any shear effects at the edge of the concrete pavement. Figure 11 shows the conduit and the ground wire cadwelds.

FIGURE 10 Drilling under bituminous shoulder.

The use of a cable locator and a milling machine in establishing the system ground worked quickly and well. Drilling under the shoulder for the ground lead was an excellent idea. However, when the system ground trench was not backfilled promptly, the sides collapsed at several locations and the shoulder was damaged.

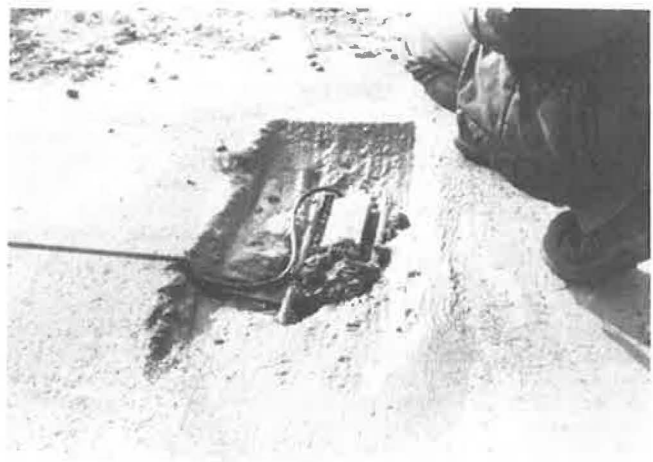
A corrosion probe was placed in both roadways in each system in the passing lane near the centerline. The probe consisted of a 6-in. piece of 5/8-in. reinforcing steel with a number 8 stranded wire attached. The steel was cast in a 3 x 3 x 8-in. block of salt-laden concrete in order to create a strong corrosion cell. The concrete contained 15 lb of chloride per cubic yard of concrete.

through a saw cut to the edge of the pavement and then to the collector trench in the same manner as that used for the system grounds. Each corrosion probe also had its own ground wire. The probe was patched along with the grounds (Figure 13). The wire was sealed in the saw cut with epoxy. Test stations were provided for each corrosion probe.

FIGURE 13 Corrosion probe.

Initial testing of the system has indicated that the corrosion probe can be polarized. This indicates that the reinforcing steel can be, too. Extensive copper-copper sulfate half-cell tests are sorely needed. This is work that was intended to be done in 1984, but the operation of one of the rectifiers was lost before the testing could be scheduled.

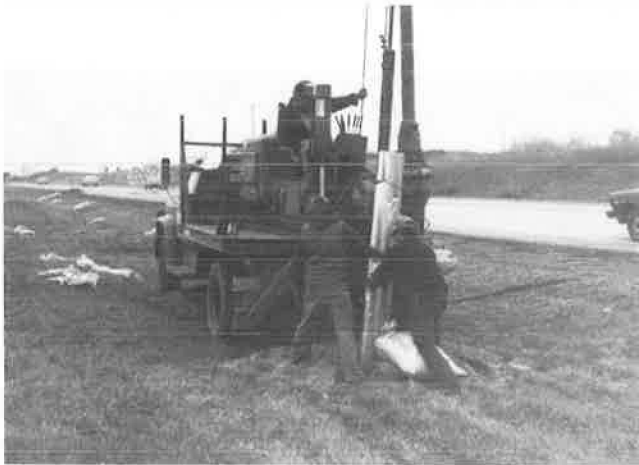
Construction of the trench system went well. The construction of the post-hole systems was another matter, however. The contractor worked on the deep system first. A high-speed drill was used to auger the 15 ft. The soil was a very fine sand. The sides of the post hole tended to collapse inward and this eventually became quite a problem. The anodes and canisters were lowered into the post holes by a choker with another truck with a boom (Figure 15). The canisters were then backfilled with coke breeze.

FIGURE 15 Lowering canister into post hole.

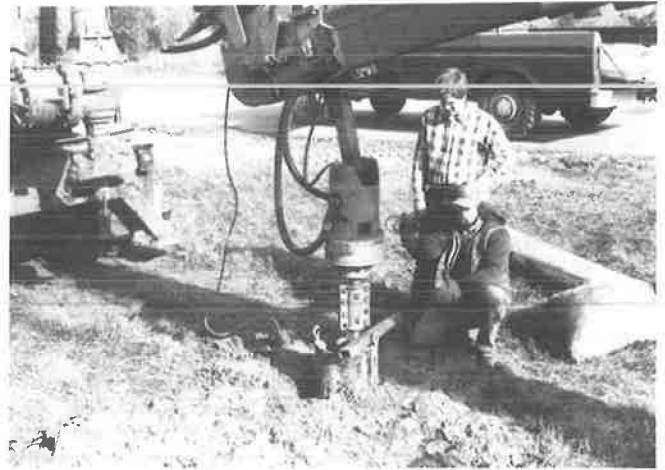
switch to a much slower auger. Eventually, the holes were predrilled with a higher-speed auger and completed at low speed in a casing (Figure 16).

FIGURE 16 Drilling in casing.

As mentioned, the soil posed a problem. The contractor started at the highest part of the project. As each hole was drilled, the work went to a lower level and came nearer the water table. The sides of the holes would not hold and the contractor had to
