# Cathodic Protection, Concrete and Bituminous Maintenance, and Bridge Repainting

WASHINGTON, D.C. 1985

## Transportation Research Record 1041

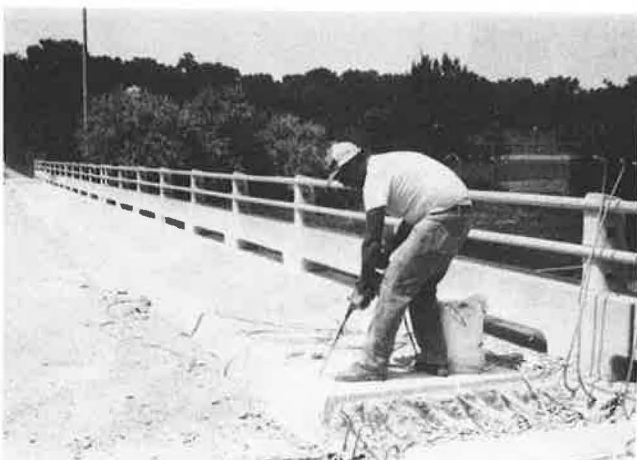
FIGURE 7 Drilling hole through curb for primary anode wire.

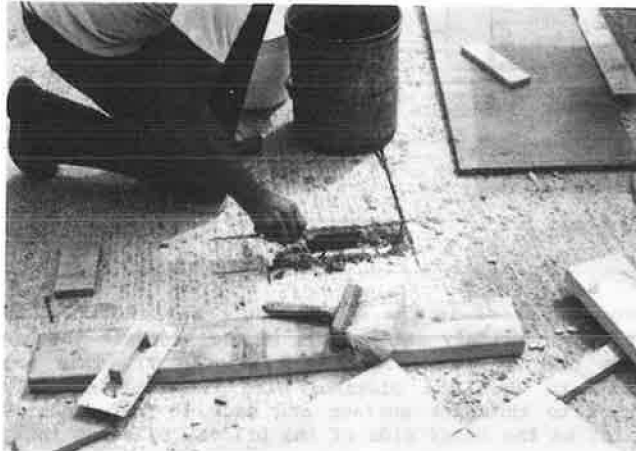
FIGURE 9 Patching reference cell.

A silver-silver chloride reference cell was placed in each span of the bridge on August 5 to provide control of the rectifier output. These were placed as close to the depth of the steel as spacing of the steel would permit. The reference cells were patched with a salt-bearing concrete proportioned and supplied by the designer. Before the reference cell was placed, the patch area was moistened. A bed of fresh concrete was prepared, the reference cell was placed in it, and the patch was completed (Figure 9).

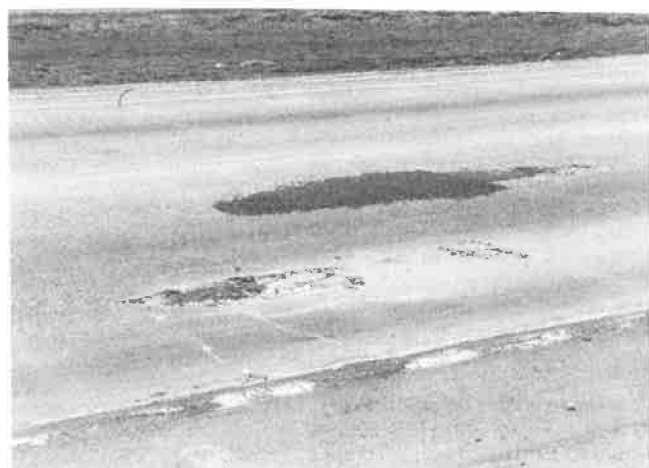
FIGURE 1 Deterioration of CRCP.

The distress in CRCP is visible throughout the year in the form of old patches on the pavement surface, and the spalls and potholes are a particular problem in the spring (Figure 1).

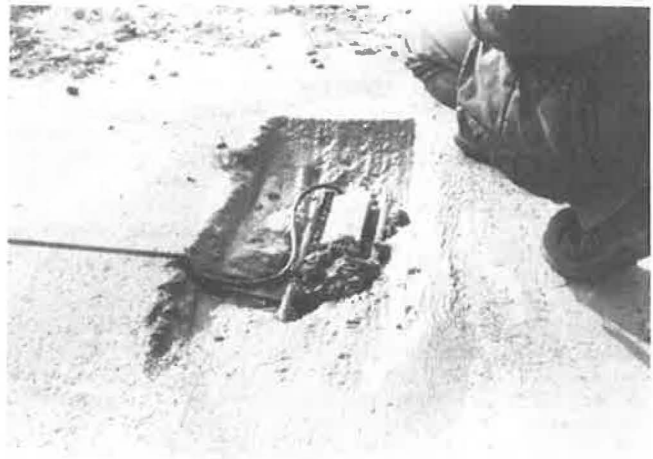
FIGURE 13 Corrosion probe.

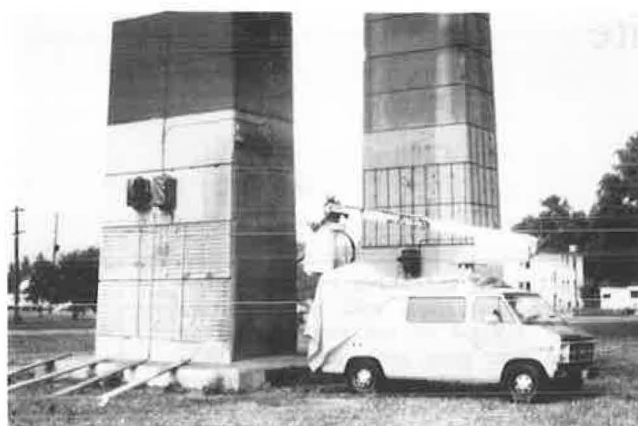
FIGURE 1 Systems 1, 2, and 3 under construction, August 1982: System 1, right column; Systems 2 (upper) and 3 (lower), left column.

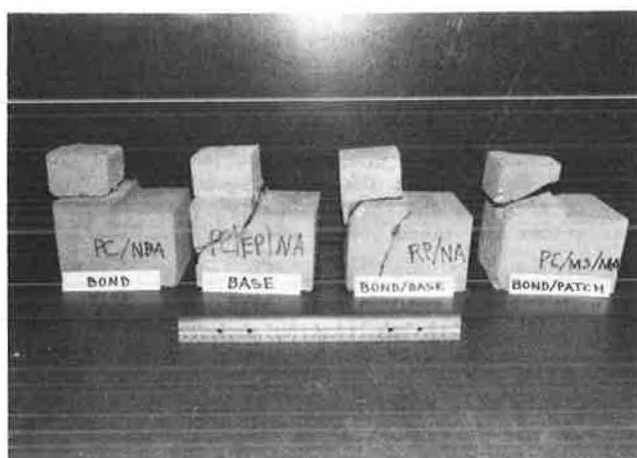
**FIGURE 5 Failure modes for composite impact specimens.**

The composite impact specimens exhibited four modes of failure. These are shown in Figure 5 and are designated bond failures, base failures, bond or base failures, and bond or patch failures. Bond failures occurred in only a portion of the 6-hr tests. Tests in Groups 2, 3, and 4 experienced one of the three latter failure modes. In these specimens the bond strength, or the residual strength provided by anchors, was sufficient to cause failure in the base or patch material.
