## Establishing Load Transfer in Existing Jointed Concrete Pavements

WOUTER GULDEN and DANNY BROWN

In this paper are described the results of a research project that had the objective of developing construction procedures for restoring load transfer in existing jointed concrete pavements and of evaluating the effectiveness of the restoration methods. A total of 28 test sections with various load transfer devices were placed. The devices include split pipe, figure eight, vee, double vee, and dowel bars. Patching materials used on the project included three types of fast-setting grouts, three brands of polymer concrete, and plain portland cement concrete. The number and spacing of the devices and dowel bars were also variables in the project. Dowel bars and double vee devices were used on the major portion of the project. Performance evaluations were based on deflection tests conducted with a 20,000-lb axle load. Horizontal joint movement measurements and visual observations were also made. The short-term performance data indicate good results with the dowel bar installations regardless of patching materials. The sections with split pipe, figure eight, and vee devices failed in bon

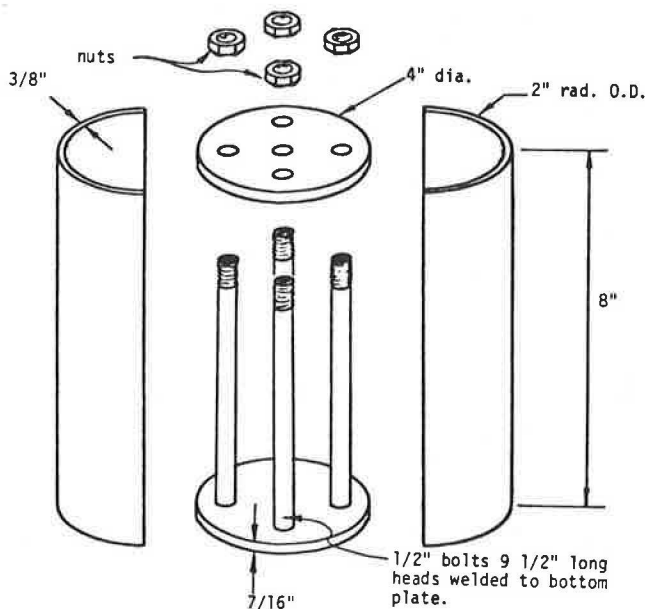
FIGURE 1 Georgia split pipe device.

This device was developed by the Georgia DOT Office of Materials and Research personnel and is shown in Figure 1. To install these devices the two sides of the "split pipe" are epoxied to either side of the 4-in.-diameter core hole and the epoxy is allowed to set. The top and bottom plates rest on the top and bottom edges of the two split pipe pieces. The four bolts are tightened and the load transfer between the slabs is carried by the four bolts and the epoxy bond between the split pipe pieces and the concrete core hole surfaces. Thermal expansion movement is accommodated by the slippage of the top and bottom plates on the end of the split pipe pieces.

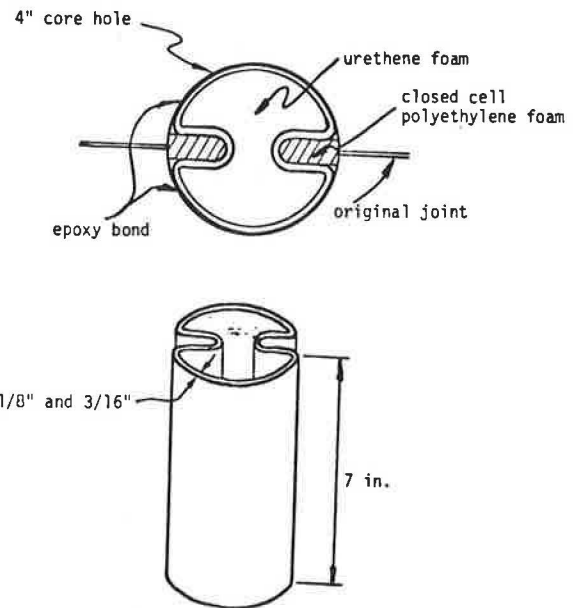
FIGURE 2 Figure eight device.

This device is a single piece cylindrical metal shell formed in the shape of the numeral eight as shown in Figure 2. The device is installed in a 4-in.-diameter core hole and epoxy is used to bond the device to the walls of the core hole. The center of the device and the indentations on the side are filled with foam to keep out debris. The device has previously been used experimentally in France (4).

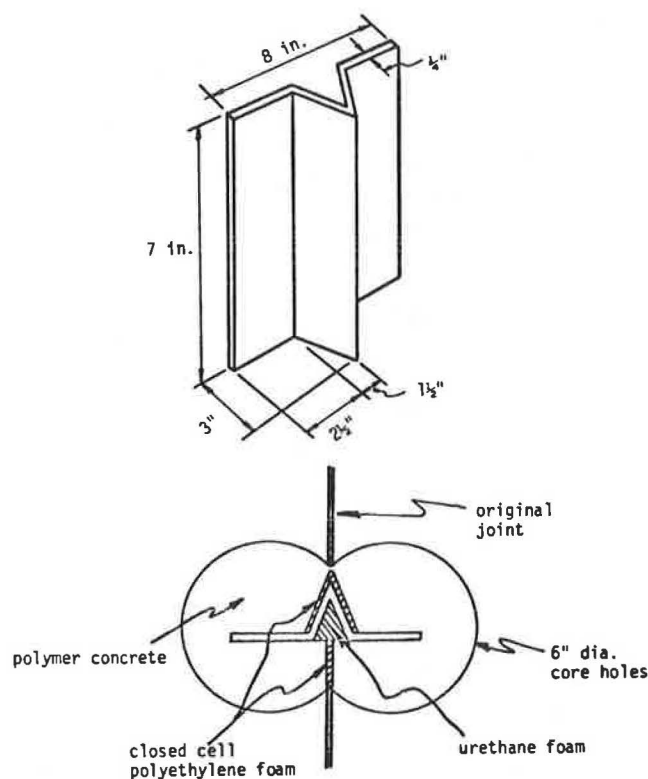
FIGURE 3 Vee device.

This type of load transfer device was first proposed in a report published by FHWA in 1977 (3) along with the figure eight device. The device consists of a 1/4-in.-thick steel plate bent into the shape of a V as shown in Figure 3. The device is not commercially available and was specially fabricated for this research project.

To be able to install the vee device, two 6-in.-diameter core holes have to be drilled and then filled with a patching material after installation. The vee portion was filled with urethane foam and a thin layer of polyethylene foam was placed around the outside of the V to allow for expansion and contraction of the slab. An additional piece of foam was used to reestablish the joint.

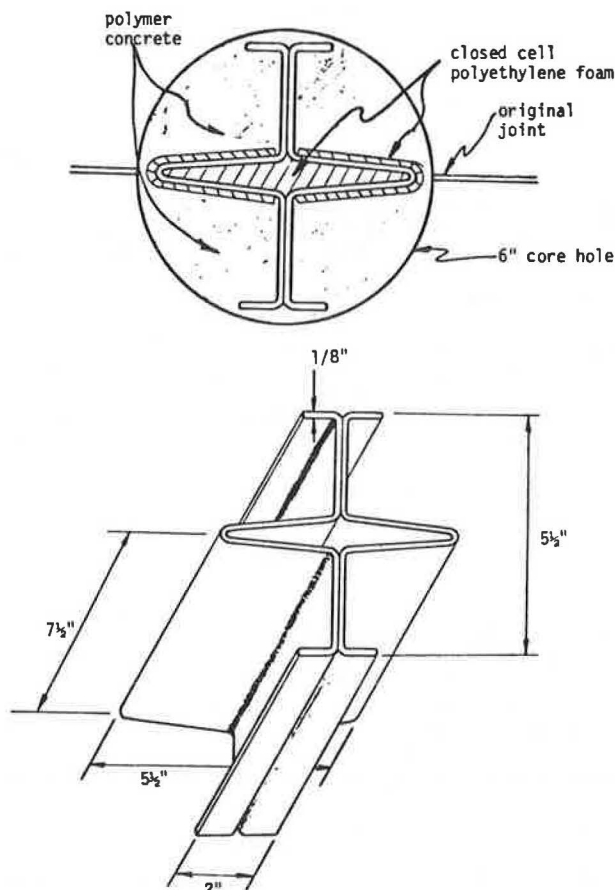
FIGURE 4 Double vee device.

This device is essentially two vee devices placed back to back and downsized to accommodate installation in a 6-in. core hole. The device was designed and initially tested at the University of Illinois (5) and is now commercially available under the trade name of LTD Plus. Some minor additional design changes to the device shown in Figure 4 have taken place since its use in this research project. The center section of the device is filled with foam to keep out debris and a thin foam pad is placed around the outside of the vee portion to allow for expansion and contraction. The devices used in this project are epoxy coated to prevent rusting and current devices are manufactured from stainless steel.

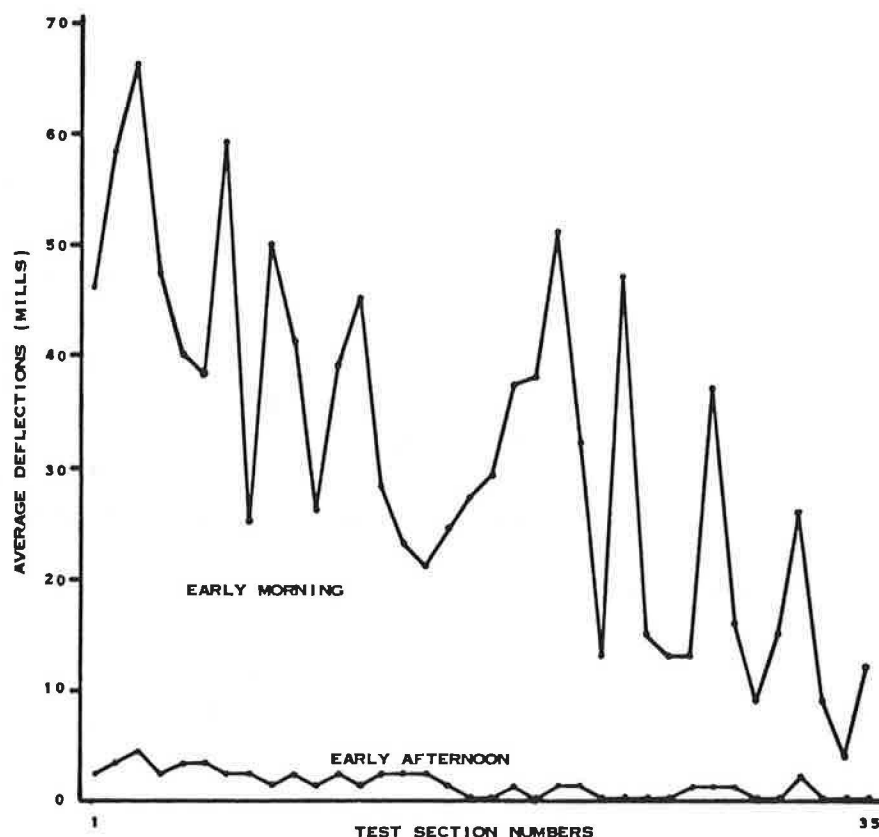
FIGURE 5 Deflection levels of leave slab corners, September 1982.

The effects of seasonal changes on the load transfer conditions were evident from the three series of tests that were conducted at different times of the year and clearly showed that the higher deflections were obtained in September 1982 and always occurred in the early morning test series for all three evaluation periods. The deflections obtained with the load on the leave side of the joint also were generally larger than the deflection obtained on the approach side when loaded. The deflection data also show that the vertical movement measured in the early afternoon is generally negligible regardless of the magnitude of the movement measured in the early morning (Figure 5). Performance comparisons of the various load transfer systems were therefore based on deflections measured during the early morning hours when significant slab movements are likely to take place.

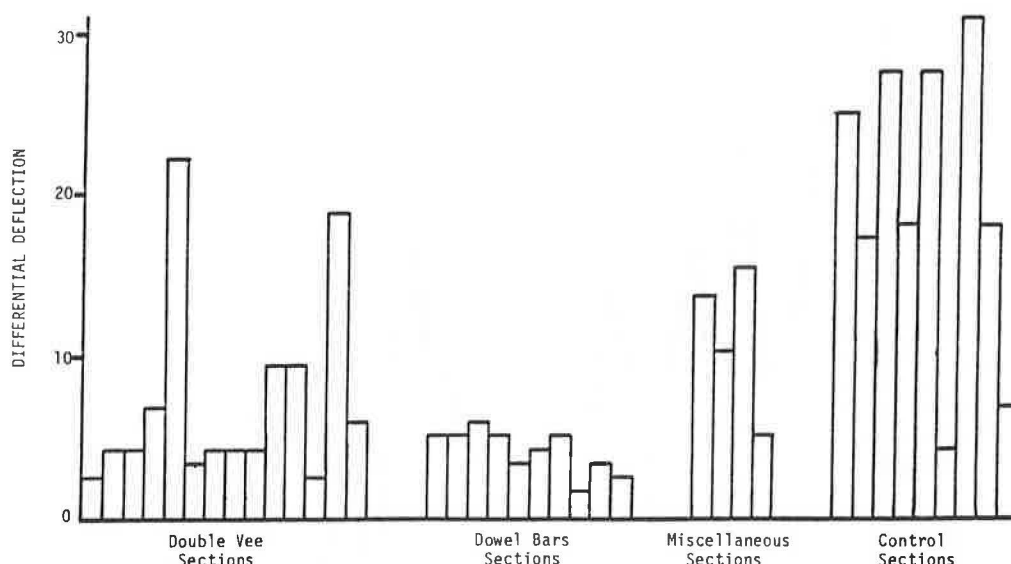
FIGURE 6 Differential deflection values in early morning on leave slab, March 1983.

The critical data for analysis are the deflections obtained during the early morning testing with the load placed on the leave side of the joint. The average differential deflection values for each test section are shown in Figure 6 for the March 1983 test period with the load placed on the leave slab. The bar charts in Figure 6 clearly show that all the sections with the dowel bars were performing well along with 10 of the 14 sections containing double vee devices. Section 4, containing the vee device, shows good performance on the bar chart; however, the data are suspect for this section for March 1983 because the deflection difference obtained in September 1982 was 35 mils. The March 1983 readings were generally much less than those obtained in September 1982 for sections showing poor performance. For the sections with good performance there generally was not much difference between the September 1982 and March 1983 differential deflection values. This is an indication of the seasonal influence on sections with little or no mechanical interlock. When adequate mechanical interlock is present, the

The sections containing dowel bars are all performing well compared to the control sections regardless of the number of dowels per joint. Little difference can be noted between the sections with the split pipe, figure eight, and vee device and the control sections, which are all performing poorly.

The performance of the sections with the double vee devices varies: half of the sections show good performance and half of the sections show marginal to poor performance.
