An Experimental Evaluation of Autostress Design

CHARLES W. ROEDER and LIV ELTVIK

The Whitechuck River Bridge was this test structure (9,10). The bridge was designed by the ASD method and was constructed in 1982. A nondestructive load test, which simulated overload and induced yielding, was performed immediately after construction. Strains, deflections, temperatures, and concrete deck cracking were measured and observed during the load test, and a series of long-term observations were taken for the 2-year period after the load test.

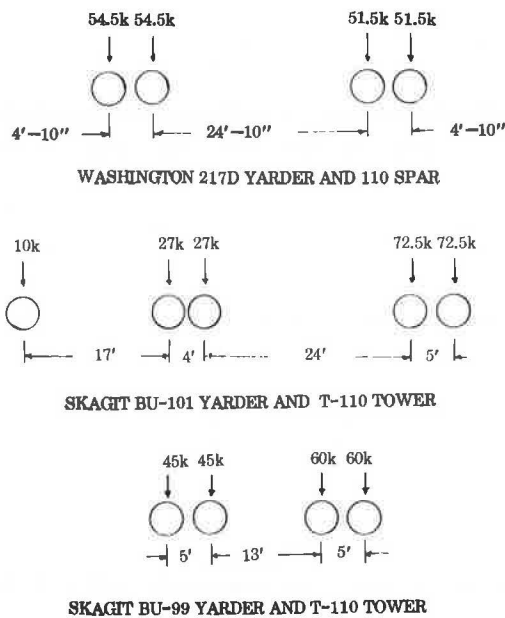
FIGURE 2 Design vehicle axle loads for overload limit state.

The new bridge was designed for AASHTO HS-20 service loads. The overload limit state used a 1.0 load factor applied to the axle loads shown in Figure 2 plus impact, and the maximum load limit state used a load factor of 1.3 applied to the overload. ASD permits controlled yielding during overload and plastic limit analysis behavior during maximum load.

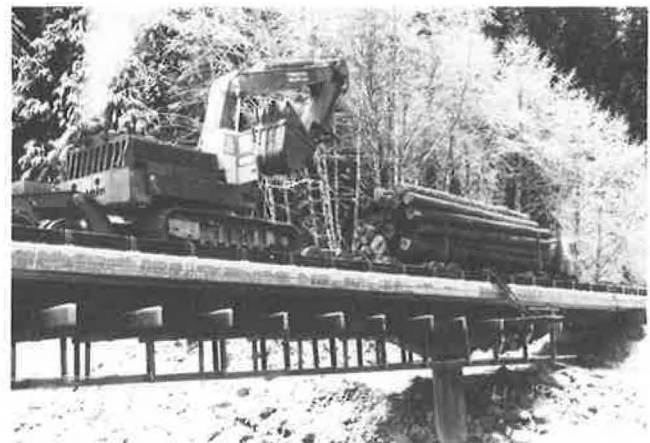
FIGURE 6 Photograph of two test vehicles applied simultaneously back-to-back during LP6.

Eighteen major load points, LP1 to LP18, and eleven minor load points (LP1A, LP2A, etc.) were used in the load test. LP1 through LP3 simulated service load conditions and no yielding was expected, since a single vehicle was used. Although a single vehicle was used in LP4 and LP5, limited yielding was expected because the loads were applied at critical locations (near the curb and with the heavier, longer vehicle straddling the piers). LP6, 7, 8, and 9 all used both vehicles back-to-back and near the curb as shown in the photo of Figure 6. Significant yielding was expected during LP6 and LP7, but little or no yielding was expected during

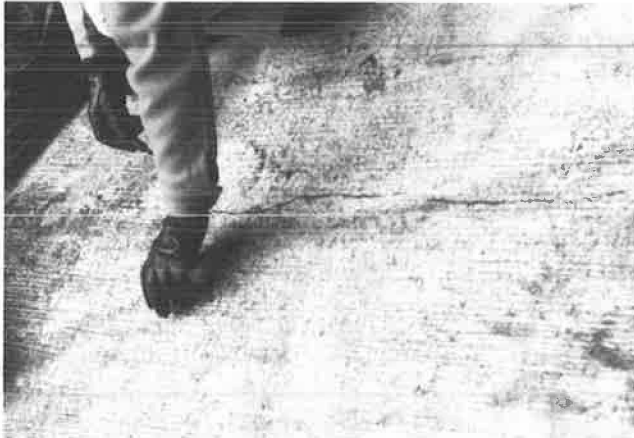
FIGURE 7 Photograph of deck crack marked and observed during LP6.

closely examined for tension cracks at each load point. Concrete cracking was smaller and less widespread than expected. A single tension crack formed over approximately the center of each pier during the test (see Figure 7). The cracks started initiation during LP2 and were formed or were visible on the deck surface through LP9. The cracks were not visible on the deck surface after the loads were removed.

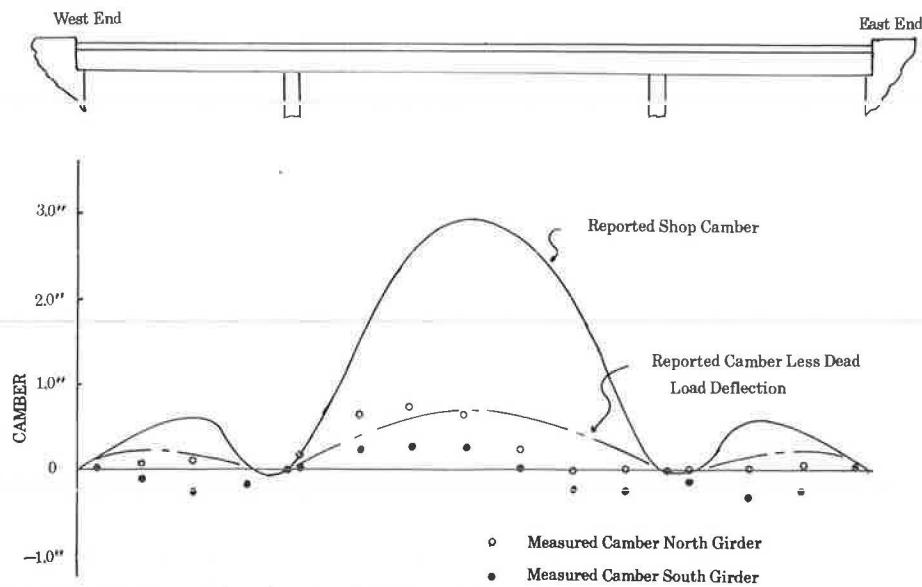
FIGURE 11 Reported camber for the bridge girders at the fabricator shop and measured camber prior to testing.

The previous data indicate that yielding occurred due to overload of the structure. However, the yielding started sooner than was expected and the permanent deflection and concrete cracking were smaller than was anticipated. Figure 11 helps to illustrate why these unexpected results were noted. This figure shows the reported camber of the steel girders in the fabrication shop, the camber with computed, elastic, dead load deflections removed, and the absolute deflection of the bridge girders at the start of the test. (Note that the deflections shown in Figure 8 and all later figures are relative to this absolute value.) The figure shows that the actual dead load deflection was larger than expected. The girders were cambered by the flame-cambering process, and this process, when combined with hot-

rolling, introduces residual stresses approaching the yield stress (13). The residual stresses caused the steel to yield during placement of the dead load, and permanent deflection had occurred before any live load was applied. These plastic dead load deflections were larger at the east end because the deck concrete was placed from east to west. During the load test, yielding continued through LP1 to LP7, but the permanent deflections were much smaller than expected during these later loads, because much of the permanent deflection had already occurred. Fabrication residual stresses affect the order and time of yielding but they have no impact on the ultimate strength of the bridge girders (12,13).
