TRANSPORTATION RESEARCH RECORD 1044

# Structures and Foundations

TRANSPORTATION RESEARCH BOARD

WASHINGTON, D.C. 1985

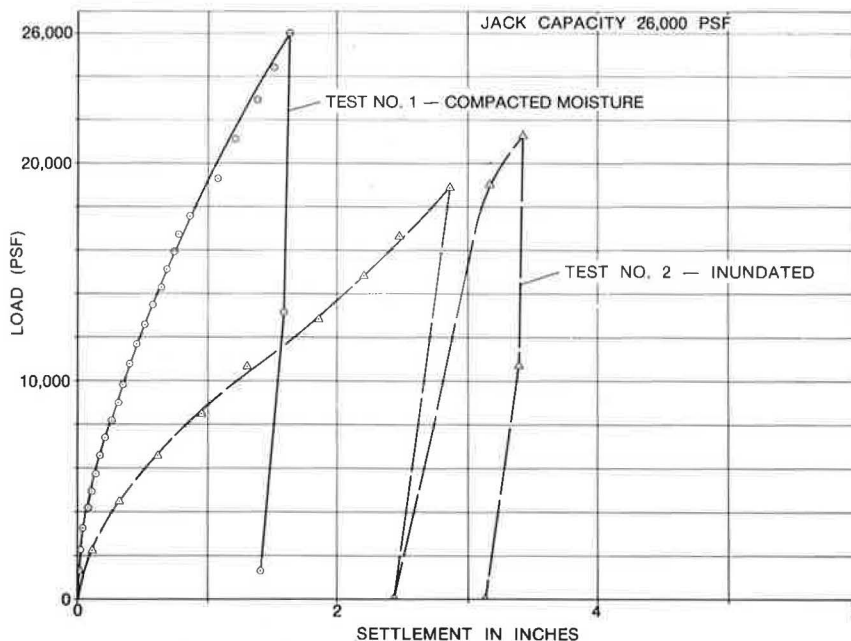
FIGURE 5 Load-settlement curves—compacted overburden fill.

Interpretation of the load-settlement curves involves identification of the failure point, or ultimate load at which the loaded plate causes a bearing capacity failure of the supporting soil. In the case of a general shear failure, the failure point is theoretically clearly definable as a peak or high point in the curve. However, for punching or local shear conditions, there is seldom a sharp break in the curve and the failure point is usually difficult to determine (1).

A peak load point was not clearly identifiable on any of the four load-settlement curves. Among the methods reviewed for interpreting plate load test plots, the Semi-Log Plot-Intersecting Tangents method

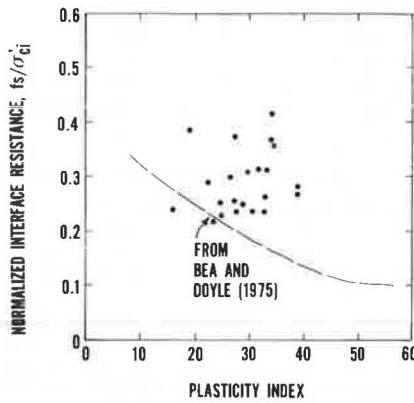
FIGURE 5 Normalized resistance versus plasticity index (16).

values of  $\phi_{ss}$  for the undrained tests was from 12 to 16.5. Figure 5 (16) shows the relationship between  $f_s/\sigma'_{ci}$  and the plasticity index. Ratios of  $f_s/\sigma'_{ci}$  between 0.2 and 0.3, or  $\phi_{ss}$  between 11 and 16 are recommended. The major conclusion from the two investigations is that there is no limit to the side friction that can be obtained. This is in contrast to the concept of limiting side friction used by the American Petroleum Institute (23).

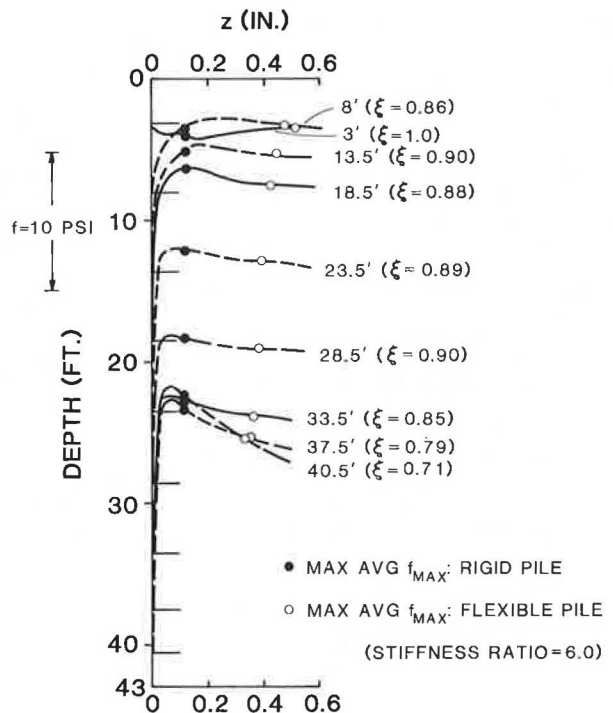
FIGURE 7 Set of  $f$ - $z$  curves.

The results of Figure 7 have been replotted in Figure 8 in the form of  $\xi$  (at 0.6 in.) versus  $\Delta$ , the normalized vertical distance between the pile tip and a generic depth in the soil. The variable  $\xi$  is approximately constant at 0.90-0.95 for  $\Delta$  exceeding 15 diameters. For  $\Delta$  less than 15 diameters,  $\xi$  decreases sharply to approximately 0.70 at  $\Delta = 2$  diameters. This behavior suggests that the farther the pile travels past a given depth of soil during installation, the greater the degree of soil destructuring at the pile-soil interface and the higher the value of  $\xi$ . If such is the case, the average  $f_{max}$  decreases with increasing pile penetration because the angle of soil-to-pile friction  $\phi_{ss}$  decreases at a given depth as the penetration increases, assuming the correctness of the

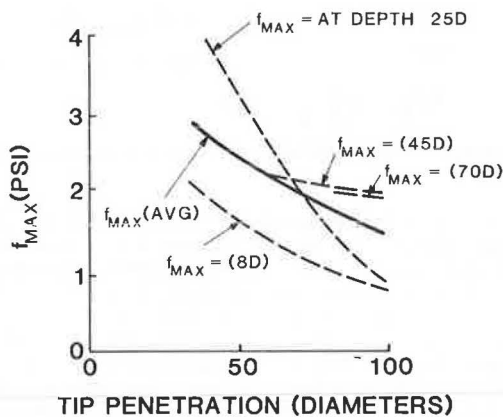
FIGURE 9 Maximum load transfer versus tip penetration for model test.

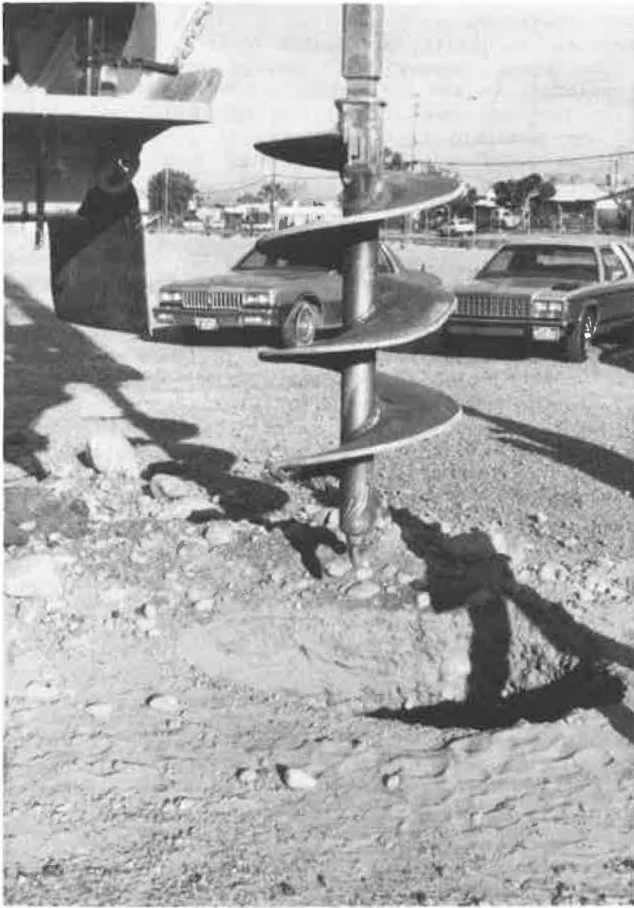
FIGURE 1 A 36-in. helical auger for large observation borings.

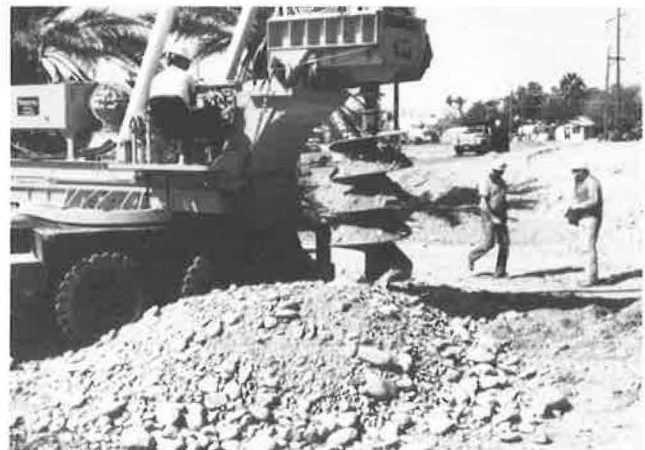
FIGURE 3 S-G-C drilling with a Texoma Tarus holedigger.

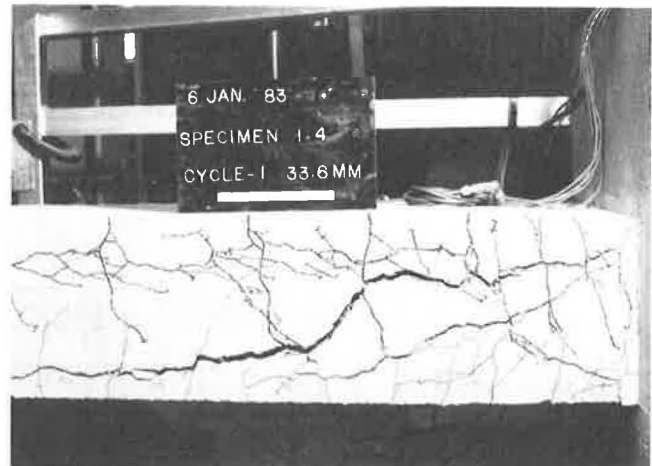
FIGURE 10 Final crack pattern for Specimen 1-4, 4δy/l.

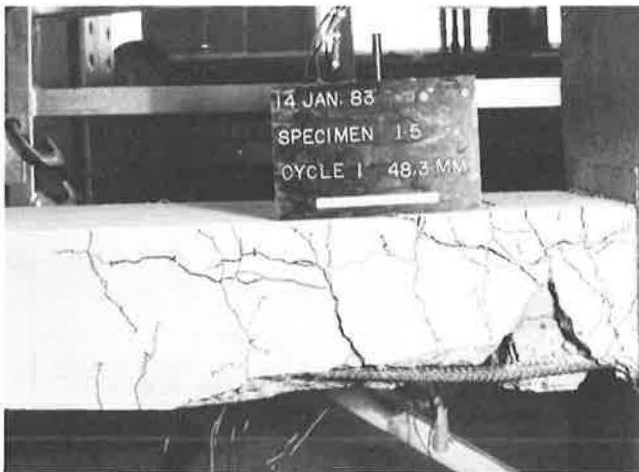
FIGURE 9 Final crack pattern for Specimen 1-5, 7δy/l.

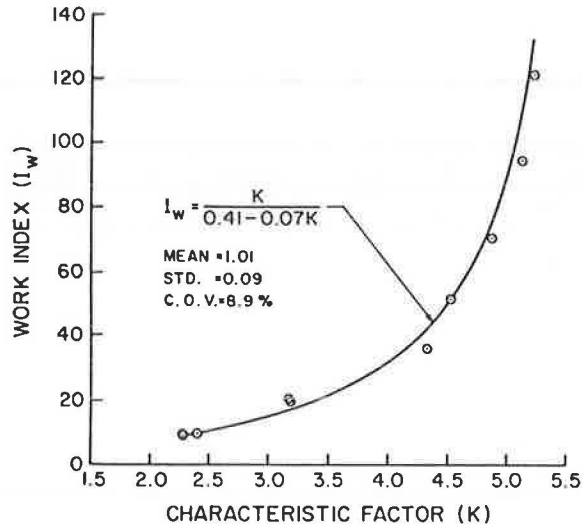
FIGURE 11 Relationship between work index and the characteristic factor,  $K$ .

to be linear. The obtained mean and coefficient of variance values of 1.04 and 7 percent, respectively, indicate an excellent agreement between the two indices. This would justify the use of the simplified work index,  $I_w$ , in lieu of  $I_w'$  to represent the actual absorbed energy,  $W_a$ . The relationship between  $I_w$  and the proposed nondimensional factor  $K$  for all the specimens in Series I is shown in Figure 11. The

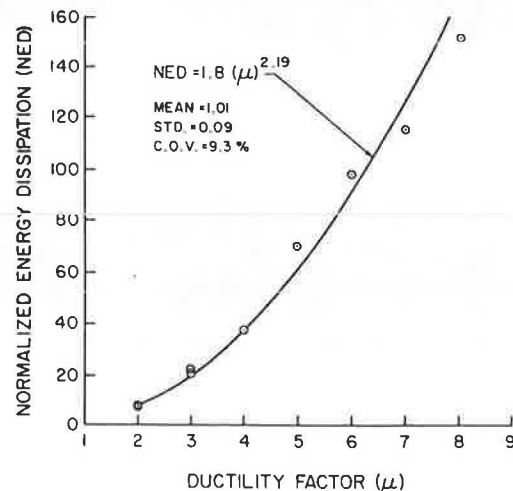
FIGURE 13 Relationship between normalized energy dissipation and ductility.

definition, this energy could be evaluated based on the areas enclosed by the load-deformation hysteresis loops preceding failure deflection. The relationship between the normalized energy dissipation,  $NED$ , with respect to the linearized applied energy of the first cycle,  $P_y \times (\delta_y/2)$ , and the ductility factor,  $\mu$ , for all the specimens in Series I, is shown in Figure 13.

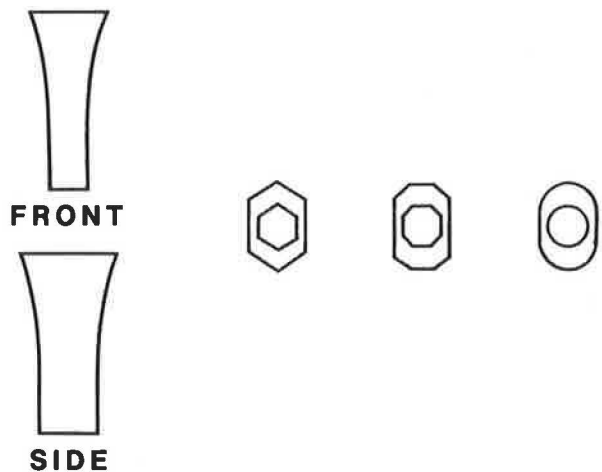
FIGURE 8 Standard architectural columns with two-way flare.

Columns with their lower portions in water rely on the structural conditions for their shape. Columns resting on spread footings or in drilled holes can appear to disappear into the water. This is a distinct advantage with fluctuating water levels. Columns in water supported on pile caps must consider the pile cap as an element in their overall design. Pile bents exposed as columns are used only when low clearance dictates the use of thin superstructure.

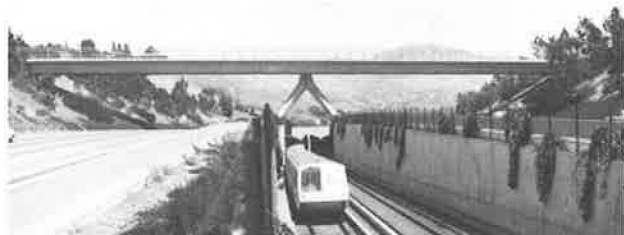
FIGURE 9 Nonstandard architectural column.

There will always be a need for nonstandard columns. Special site conditions, such as Figure 9, require an overcrossing to span a divided highway with a depression in the center for mass transit. Inadequate space for one large column presented the problem of two thin columns resulting in a three-span structure. The structure depth would have visually overpowered the columns. The result was a massive-looking superstructure. Combining all the problems produced a unique solution with columns and superstructure in proportion.

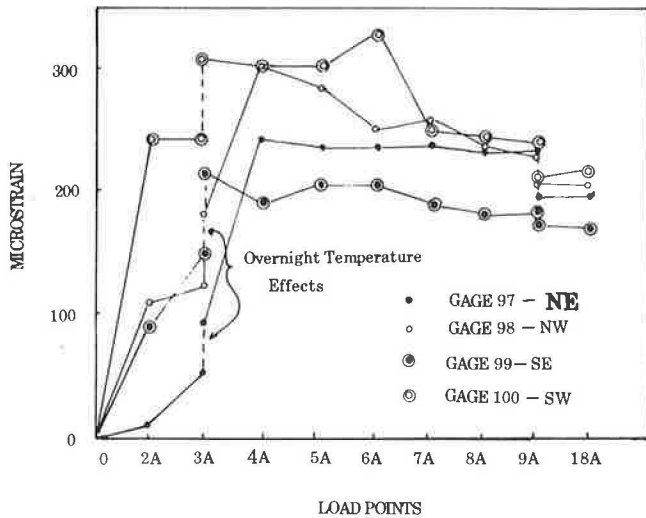
FIGURE 9 Measured strains in the reinforcing bar in the bridge deck over the steel girders and interior pier with no load on the bridge.
