TRANSPORTATION RESEARCH RECORD 1053

Timber Bridges

Performance and rehabilitation of timber bridges.

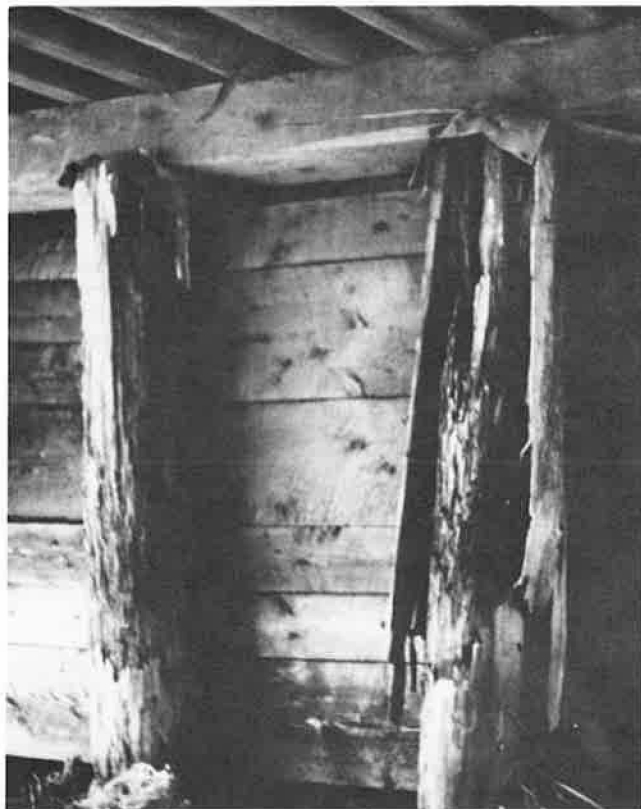
FIGURE 4 Sheet metal caps between pile tops and stringer support caps may increase decay hazard.

2. Sheet metal covers between pile or post tops and overlying stringer support caps are also of questionable value. The metal covers are usually installed before the timber cap is placed. When drift pins are driven down through the cap into the pile or post top, the metal cover is punctured and dimpled, creating a funnel for trapped water to enter the pile top and run down the drift pin past the treated top surface into the unpreserved inner wood. Again, the metal also inhibits drying, thus setting up a "double-jeopardy" situation for a high moisture content in untreated wood, which is one of the conditions conducive to the growth of decay fungi. Some results are shown in Figure 4.

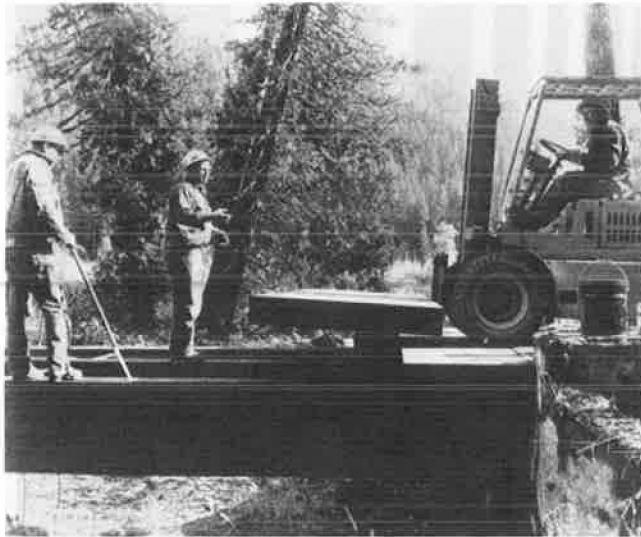
FIGURE 6 Glued-laminated deck slabs being installed as a replacement deck on a 12-year-old bridge.

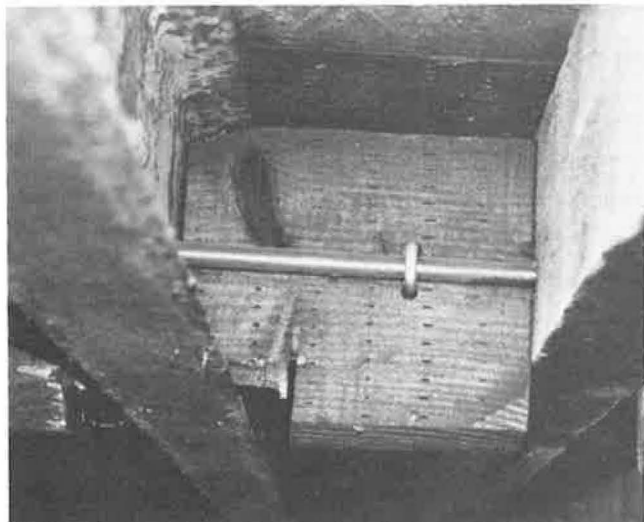
FIGURE 2 New blocking placed between existing steel and timber beams.

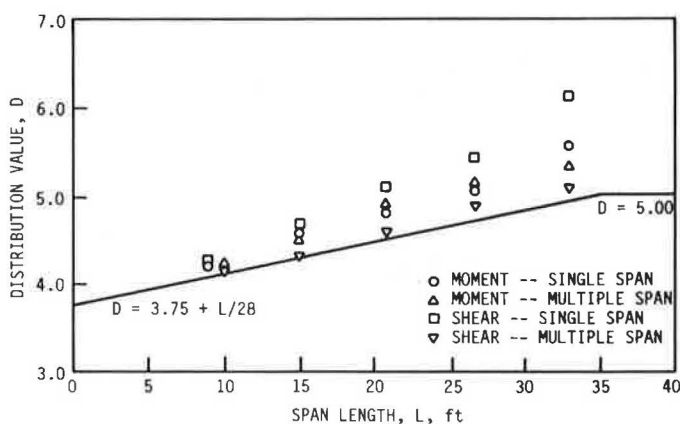
FIGURE 7 Plot of critical D values for all cases considered in parameter study for multiple-lane bridges.

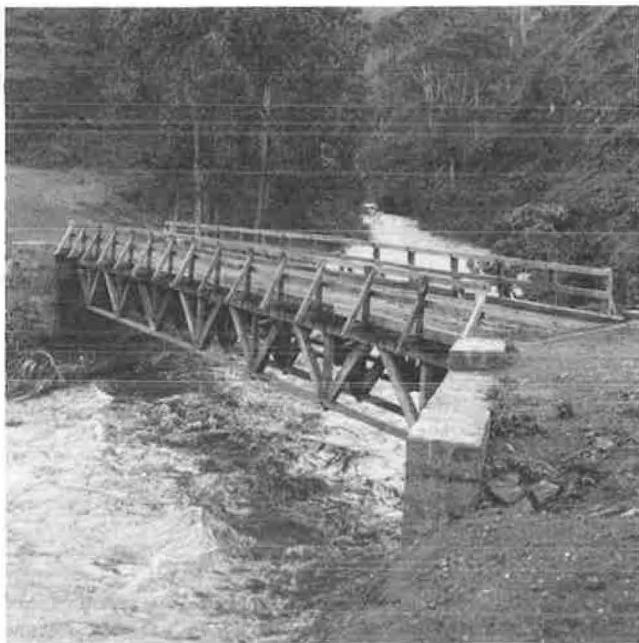
FIGURE 1 The 4-truss bridge at Nyeri.

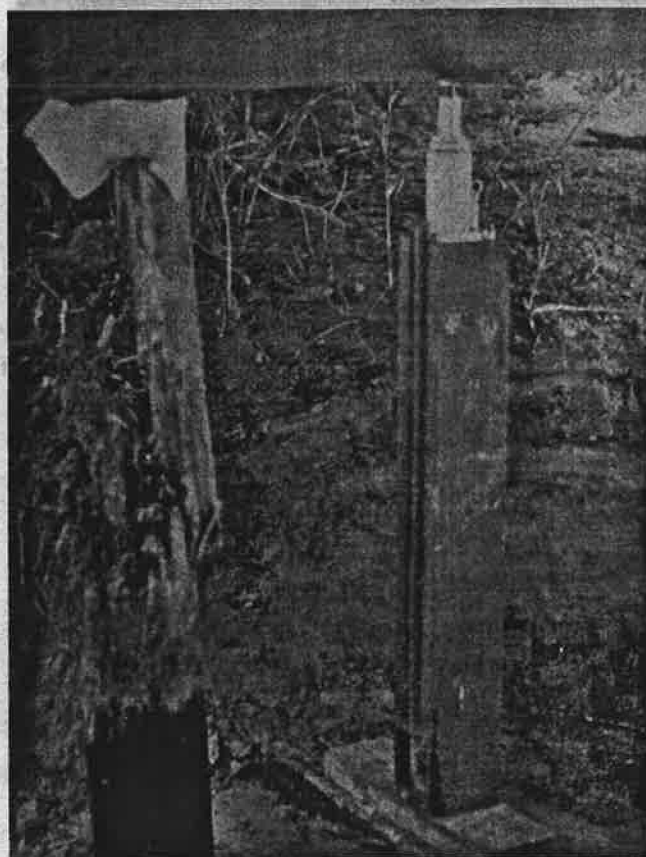
FIGURE 2 Seriously deteriorated pile with jack supporting pile cap.

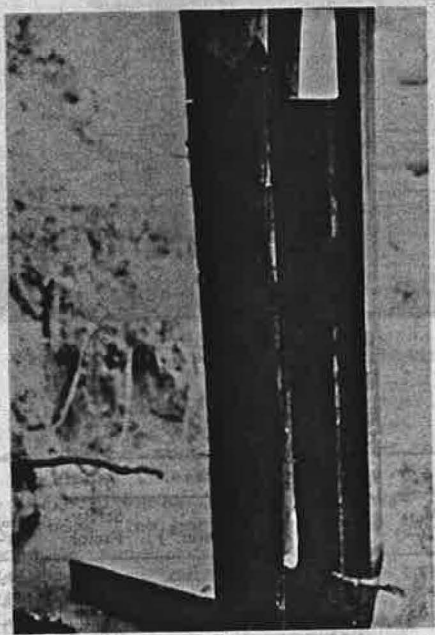
FIGURE 5 Pile with replacement section in place.

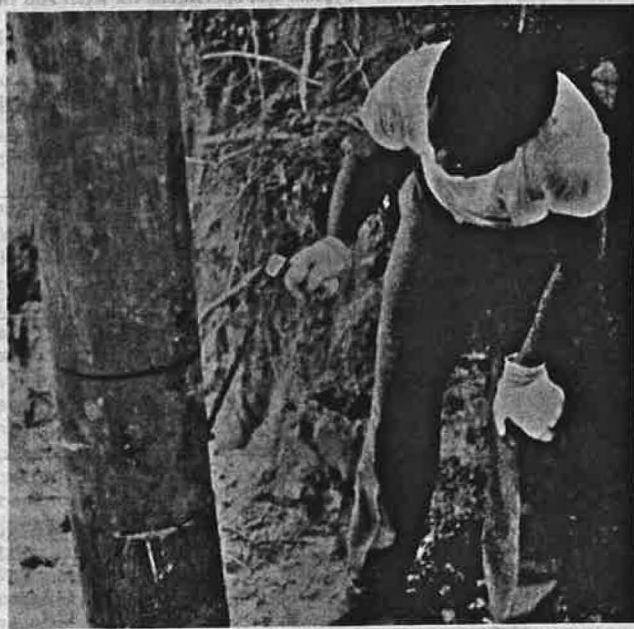
FIGURE 6 Spiral steel rod being placed at joint.

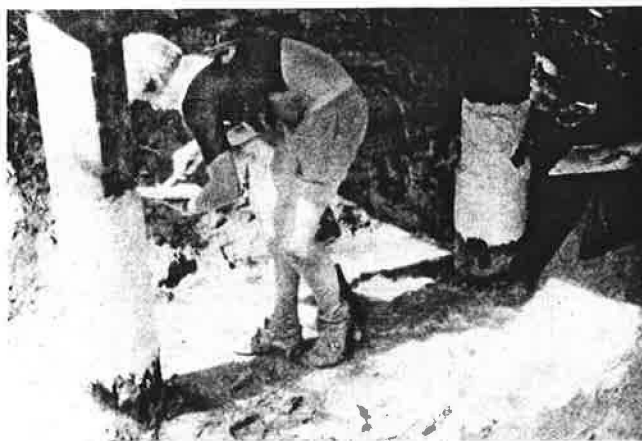
FIGURE 7 Sealing the region between epoxy trenches with gel.

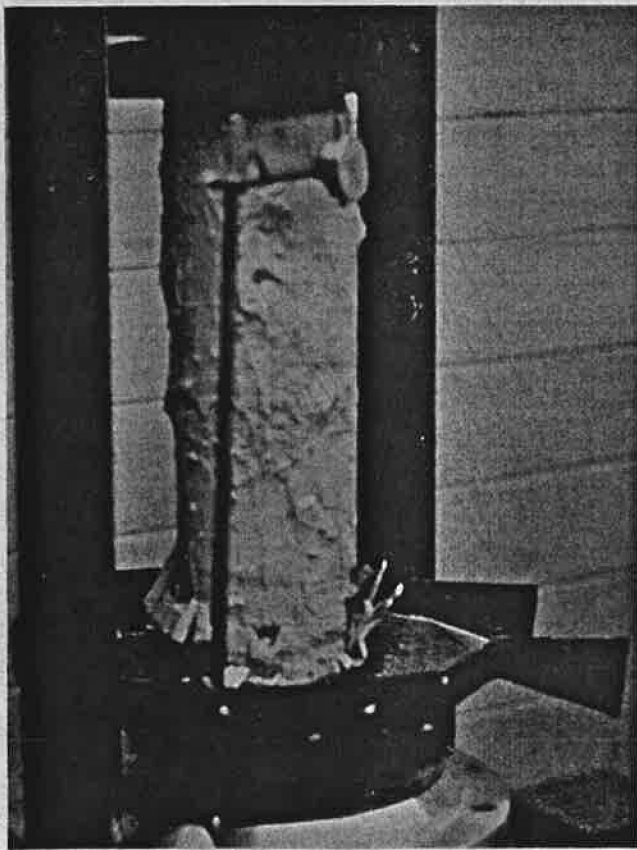
FIGURE 9 Failed compression test specimen.
