Low-Maintenance End Treatment for Concrete Barriers

DEAN L. SICKING and HAYES E. ROSS, Jr.

ABSTRACT

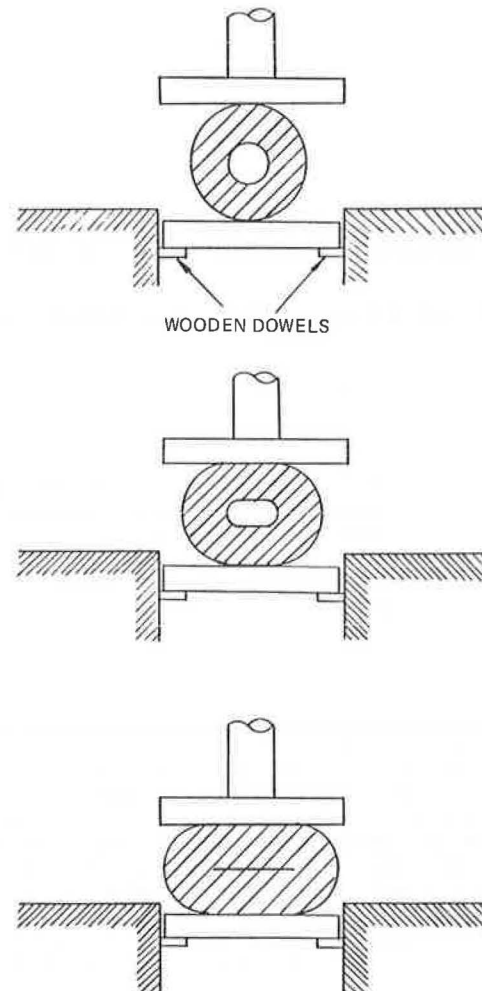
FIGURE 1 Scale-model cylinder dynamic testing configuration.

The energy absorbed during a dynamic test has three sources: (a) inertia, (b) elastic stiffness, and (c) damping. As shown in Figure 1, when the bore

of a test specimen was completely collapsed, approximately one-half of the specimen had been accelerated to the speed of the impact plate, while the other half was virtually stationary. The energy absorbed by the inertia of the specimen was then estimated from the impact velocity and the mass of the specimen as

However, study of the dynamic response of rubber cylinders to transverse compression has been quite limited. The nonlinear characteristics of rubber and the large strains associated with the collapse of a cylinder make dynamic analysis virtually impossible. Therefore an empirical study of the dynamic force deflection characteristics of rubber cylinders was undertaken. One-fifth-scale-model cylinders, made from several different rubber compounds, were obtained in a variety of wall thicknesses. The scale-model cylinders were then tested statically and at three different impact speeds (5, 30, and 75 fps) to determine their force deflection characteristics. Figure 1 shows a sketch of the test setup used in the dynamic tests. Note that the test configuration allowed the sample to be compressed fully at a constant velocity.

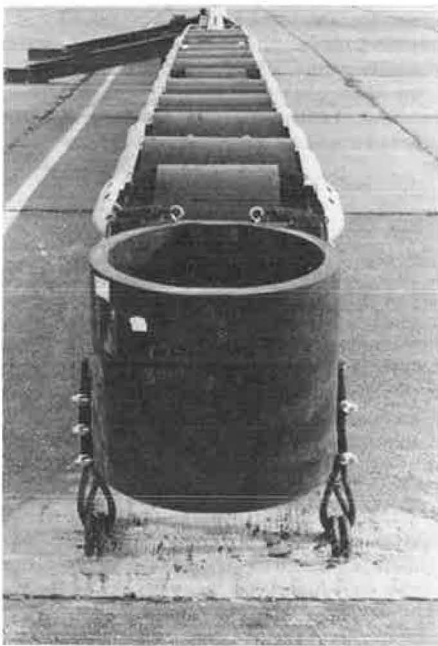
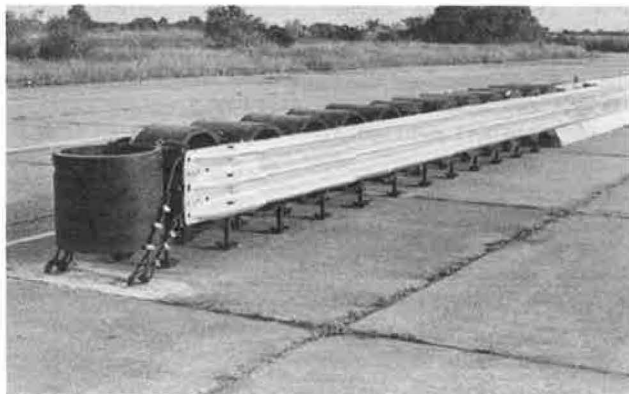
FIGURE 2 Low-maintenance end treatment.

The final end treatment design, shown in Figure 2, consists of a single row of rubber cylinder energy-absorbing cartridges separated by steel diaphragms. A rubber cylinder is placed vertically in front of the end treatment to capture colliding vehicles and prevent override or underride of the cushion. The remaining rubber cylinders are placed horizontally to allow unrestrained collapse of the cylinders. Thrie-beam fender panels attached to the diaphragms and four 5/8-in. longitudinal cables provide redirection capabilities. Fender panels are attached to the diaphragms with hinges to allow the thrie-beams to open outward without damaging the panels. Steel springs are used to prevent the fender panels from opening under wind loadings.

The rubber cartridges do not have sufficient elastic stiffness to completely restore the system after it has been struck. Four lightweight cables are attached between the diaphragms to allow the cushion to be pulled back into place after an impact. The end treatment is designed to sustain most impacts without replacement of any parts and to be restored to its original configuration in less than an hour.

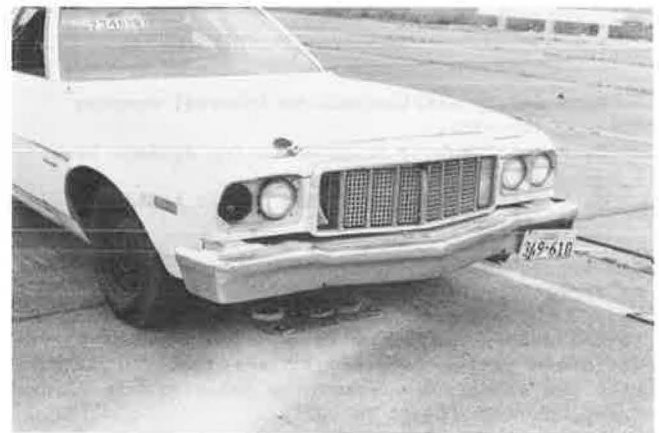
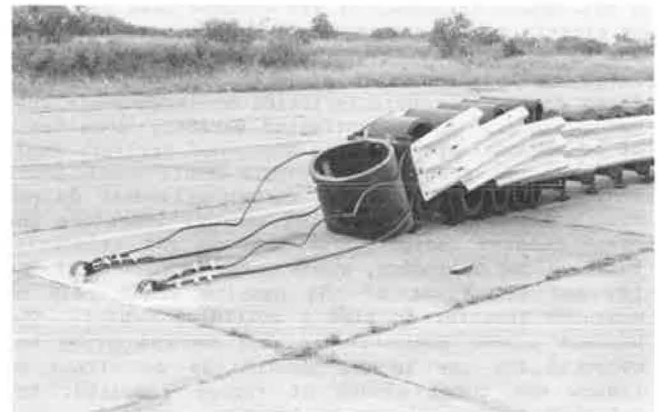
FIGURE 3 Test vehicle and low-maintenance end treatment after 30-mph impact.

The first test was conducted at 30 mph with an uninstrumented vehicle. The cushion performed well and stopped the vehicle in approximately 15 ft. The test vehicle exhibited no tendency to vault over or underide the cushion. The vehicle rebounded off the cushion at approximately 5 mph. As shown in Figure 3, the test vehicle was only lightly damaged and cushion damage was limited to minor bending of some of the skid shoes under the steel diaphragms.

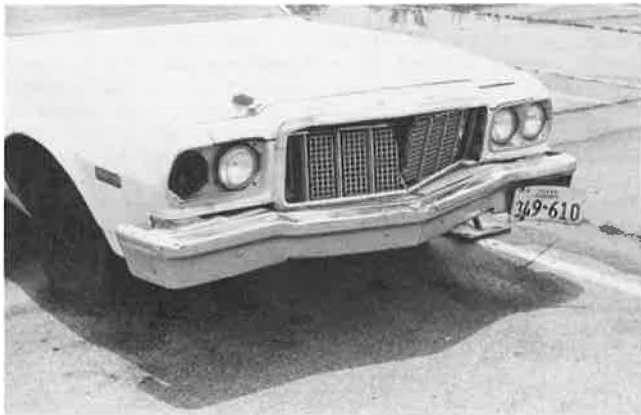
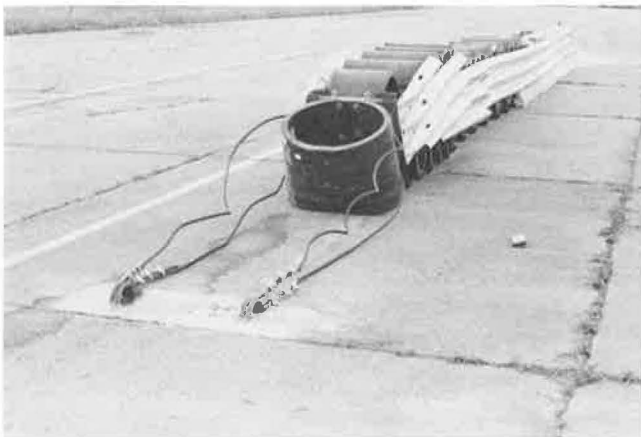
FIGURE 4 Vehicle and end treatment after 40-mph impact.

The cushion was pulled back into place in less than an hour and a second test was conducted at 40 mph. The end treatment smoothly decelerated the test vehicle over a distance of 17.5 ft and vehicle damage was light. The vehicle again rebounded off the cushion at approximately 5 mph. Some of the hinges supporting the three-beam fender panels were damaged and the legs under the leading diaphragm were bent when they contacted the legs under the second diaphragm. Figure 4 shows the end treatment and test vehicle after the second test.

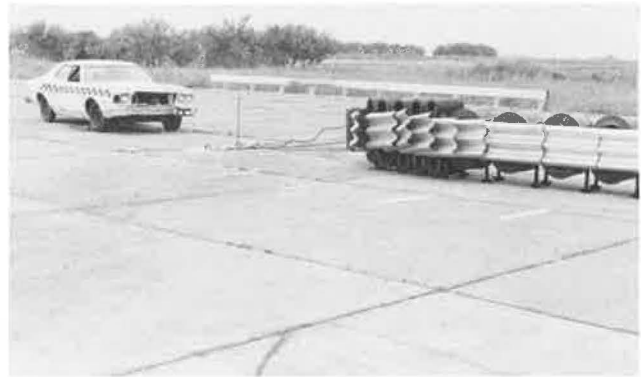
FIGURE 5 Vehicle and end treatment after Test 3.

The hinges on the front of the cushion were replaced with larger hinges and the method of attachment to the diaphragms was improved to reduce the possibility of damage. The legs on the first diaphragm were removed and replaced with a single leg in the center such that it would not contact the legs on the second diaphragm during impact. The test vehicle was then instrumented and a third test was conducted at 51 mph. The test vehicle was smoothly decelerated and was pushed back out of the cushion at approximately 7 mph. The vehicle was only moderately damaged, as shown in Figure 5. All occupant risk values, given in Table 4, were well below recommended limits (2). The end treatment was pulled back into place in less

than an hour and, with the exception of some of the new hinges, was undamaged.

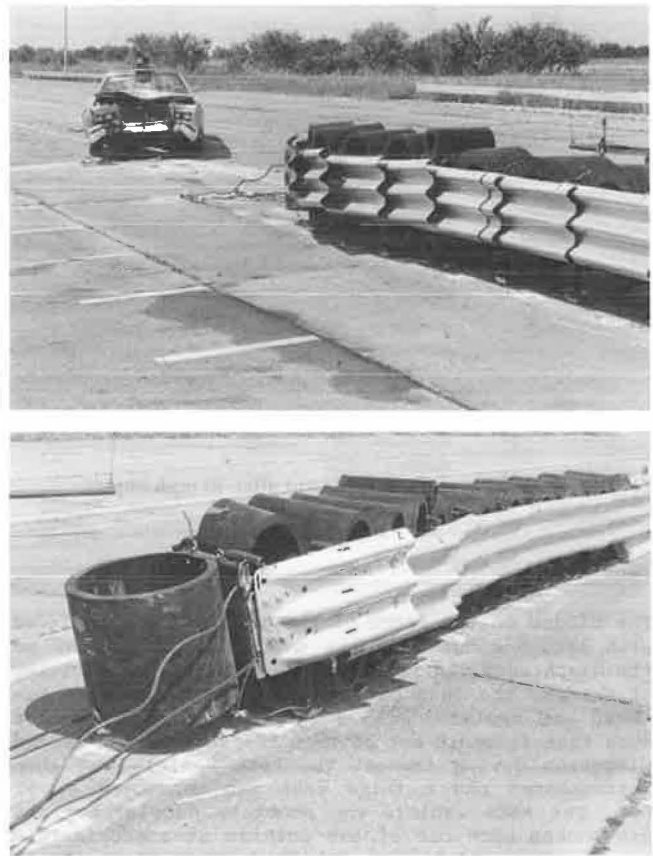
FIGURE 7 Vehicle and end treatment after Test 5.

The cushion and test vehicle were damaged moderately, as shown in Figure 7. One of the redirection cables snagged on a diaphragm and was broken, and one of the lightweight restoration cables between the diaphragms was cut. As a result, the cushion could not be pulled back into position as in previous tests. In addition, there was minor damage to several of the hinges and the legs under the diaphragms. There was still some minor contact between the 3/4-in. rods on the hinges and the fender panels. Therefore it is recommended that the hinges be replaced with a flat plate design. This design should be slightly stronger than those used in the tested design.

Cushion repair was accomplished by replacing two 5/8-in.-diameter lateral restraint cables and two 1/4-in.-diameter restoration cables. It should be noted that the damaged lateral restraint cables were old and may have been frayed or damaged during previous research. However, it is recommended that all lateral restraint cables be visually inspected after every accident.

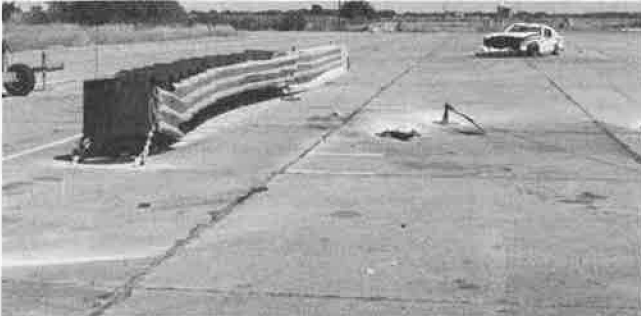
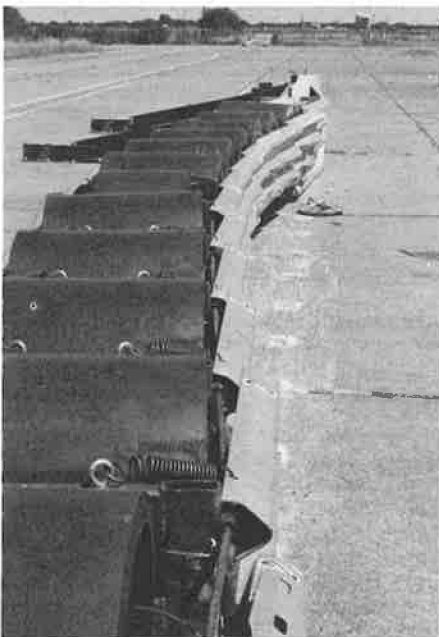
FIGURE 8 Vehicle and end treatment after Test 6.

The end treatment was not damaged heavily for a test of this severity, as shown in Figure 8. Repair would have been limited to the replacement of the last diaphragm, two thrie-beam fender panels, one wood block-out on the face of the concrete barrier, and one redirection cable. No rubber cells showed any sign of damage. As in most impacts of this severity, the test vehicle sustained considerable damage.

During the test the lateral support element at the front of the concrete barrier gave way and the front of the barrier deflected 4 in. As the barrier was deflected, it rolled away from the impacting vehicle thereby extending the lower curb face beyond the edge of the treatment. The wheels of the test vehicle snagged somewhat on the exposed lower face and generated relatively high longitudinal and lateral forces on the automobile. Although barrier anchorage for field installations would likely be more substantial and limit this problem, it is recommended that the barrier end be transitioned to a vertical wall to further reduce the likelihood of such an occurrence.
