Concrete Safety Shape with Metal Rail on Top To Redirect 80,000-lb Trucks

T. J. HIRSCH, W. L. FAIRBANKS, and C. E. BUTH

ABSTRACT

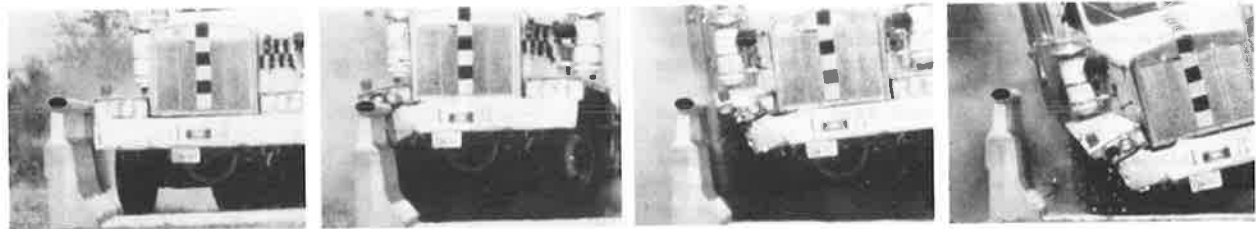
FIGURE 9 Summary of data for Test 2416-1.

Test No. 2416-1
 Date 9/18/84
 Test Installation. Mod. Texas Type T5
 Bridge Rail w/Mod.
 Texas Type C4
 Metal Rail
 Length of Installation 101.2 ft (30.8 m)
 Metal Rail Deflection
 Permanent 0.5 ft (0.2 m)
 Maximum 0.9 ft (0.3 m)
 Vehicle. 1981 Kenworth Tractor
 with Freuhauf
 Van-type Trailer

Vehicle Weights
 Empty Weight 32,080 lbs (14,564 kg)
 Gross Static 80,080 lbs (36,356 kg)
 Impact Speed 48.4 mph (77.9 km/h)
 Impact Angle 14.5 deg
 Tractor Accelerations at Drive Axles
 (Max. 0.050 sec Avg)
 Longitudinal -2.4 g
 Lateral 5.5 g
 Vertical 3.9 g
 Max. Roll Angle 90 deg

The truck struck the rail at 48.4 mph (77.9 km/hr) at a 14.5-degree angle. The impact point was 26 in. (66 cm) downstream from Post 5, and the truck was contained and redirected. The tractor-trailer did, however, roll 90 degrees and came to rest on its side approximately 175 ft (53 m) from the impact point. Figure 8 shows the bridge rail and test site immediately after the test. The truck sustained damage to the right front and right tandem wheels. The cab of the truck remained intact. A summary of the crash test data is shown in Figure 9.

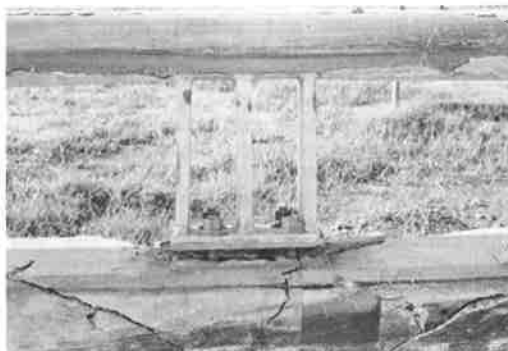
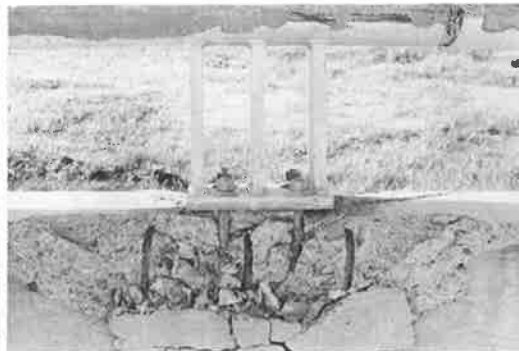
FIGURE 10 Posts 5-8 after test.

The bridge deck supporting the rail sustained no damage. The concrete parapet was not significantly damaged, but the metal rail experienced damage between Posts 5 and 8 (Figure 10). It was determined from the overhead film that the metal rail was deflected a maximum of 11 in. (27.9 cm) and sustained

a permanent deflection of 6 in. (15.2 cm). The concrete rail was permanently displaced 0.5 in. (1.3 cm). The threads were stripped from the trafficside anchor nuts of Posts 5 and 6 of the metal rail. Examination revealed that the thread fit was too loose on the bolts 7/8 in. (2.2 cm) in diameter

anchoring the metal posts. This problem has occurred with some previous tests, and laboratory experiments indicated that the bolts with the improper nut fit developed only 75 percent of the ultimate tensile strength developed by those bolts with proper nut fit. The trafficside anchor bolts of Posts 6 and 7 pulled loose from the concrete parapet. Figure 11 is sequential photographs showing overhead and frontal views of the crash test.

The four ASTM-A325 anchor bolts 7/8 in. (2.2 cm) in diameter by 13 1/2 in. (34.3 cm) long used at each post had two deficiencies. The threads on the bolts were cut too loose (not according to specifications) and permitted the nuts to be stripped off at two posts. The anchor bolts were not long enough to develop their strength. The length of 13 1/2 in. (34.3 cm) should be increased to at least 18 in. (46 cm) to increase the development length.
