TRANSPORTATION RESEARCH RECORD 1065

# Roadside Safety

<b>TIMBER POLE SAFETY BY DESIGN</b> Don L. Ivey and James R. Morgan .....	1
<b>PENNSYLVANIA'S GUIDE RAIL STANDARDS: A COST-EFFECTIVE CHANGE</b> Louis C. Schultz, Jr., et al. ....	12
<b>EVENTS THAT PRODUCE OCCUPANT INJURY IN LONGITUDINAL BARRIER ACCIDENTS</b> Malcolm H. Ray, Jarvis D. Michie, and Martin Hargrave .....	19
Discussion John G. Viner .....	28
Authors' Closure .....	30
<b>LOW-MAINTENANCE END TREATMENT FOR CONCRETE BARRIERS</b> Dean L. Sicking and Hayes E. Ross, Jr. ....	31
<b>DEVELOPMENT OF CONDITION SURVEYS AND INVENTORIES FOR GUIDE RAIL AND DRAINAGE FACILITIES</b> G. J. Malasheskie et al. ....	38
<b>REAL-WORLD IMPACT CONDITIONS FOR RUN-OFF-THE-ROAD ACCIDENTS</b> King K. Mak, Dean L. Sicking, and Hayes E. Ross, Jr. ....	45
Discussion J. D. Michie .....	54
Authors' Closure .....	54
<b>A LOW-MAINTENANCE, ENERGY-ABSORBING BRIDGE RAIL</b> W. Lynn Beason, T. J. Hirsch, and John C. Cain .....	56

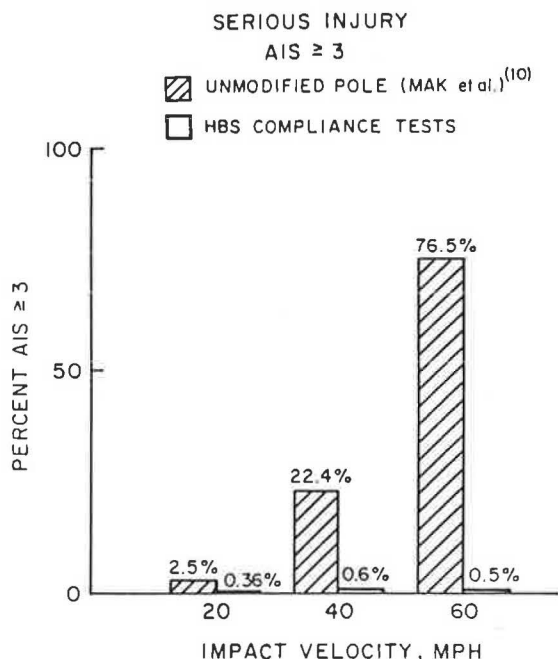
FIGURE 11 Comparison of injury levels from HBS compliance tests with unmodified pole injury levels (% AIS 3).

rate levels for any test can be seen by examining Table 2, it is somewhat easier to compare those levels using Figures 10 and 11. These bar graphs were developed for each test speed using Method 1 and present the average injury level for all tests at that speed. In Figure 10 it is seen that a significant improvement results. The greater improvement, however, is shown by Figure 11. A major decrease in the AIS  $\geq 3$  injury rate is demonstrated. This decrease, for the five compliance tests conducted, averages 91 percent. It is apparent from

Figure 11 that the reduction becomes more pronounced as the speed increases. There is a slight advantage at 20 mph that progresses to a major improvement at 60 mph. For the 40- and 60-mph test conditions, the probability of injury greater than AIS = 3 is reduced by 97 percent.

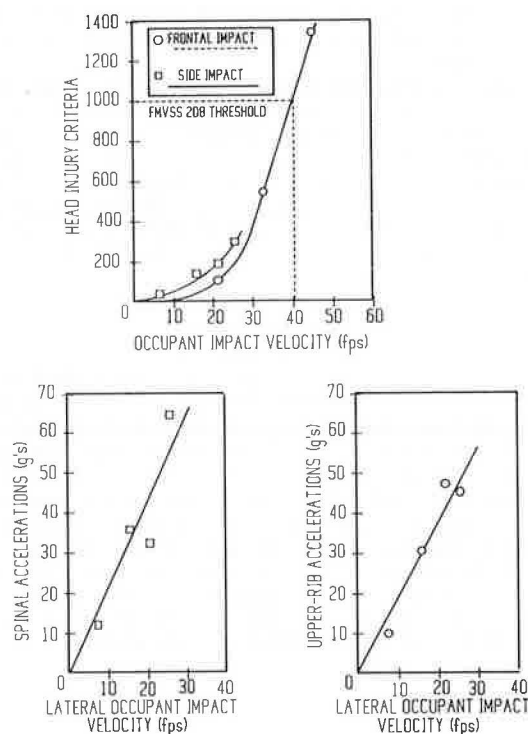
FIGURE 7 Sled test dummy responses.

Figure 7 shows a plot of the dummy response data for the side impact sled tests given in Table 2 of the paper. The discussant states that because the spinal and lower rib accelerations vary slightly the data are flawed. Figure 7 shows that all of the data are within normal experimental tolerances. Furthermore, data for frontal impacts, also given in Table 2 of the paper, confirm that an occupant head impact velocity of 40 fps into a late-model vehicle wind-

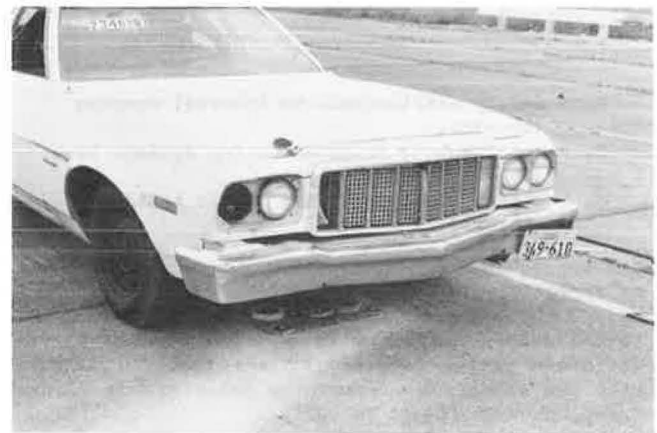
**FIGURE 3 Test vehicle and low-maintenance end treatment after 30-mph impact.**

The first test was conducted at 30 mph with an uninstrumented vehicle. The cushion performed well and stopped the vehicle in approximately 15 ft. The test vehicle exhibited no tendency to vault over or underide the cushion. The vehicle rebounded off the cushion at approximately 5 mph. As shown in Figure 3, the test vehicle was only lightly damaged and cushion damage was limited to minor bending of some of the skid shoes under the steel diaphragms.

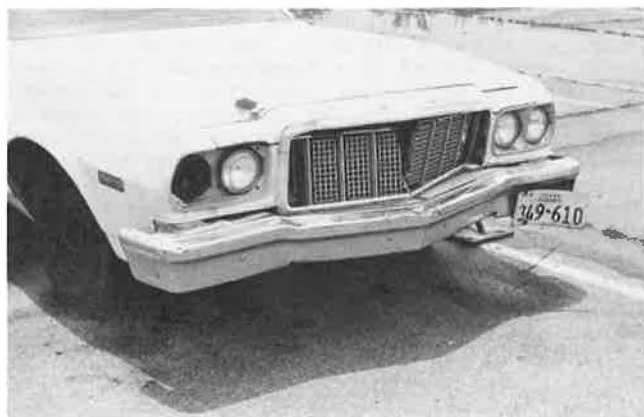
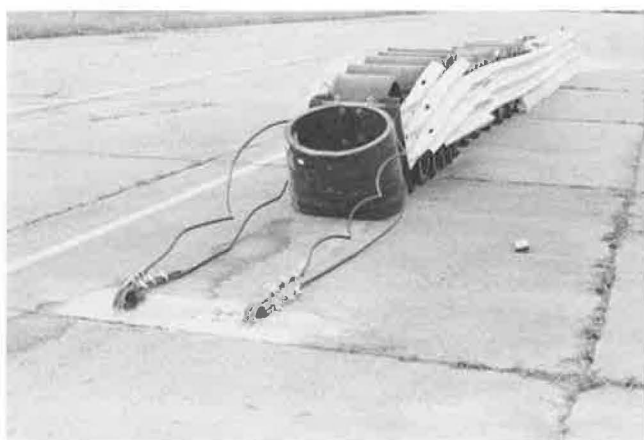
FIGURE 4 Vehicle and end treatment after 40-mph impact.

The cushion was pulled back into place in less than an hour and a second test was conducted at 40 mph. The end treatment smoothly decelerated the test vehicle over a distance of 17.5 ft and vehicle damage was light. The vehicle again rebound off the cushion at approximately 5 mph. Some of the hinges supporting the three-beam fender panels were damaged and the legs under the leading diaphragm were bent when they contacted the legs under the second diaphragm. Figure 4 shows the end treatment and test vehicle after the second test.

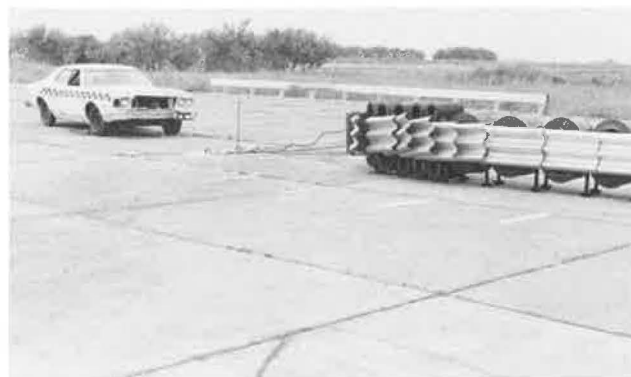
FIGURE 5 Vehicle and end treatment after Test 3.

The hinges on the front of the cushion were replaced with larger hinges and the method of attachment to the diaphragms was improved to reduce the possibility of damage. The legs on the first diaphragm were removed and replaced with a single leg in the center such that it would not contact the legs on the second diaphragm during impact. The test vehicle was then instrumented and a third test was conducted at 51 mph. The test vehicle was smoothly decelerated and was pushed back out of the cushion at approximately 7 mph. The vehicle was only moderately damaged, as shown in Figure 5. All occupant risk values, given in Table 4, were well below recommended limits (2). The end treatment was pulled back into place in less

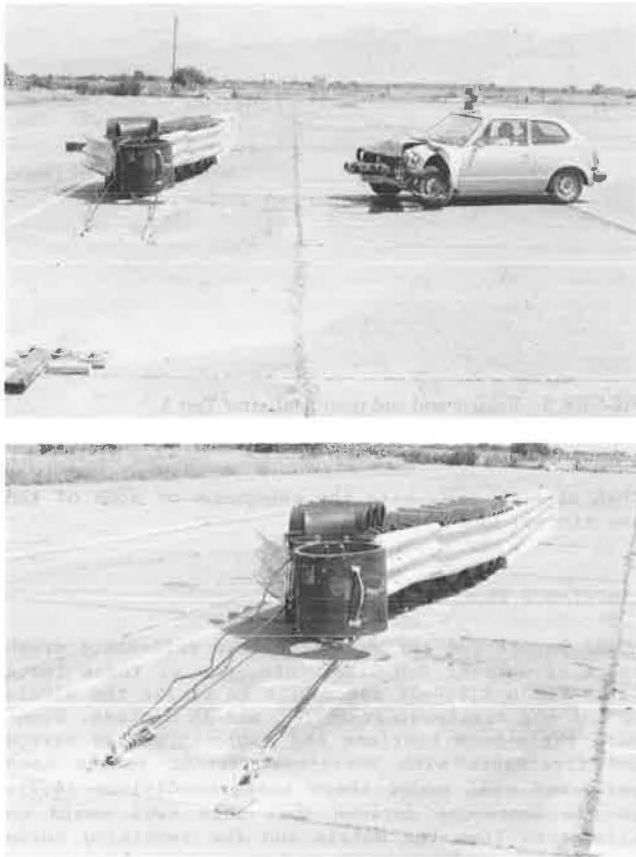
FIGURE 6 Vehicle and end treatment after Test 4.

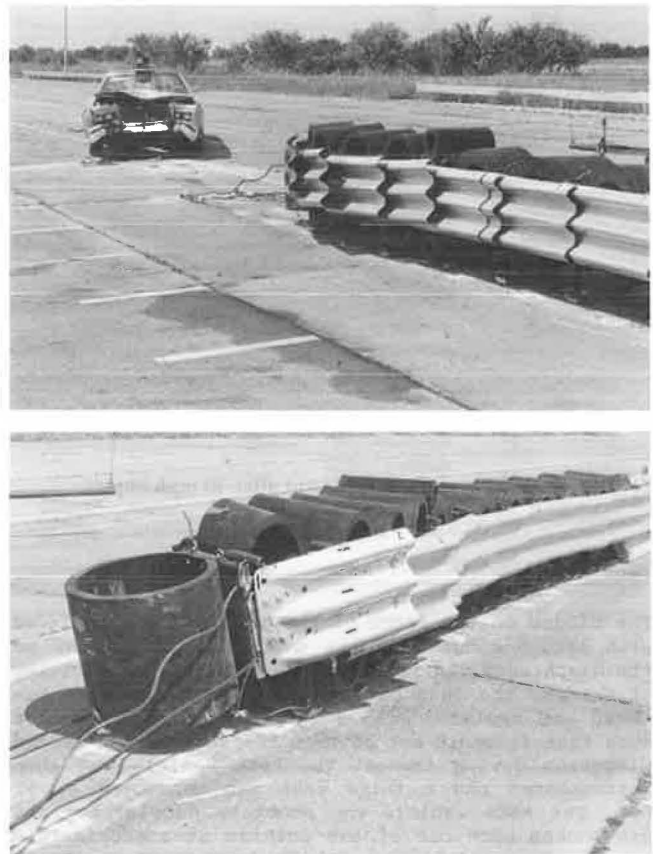
FIGURE 7 Vehicle and end treatment after Test 5.

The cushion and test vehicle were damaged moderately, as shown in Figure 7. One of the redirection cables snagged on a diaphragm and was broken, and one of the lightweight restoration cables between the diaphragms was cut. As a result, the cushion could not be pulled back into position as in previous tests. In addition, there was minor damage to several of the hinges and the legs under the diaphragms. There was still some minor contact between the 3/4-in. rods on the hinges and the fender panels. Therefore it is recommended that the hinges be replaced with a flat plate design. This design should be slightly stronger than those used in the tested design.

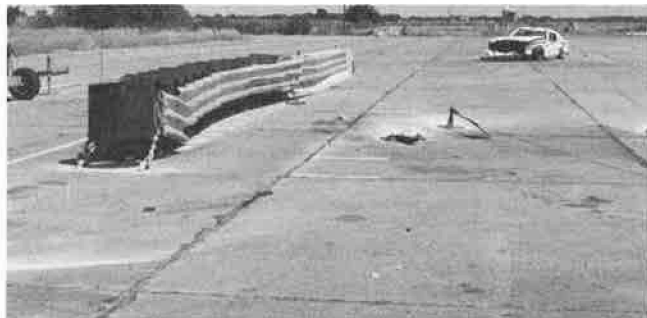
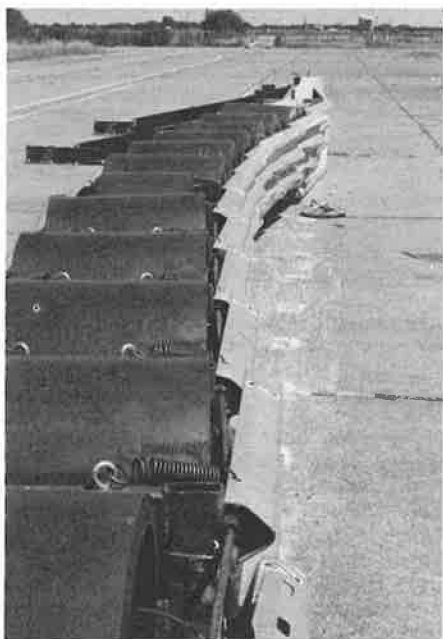
FIGURE 8 Vehicle and end treatment after Test 6.

The end treatment was not damaged heavily for a test of this severity, as shown in Figure 8. Repair would have been limited to the replacement of the last diaphragm, two thrie-beam fender panels, one wood block-out on the face of the concrete barrier, and one redirection cable. No rubber cells showed any sign of damage. As in most impacts of this severity, the test vehicle sustained considerable damage.

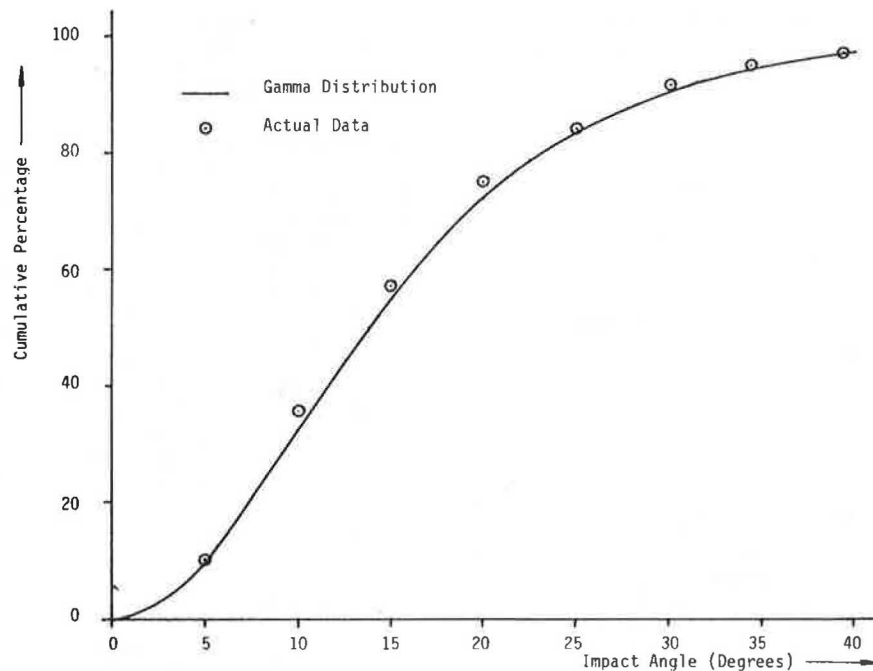
FIGURE 2 Impact angle distribution for combined data.

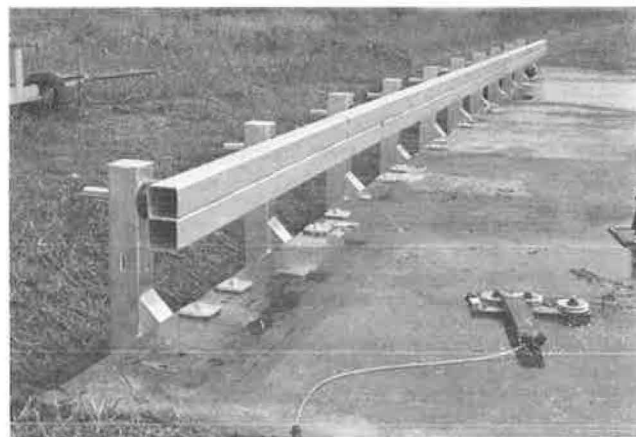
FIGURE 4 59-ft (18-m) section of energy-absorbing bridge rail.

The tests were conducted using the 59-ft (18-m) section of the energy-absorbing bridge rail shown in Figure 4. NCHRP Report 230 specifies that a 75-ft (22.9-m) section of the bridge rail should be tested; however, it is the opinion of the authors that the performance of the bridge rail is not affected by this deviation. Further, the acceptance of the shorter section allowed the use of an existing standard SDHPT bridge deck.

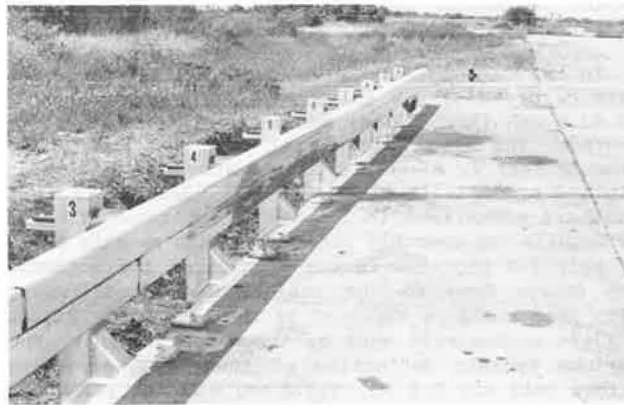
FIGURE 10 Bridge rail after Test 2.

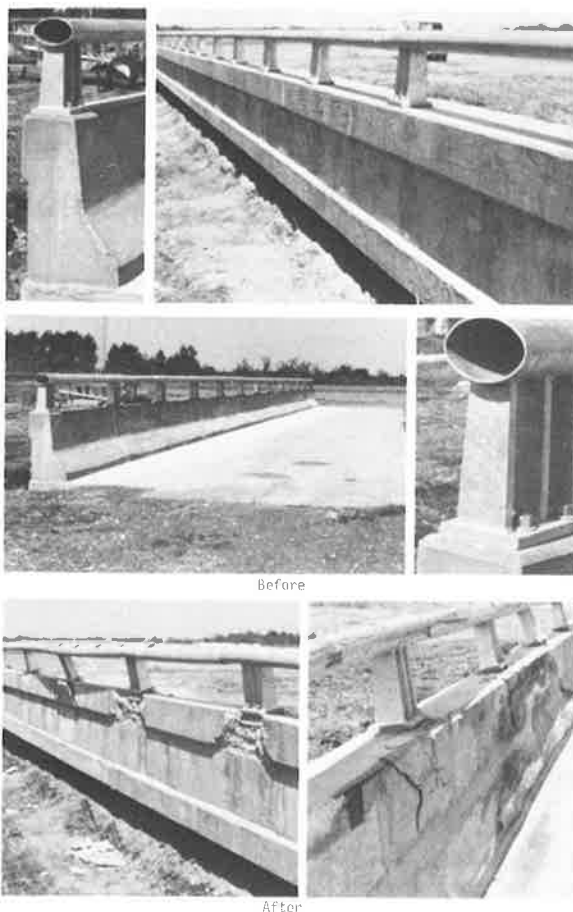
FIGURE 8 Bridge rail before and after test.
