The Development of Deck Assessment by Radar and Thermography

D. G. MANNING and F. B. HOLT

ABSTRACT

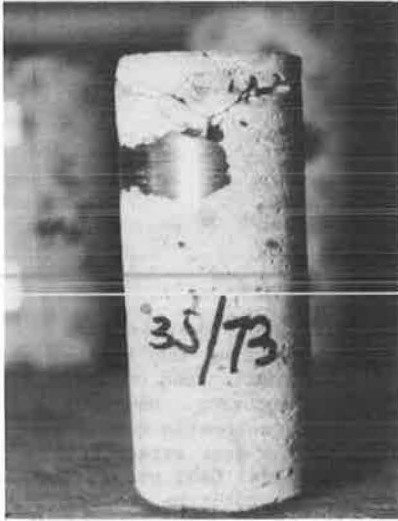
FIGURE 1 Corrosion-induced delamination in a concrete core.

The most serious form of deterioration is that caused by corrosion of embedded reinforcement. As the reinforcing steel corrodes, it expands and creates a crack or subsurface fracture plane in the concrete at or just above the level of the reinforcement (Figure 1). The fracture plane, or delamination, may be localized or extend over a substantial area, especially if the concrete cover to the reinforcement is small. It is not uncommon for more than one delamination to occur on different planes between the concrete surface and the reinforcing steel. Delaminations are not visible on the concrete surface. However, if repairs are not made, the delaminations progress to open spalls and, with continued corrosion, eventually affect the structural integrity of the deck. Spalls on exposed concrete decks seriously impair the riding quality of the deck.

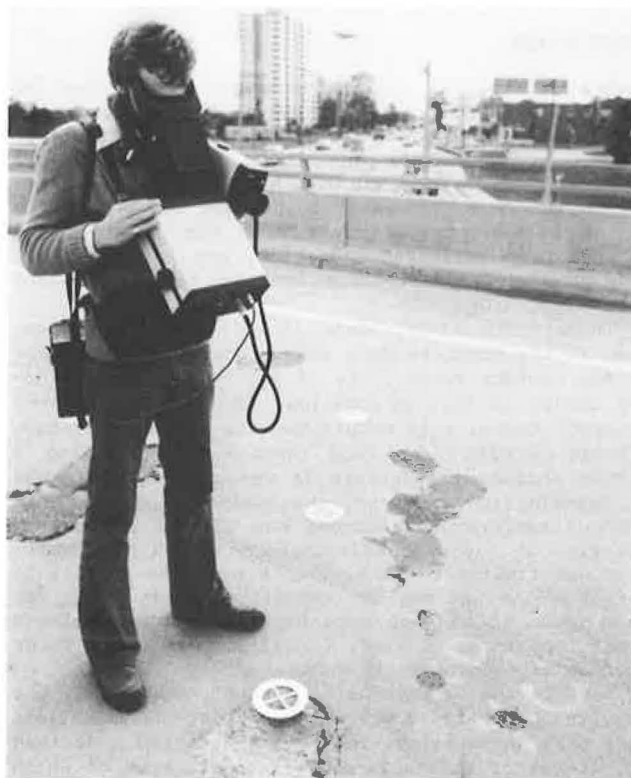
The first series of tests was made at ground level using targets to locate the position of the image (Figure 4). Although the delaminations were easily identified, the method was impractical because of the limited field of view and the difficulty of constructing a plan of the deck from photographs taken at an oblique angle.

FIGURE 4 Infrared thermovision equipment being operated at ground level.

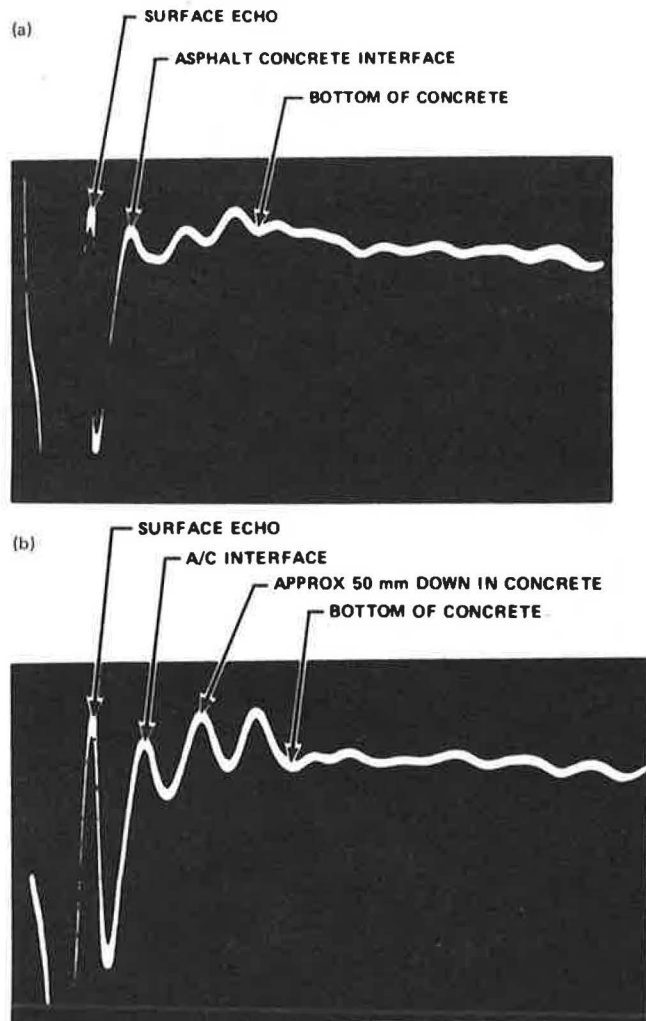
For the purposes of the investigation described here, the equipment was mounted on a cart pushed by hand along the deck. The waveforms were recorded at grid points using an instant camera. Figure 5a shows a typical radar signal for a sound portion of the deck and Figure 5b shows the signal for a section known to be delaminated. In areas where the concrete is deteriorated or the character of the interface changes, the amplitude and time of the echo also change.

FIGURE 5 Typical radar waveforms: (a) radar output for sound concrete, and (b) radar output for delaminated concrete.

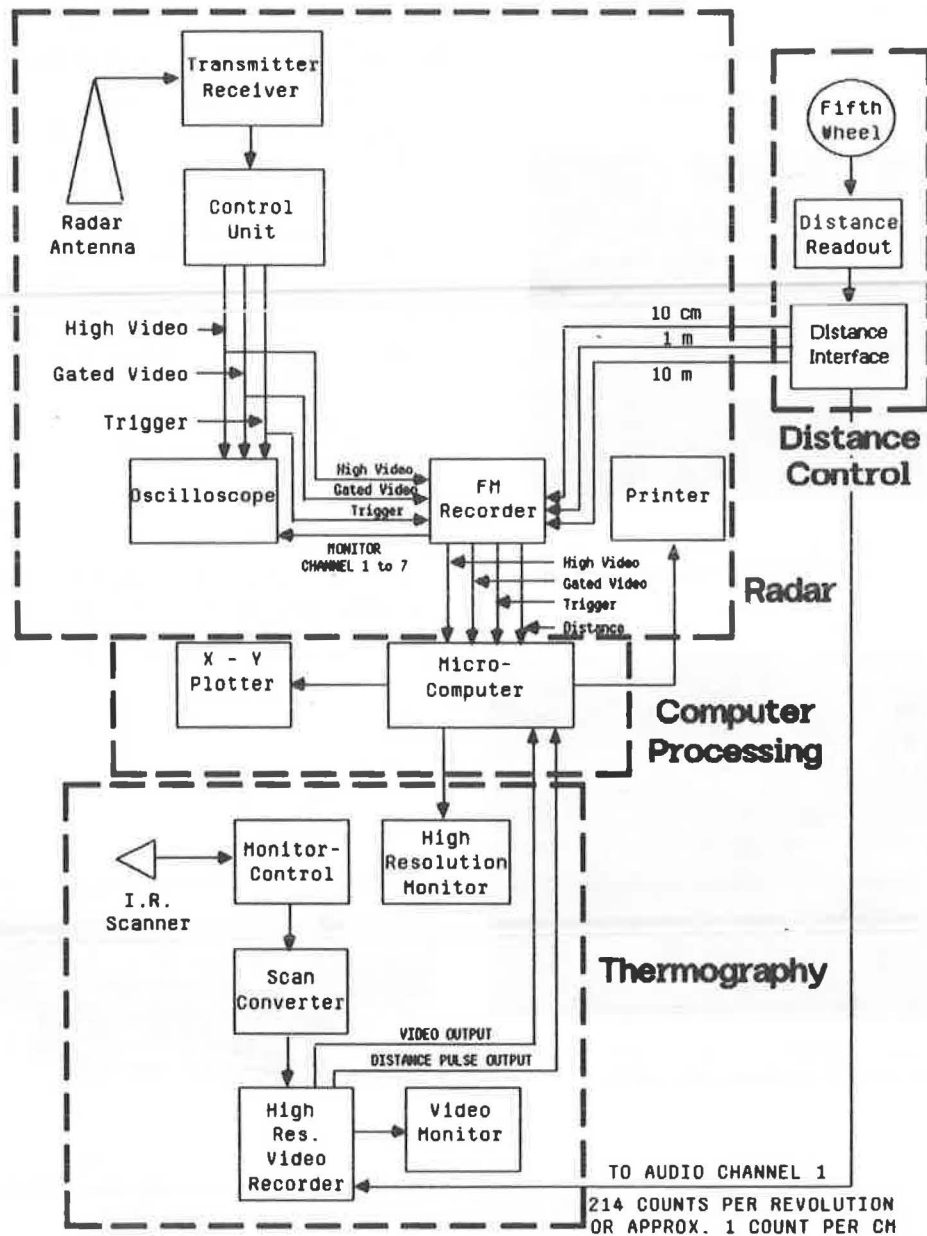
Figure 6 shows the exterior of the vehicle with the radar antenna and the infrared scanner in position. A schematic representation of the infrared and radar components is shown in Figure 7.

FIGURE 7 Schematic representation of the DART system.

The radar signal passes from the control unit inside the vehicle through the transmitter/receiver mounted on the front of the vehicle, through the antenna, and into the bridge deck. The return echoes are received by the antenna and returned to the control unit inside the vehicle. The waveform is simultaneously displayed on an oscilloscope and recorded on a seven-channel FM tape recorder. The operator can monitor the signal from the control unit and from the tape recorder, thus permitting a check of the quality of the signal before and after recording. As well as recording the raw waveform, the trigger pulse for the system, a gated version of the waveform, and three sets of distance information are recorded for analysis using a microcomputer. The radar itself is battery powered and has an operating time of approximately 6 hr on a charge.

monide (InSb) detector. It has a sensitivity of approximately 0.1°C. Using a 20 degree lens, the system is capable of scanning an entire traffic lane width in a single pass. The scanner is connected through the scanner control unit to a proprietary interface unit to convert the scanner signal to a standard North American Television Standard Color (NTSC) video signal. The output of the interface is then fed to a high resolution videotape recorder.
