TRANSPORTATION RESEARCH RECORD 1083

Pavement and Bridge Maintenance

TRANSPORTATION RESEARCH BOARD
NATIONAL RESEARCH COUNCIL

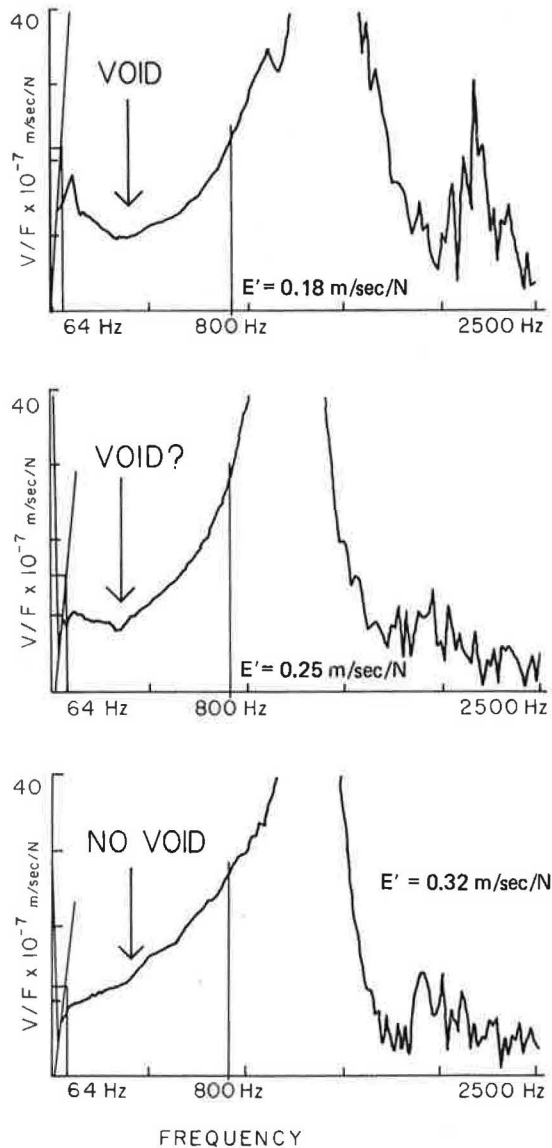
FIGURE 3 Transient dynamic response output.

tools. The basis of the TDR method is the analysis of steady-state vibration by the measurement of mechanical impedance. This method has been proved in the testing of piles in Europe (3).

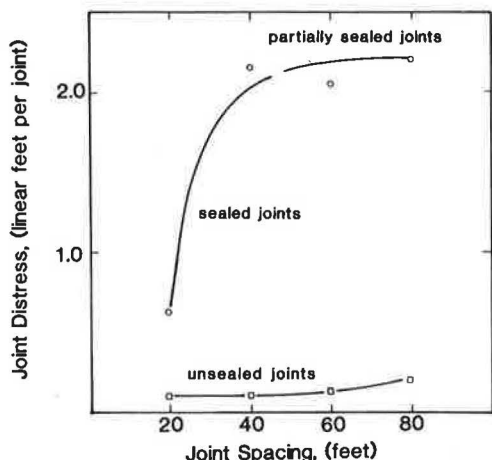
FIGURE 2 Joint distress versus joint spacing.

the sections with sealed joints, there was a large increase in joint distress with joint spacings above 20 ft and (b) the unsealed joints had much less spalling, regardless of joint spacing, than the sealed or partially sealed joints.

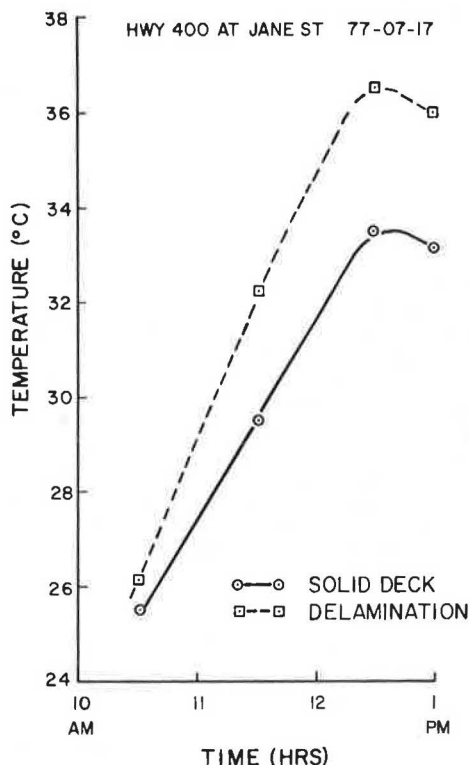
Figure 3 shows the temperature variation in sound and delaminated concrete measured by thermocouples installed 6 mm below the surface. During the test period the difference in surface temperature between the solid and the delaminated concrete reached 3°C.

FIGURE 3 Difference in temperature between solid and delaminated concrete on a thin slab deck.

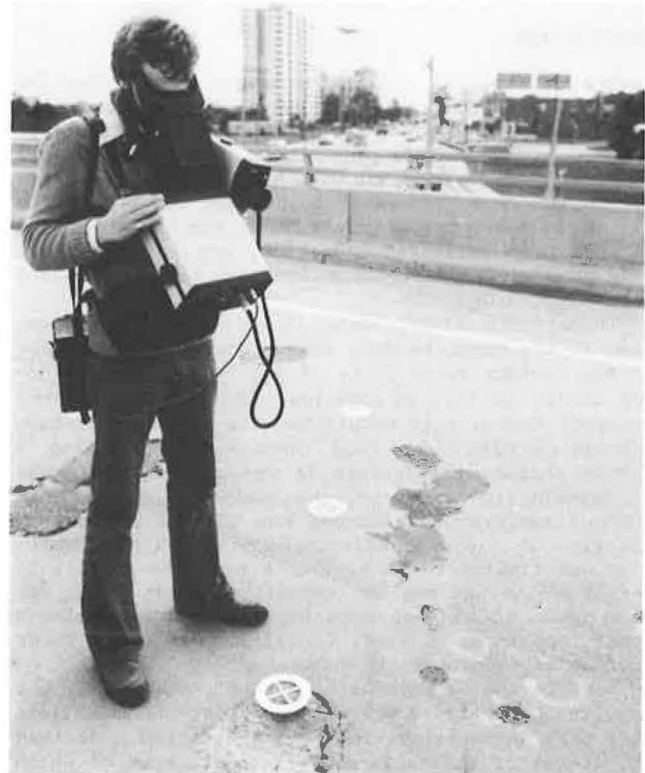
The first series of tests was made at ground level using targets to locate the position of the image (Figure 4). Although the delaminations were easily identified, the method was impractical because of the limited field of view and the difficulty of constructing a plan of the deck from photographs taken at an oblique angle.

FIGURE 4 Infrared thermovision equipment being operated at ground level.

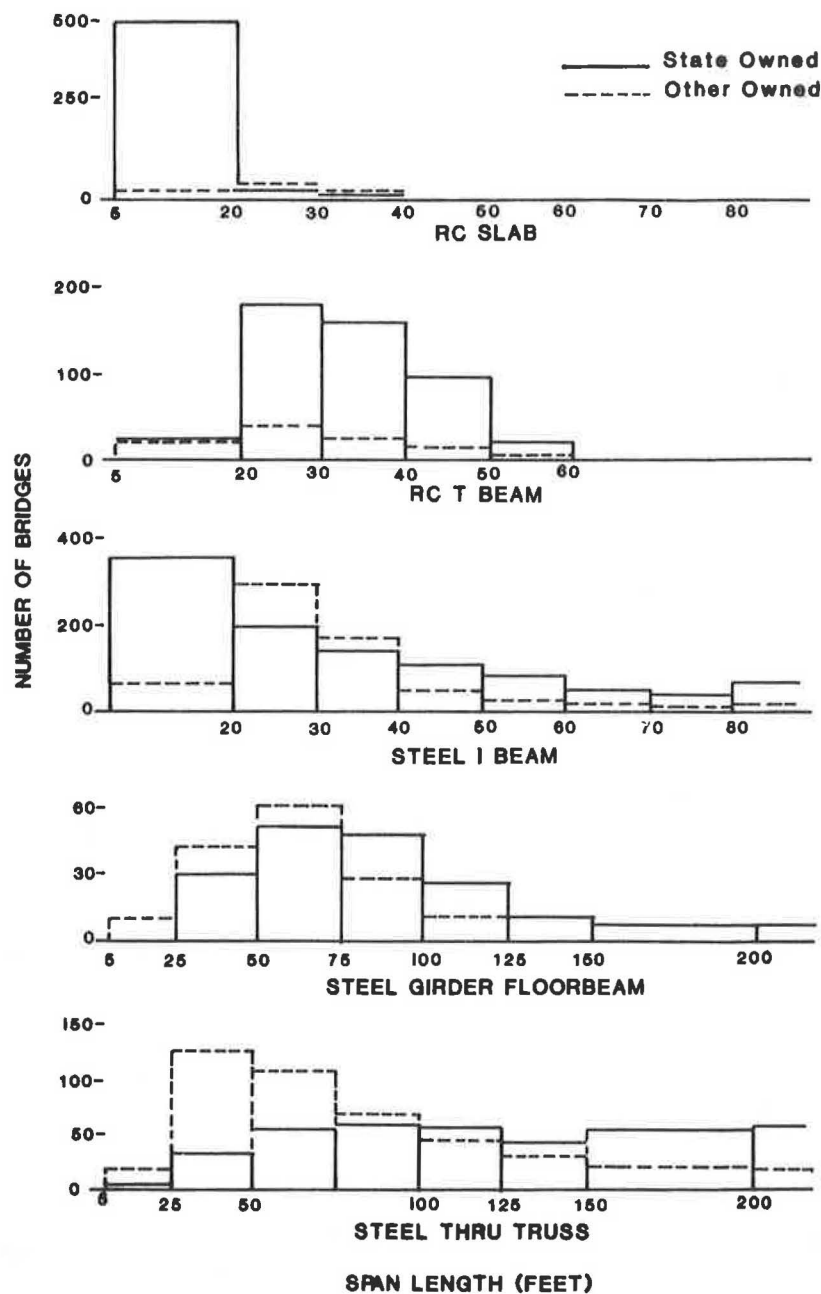
FIGURE 3 Span length distribution.
