Reflectivity and Durability of Epoxy Pavement Markings

JAMES E. BRYDEN, RONALD A. LORINI, AND PETER D. KELLY

Epoxy pavement markings on 16 projects were surveyed to determine durability and reflectivity. These markings were up to 6-years old and were installed on both portland cement and asphalt concrete pavements. Most projects were in good condition and providing acceptable daytime delineation. Although most markings also had fair or good reflectivity, some were not providing acceptable reflectivity. However, most of the poor reflectivity occurred on a few recent projects. It was not possible to relate differences in condition or reflectivity to roadway characteristics, traffic, striping contractor, or material supplier, and it appears that these differences are attributable to particular characteristics of each installation.

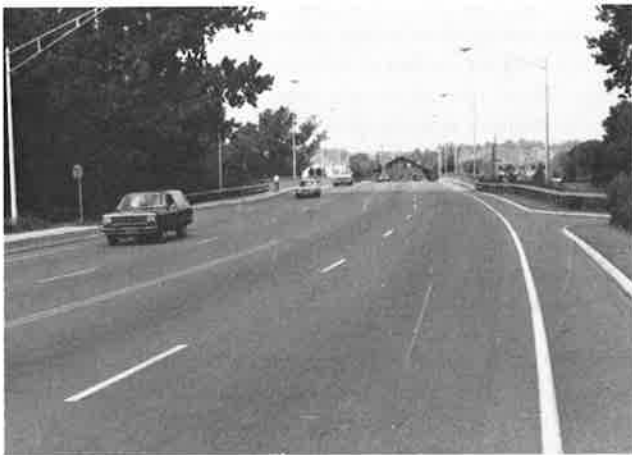
daytime delineation as shown in Figure 2. All 145 samples experienced some material loss, with most in the range of 70 to 90 percent intact. Only 26 samples were less than 70 percent intact. Most failure was in the form of small areas of missing line, with only occasional areas of more widespread failure. Abrasion failure caused by traffic and snowplow wear was the prevalent failure mode encountered, although chipping failures (loss of adhesion) were observed in a few cases. Some striping failure was also caused by failure of the pavement itself, either by deterioration of

FIGURE 2 Typical epoxy markings in good condition.

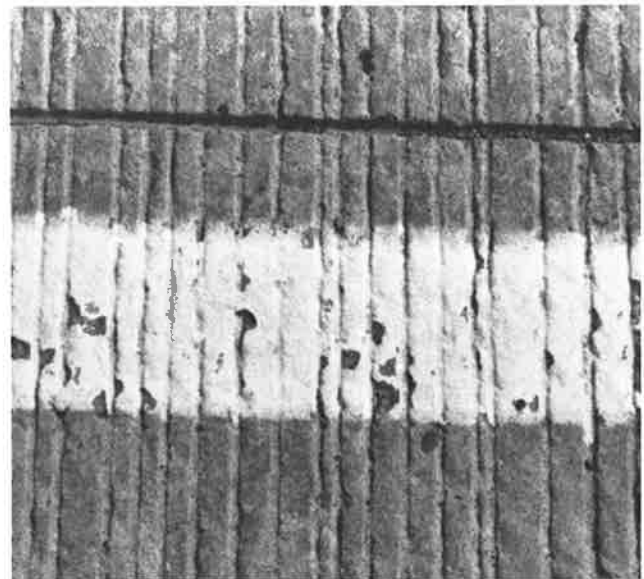
the pavement along joints and cracks, or by loss of peaks on rough-textured pavements (Figure 3) probably caused by snowplowing. Typical examples of marking failure are shown in Figure 1.

FIGURE 3 Loss of epoxy striping caused by chipping of peaks on fine-textured concrete pavement.
