Evaluation of Temporary Day-Night Visible Raised Pavement Marker Adequacy

THOMAS D. DAVIS

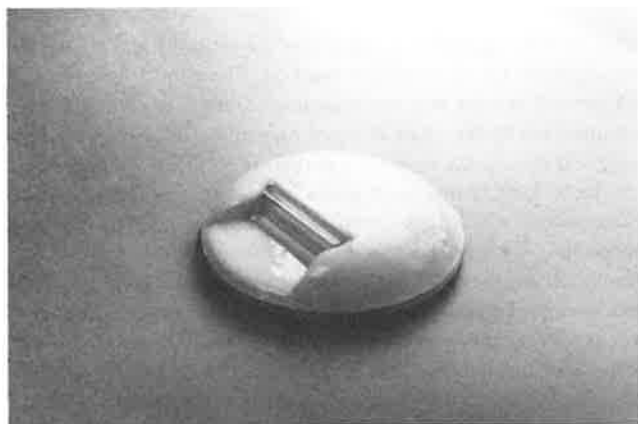
**FIGURE 1 Ferro Corporation P-15.**

1. Fourteen manufacturers were solicited for samples of day-night visible raised pavement markers. The markers had to be easy to install and present no hazard to drivers. A night reflective marker was assumed to also be wet-night reflective. The six marker types given in Table 1 and shown in Figures 1 through 6 were judged acceptable for further testing.

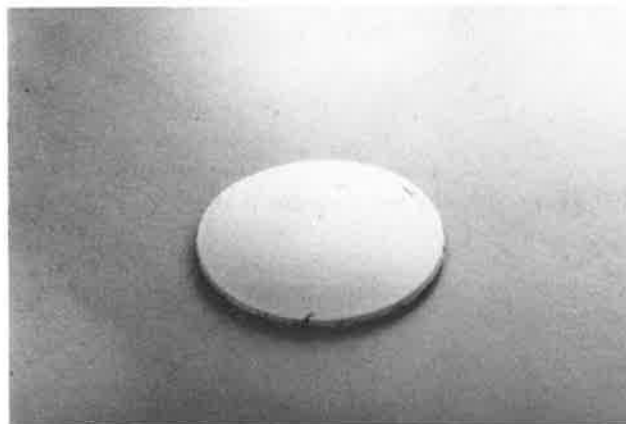
**FIGURE 4 Traffic Safety Supply Company Titan TM-40.**

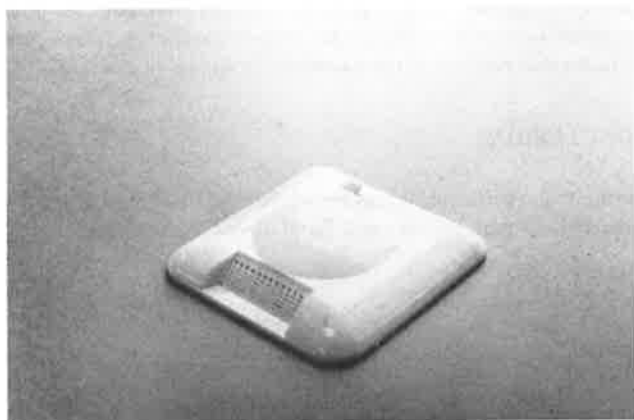
**FIGURE 2 Amerace Corporation Stimsonite 66B.**

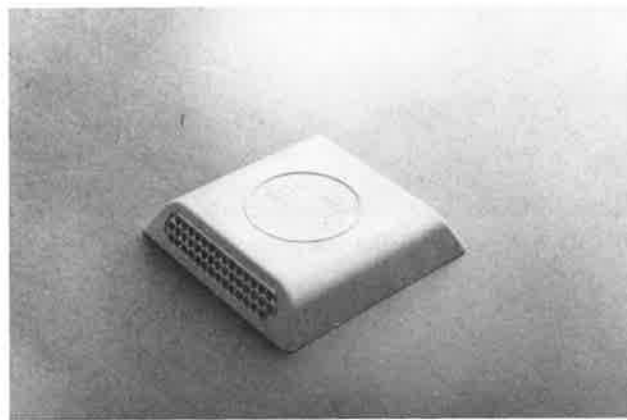
**FIGURE 5 D. Swarovski and Company Swareflex 3557.**

cube-corner-type reflectors proved adequate, they lost over one-half of their visibility after 6 months of wear (Table 3). The Swareflex (Figure 5) multiple-glass lens reflector was the only one that retained 1,000 ft of dry-night visibility after 6 months.

Also, the more vertical and nonstreamlined the marker casing and reflector facing the driver, the less likely motorists would be able to see the marker in the day with the sun behind the visible face, and the more likely the marker would come off the pavement from tire impacts. The face of the Swareflex marker toward the driver sloped 60 degrees from the pavement causing the visible face to go into a shadow and lose visibility (Table 3). The Swareflex also experienced the highest losses, no doubt from tire impacts on its nonstreamlined surface (Table 4).

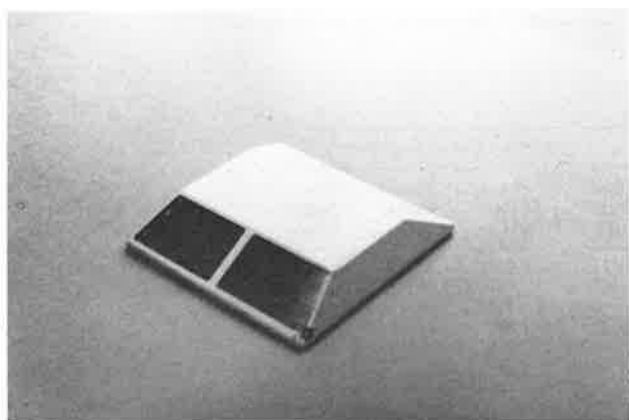
**FIGURE 3 I.T.L. Industries, Inc., Ray-o-Lite.**

The ideal marker should also avoid dedicating too much visible surface to the reflector because the reflector has low visibility in the day. The Ray-o-Lite (Figure 3) visible surface is mostly reflector and is the least visible marker in the day (Table 3).

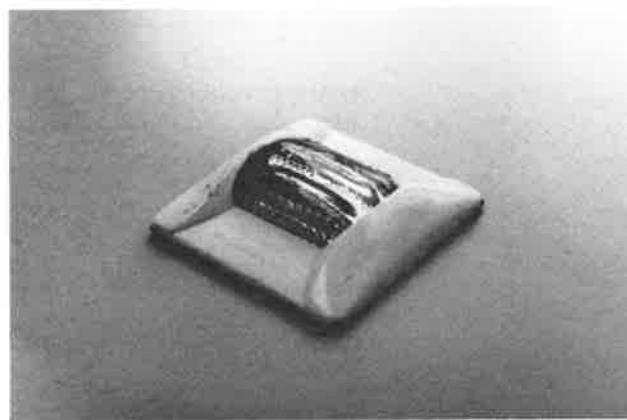
**FIGURE 6 Olympic Machines, Inc., 44C.**

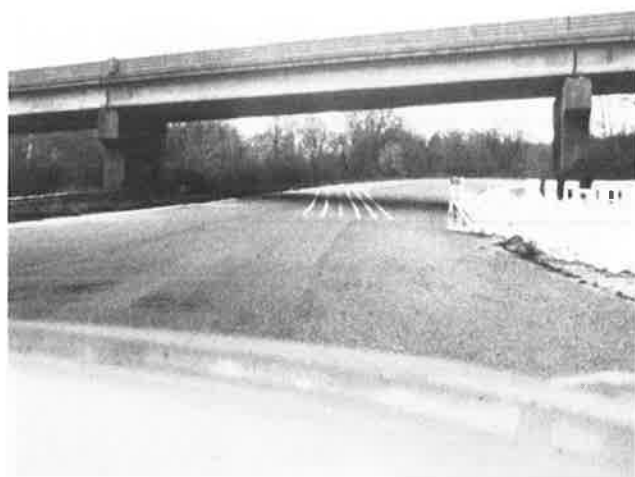
FIGURE 7 Visibility test from 200 ft away.

3. The new candidate markers were tested for visibility on an unopened section of I-78, which was asphalt, and on I-295, which was concrete. Thirty-three of each type of marker were installed at 6-ft intervals side by side as shown in Figures 7 and 8. Eight observers independently judged the visibility of the markers from a car with the sun behind, the sun in front, and at night and recorded their opinions on a questionnaire as to the distance from which they could detect each marker.

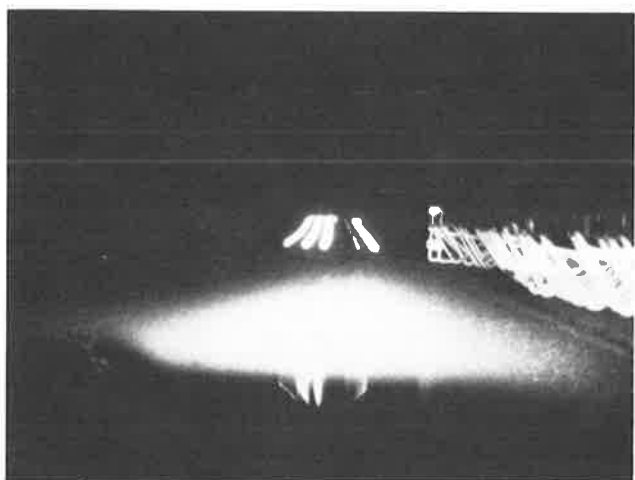
FIGURE 8 Night visibility test from 200 ft away.
