Cost Evaluation of Alternatives To Rehabilitate Asphaltic Rural Roads

ROBERT S. KORBA

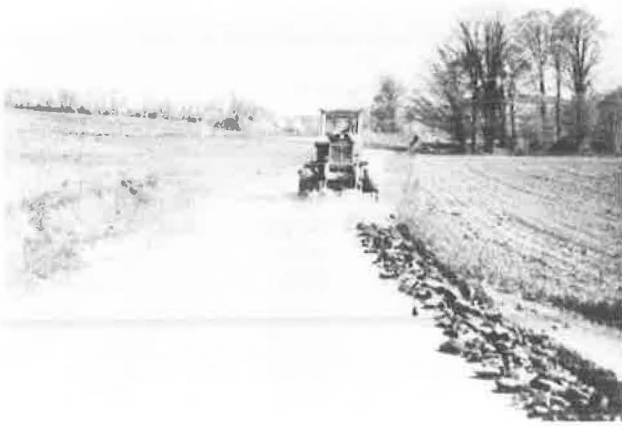
FIGURE 1 Grader scarifying roadway.

The recycling was accomplished by using a combination of county personnel and equipment and special rental equipment and operators from a contractor in the area that specialized in this type of work. The contractor furnished a water truck, a grader, scarifier (Figure 1), and a self-propelled mixing machine (Figure 2). The county furnished a grader and operator for final grading and compaction equipment. The mixing machine or rotomill was able to produce material that ranged in size from 1/8 to 1/2 in (Figure 3). It was determined through the use of core samples that enough residual asphalt (5 to 6 percent) was present. No additives or rejuvenators were used because it was believed that the residual asphalt was adequate and the goal was to be as cost-effective as possible.

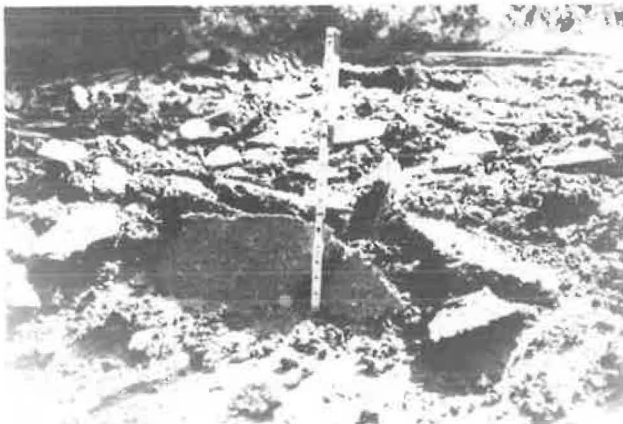
FIGURE 2 Asphalt chunks of pavement after scarifying.

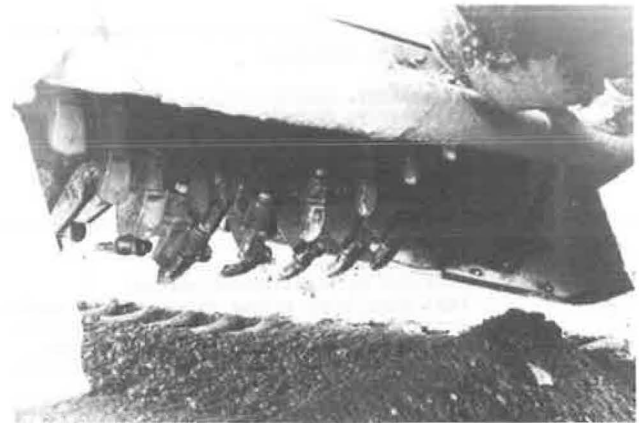
FIGURE 4 Underside of rotomill showing cutting teeth.

After the roadway was scarified (Figure 4) and the rotomill performed its job (Figure 3), the grader operator bladed this material aside in the known trouble spots so that the crew could install underdrain or engineering fabric, or both. In cases in which the roadway elevation was at the same height as an adjacent wetlands, the scarified roadway material was picked

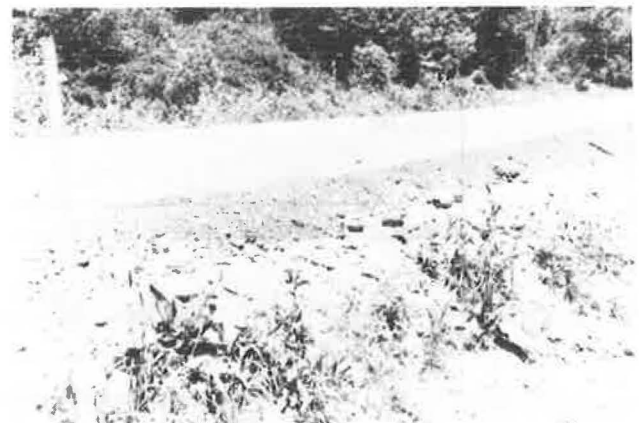
FIGURE 5 Darker material is the result of in-place recycling of existing asphalt.

up, engineering fabric was installed, 12 in of Type 3 subbase material was brought in (Table 1), and the original roadway was reinstalled (Figure 5). The engineering fabric was applied to prevent pumping of the original ground (clay) material into the gravel, which would reduce the effective drainage characteristics of the gravel and result in a loss of load bearing strength. No failures have resulted since use of the engineering fabric was begun in 1978.
