# Experience with Cathodic Protection in Missouri

ROBERT J. GIRARD

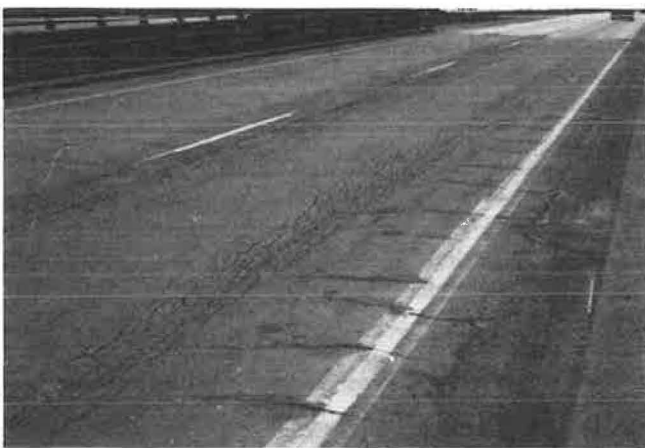
**FIGURE 2** Longitudinal cracking in wheel paths of driving lane and transverse cracking in outer shoulder where coke breeze asphaltic mixture is being shoved from the wheel path.

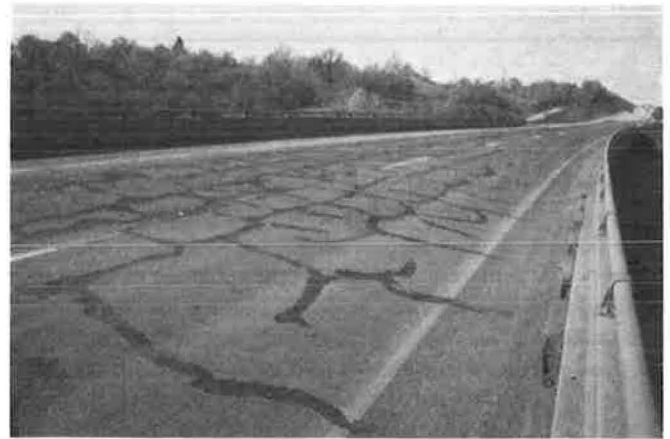
moisture content to enhance the lowering of electrical resistance. The result was frost heave during the first winter (Figure 3). Cracking in the asphaltic overlay was random, blocky, and full depth. Maintenance operations included sealing cracks and removing curb outlet cover plates as soon as the problem was detected. No subsequent massive failure of the porphyry rock asphaltic concrete has been noted; however, as time passed, the edges of the cracks spalled and worked into shallow potholes (Figure 4). Maintenance is now routine on these structures to prevent further excessive loss of overlay and to maintain a rideable surface.

**FIGURE 3** Cracking in wearing surface, porphyry asphaltic concrete, after first winter of exposure and frost heave.

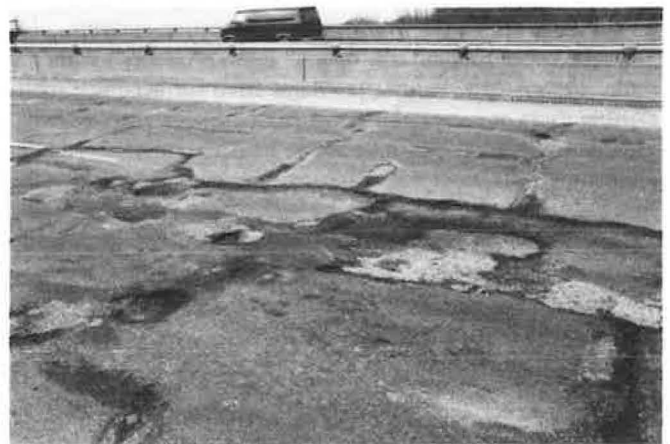
**FIGURE 4** Continued deterioration of cracking shown in Figure 3 resulted in spalling of wearing surface to the interface with coke breeze asphaltic mixture.

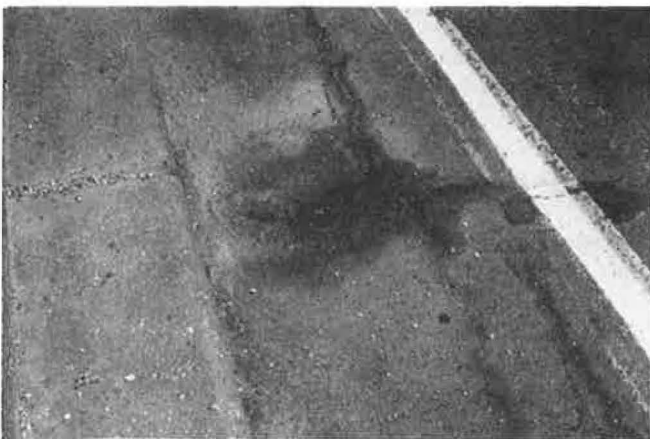
the coke breeze cathodic protection system, the anodes were made of silicon chromium cast iron alloy to minimize the yearly rate of loss due to corrosion. Nevertheless, the corrosion product has caused volume expansion around the anode sufficient to raise the asphaltic overlay material, causing some spalling (Figure 5). A brownish-colored corrosion product has also migrated to curb outlet areas and spilled onto the slope protection (Figure 6) under the bridge, causing an aesthetic problem. This product, mostly iron oxide, also appears to penetrate the concrete deck through structural cracks, as evidenced by the product flowing from the void tube vent holes (Figure 7) and staining the bottom of a voided slab deck (Figure 8).

**FIGURE 5** Corrosion of anodes caused swelling of asphaltic layers, cracking, and emission of brownish-colored corrosion product on surface.

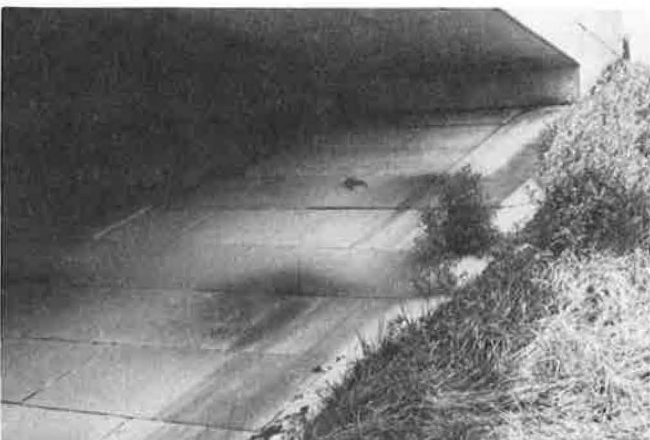
**FIGURE 6** Corrosion product from anodes migrated to curb outlets provided for water drainage, causing staining on slope protection and bridge parapet walls.

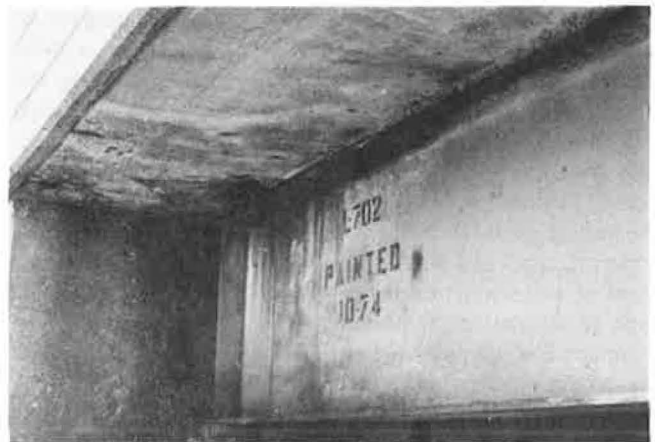
**FIGURE 8** Corrosion product and water drained from deck through improperly placed drains caused staining and corrosion of steel stringers.

onto the steel stringers (Figure 8). These observations may be of significant concern if this material is conductive enough to cause a short in the cathodic protection circuits.

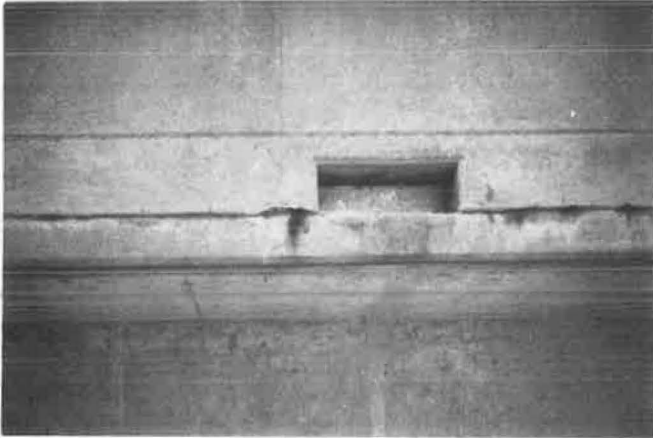
**FIGURE 9** Deterioration continues in unprotected outer parapet areas. Curb outlet Number 3 during installation of cathodic protection in 1975.

protection. The photograph in Figure 9 was taken during reconstruction in 1975, and that in Figure 10 was taken in 1986. Corrosion in this area appears heavy with deep crusting and flaking of the reinforcing steel. The lower edge of the original voided slab structure in another coke breeze cathodic protection system is spalling and continuing to corrode heavily because of salt and water ingress through joints on the surface of the deck (Figure 11). Future designs should consider the entire superstructure, and possibly the substructure, in the development of a cathodic protection system. More than one specific type of system might possibly be used to protect a given structure. For example, a sawed slot system on the deck with a conductive paint system on the parapet, curb outlet, and bottom edge areas could be used.

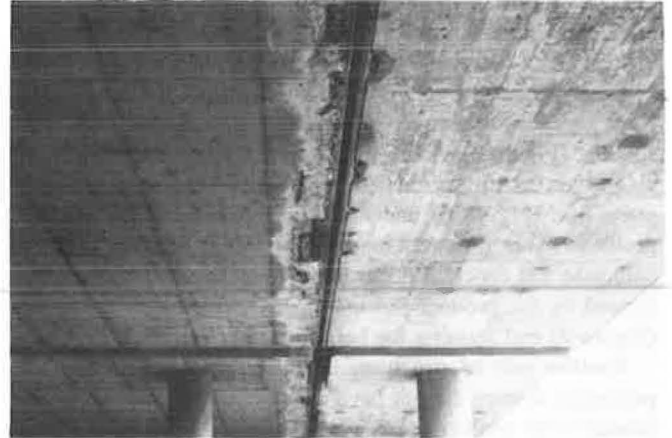
**FIGURE 11** Deterioration of underside of deck because of water and salt intrusion under surface-mounted angle iron and preformed elastomeric joint assemblies.

asphaltic materials. The simplest design was to place angle irons back to back with a preformed elastomeric joint seal inserted between them. The angle irons were attached to the deck by concrete anchor assemblies epoxied in place with non-conductive materials. Results from these designs indicated a lack of stability under traffic loading. The angle irons pull loose from the deck by stripping the anchor assemblies out of the concrete. Cracking and spalling of the overlay occur at joints and parallel to the angles. Water and salt leak under the joint and drain down the edge of the concrete deck to cause further corrosion problems, as already mentioned. To correct this problem, the designs were changed to require complete removal of a portion of the deck at the joint location and to recast the concrete with a 1-ft-wide concrete haunch at the elevation of the proposed overlay system. Steel angles were inverted and cast into the haunch system with a preformed elastomeric joint seal placed between them. Later these designs were changed to install other types of compression expansion joint systems, which eliminated the angle iron anchor assembly. These designs required a small portion of the deck to be removed and recast with the joint-anchoring device in place.

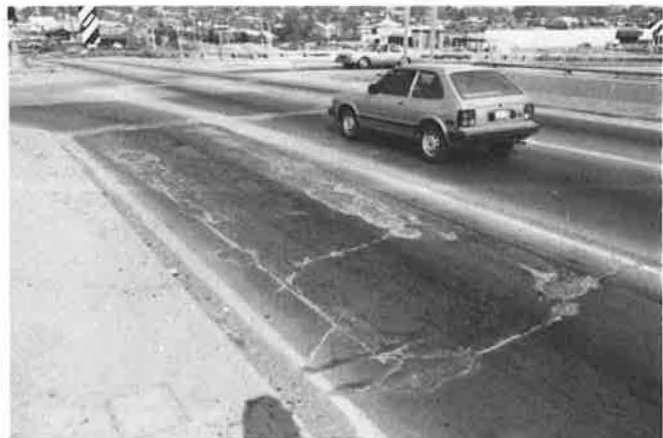
Overlays are placed on all cathodic protection installations in Missouri to protect the system from damage or wear and to give a better riding surface after deck repairs are made. However, attention should be directed to the design configuration and location of the structure when specifying the type of overlay. Asphaltic overlays tend to yield under continual stop-go movements. The use of a coke-breeze mixture may tend to aggravate such deterioration. One installation of the coke breeze cathodic protection system was on a structure with a 4 percent grade and electrically operated signals on both ends. The traffic in the stopping and acceleration areas caused washboarding, spalling, shoving, and potholing. Maintenance of the asphaltic overlay on this structure (Figure 15) was required shortly after becoming operational. Leveling efforts in the humped areas resulted in exposing the coke-breeze asphaltic mixture, which had been shoved to the extent of having a thickness greater than the total overlay design.

**FIGURE 15** Deterioration of asphaltic concrete overlay caused by stopping of vehicles.

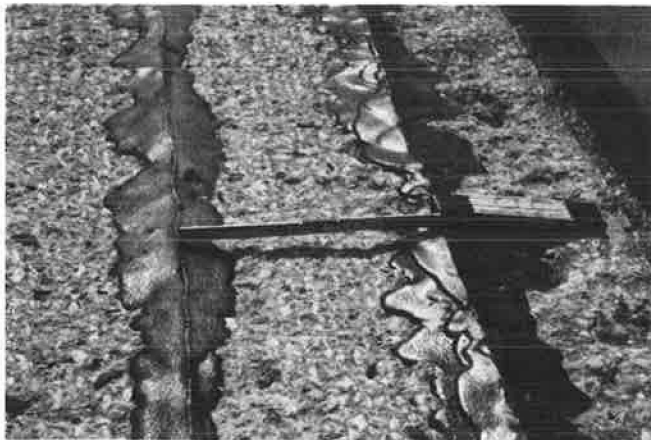
Sawed-slot designs enable the anode backfill material to be placed in a confined self-forming environment. The mounded systems do not have the benefit of forming. Placement of the normal anode backfill mixture, because of its very low viscosity, therefore requires careful and possible repeated application to achieve the desired effect. Too much backfill material placed at one time in the mounded system may cause significant spreading of the backfill material, with reduction in the amount of scarified surface left exposed (Figure 16), upon which bond of the overlay is dependent. Without sand applied to the final application, the anode backfill material will have a glossy smooth finish that will probably have less bond strength with a concrete overlay. Sawed slots, however, are time and labor intense, making placement expensive, especially for concrete made with chert gravel aggregate.

FIGURE 16 Placement of anode backfill material in the mound configuration is difficult because of the low viscosity of the material.

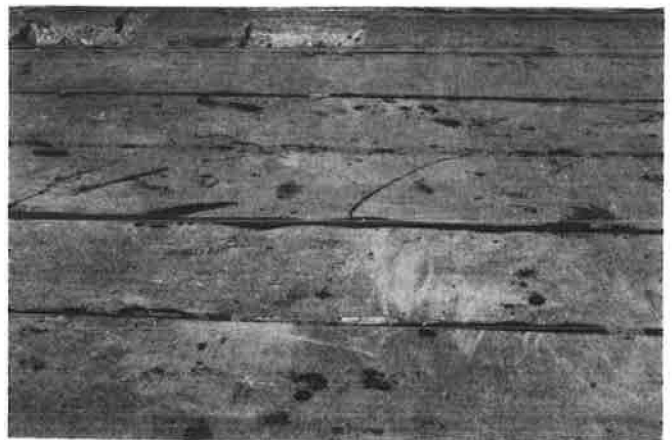
FIGURE 17 Improper placement of epoxy in slots to prevent shorts to high rebars.

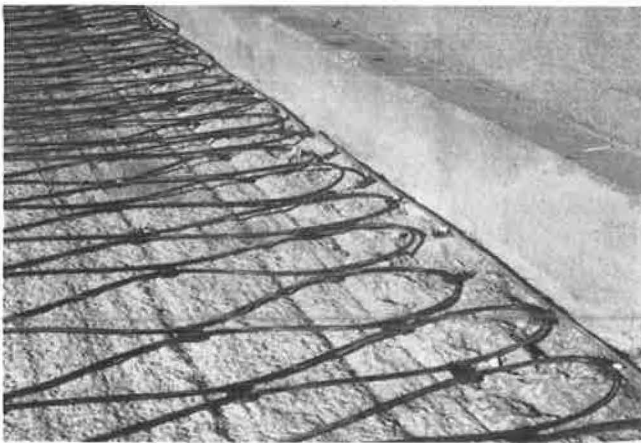
Raychem, Ferex 100 appears to be a durable anode system that is relatively easy to place compared with the other systems already discussed. Three installations with this product have been completed at this time. The only problem noted in placement was the inability to place the edge connecting rods neatly because of very rough concrete scarification, owing to hand-tool removal in the curb lines, (Figure 21). Rough surfaces cause the clip devices to rest at various angles, in turn causing the anode material to come loose easily during placement of the overlay. Experience has shown that mixer trucks can roll over this product without protection boards providing there are no sudden stops or starts.

**FIGURE 21** Raychem material is hard to hold in place if hand scarifying in curb lines is rough.

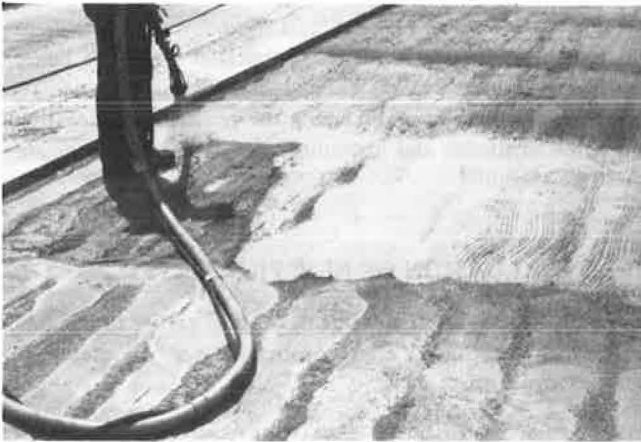
Plans were made for Matcor-Thoro conductive coating to be placed on a structure redesigned for the mounded system because of high steel. The system was changed to an experimental Matcor-Thoro conductive coating because of the structure's 4.74 percent grade and inability of the contractor to confine the specified anode backfill material to the immediate anode area only. Matcor-Thoro was applied with air jets as a spray (Figure 22). The strength and resistance properties appeared to be low

**FIGURE 22** Application of Matcor/Thoro conductive coating.

and high, respectively, according to standard laboratory tests. There appeared to be some separation, or a floating of the carbon material to the surface, in the mixture after placing because of its relatively slow rate of set and moderate viscosity. The Matcor-Thoro material was placed in two lifts with the second receiving a comb texturing to enhance bonding with the Latex-modified concrete overlay.
