Bridge Approach Pavements, Integral Bridges, and Cycle-Control Joints

MARTIN P. BURKE, JR.

The 1977 Final Report of the National Experimental and Evaluation Program for Watertight Bridge Deck Joint Seals documents the experiences of 40 state transportation departments for a period of 7 years. The summary contains a paragraph indicating that a number of states have shown strong interest in bridges of some length built without joints, and designs with integral abutments. Many such bridges have been built in Tennessee, according to this report, with the only evidence of movement showing in the form of a crack in the approach pavement off the structure. Those cracks are of a minor nature and do not appear to present a problem. However, as is evidenced by the bridge approach designs presently being used by a number of states, and illustrated and evaluated in this paper, some transportation departments are fully aware that the designs of approach pavements for integral bridges need special consideration and provisions if they are to survive for more than 5 to 10 years without serious distress. They are aware that the cracks described do not begin to suggest the potentially serious dist

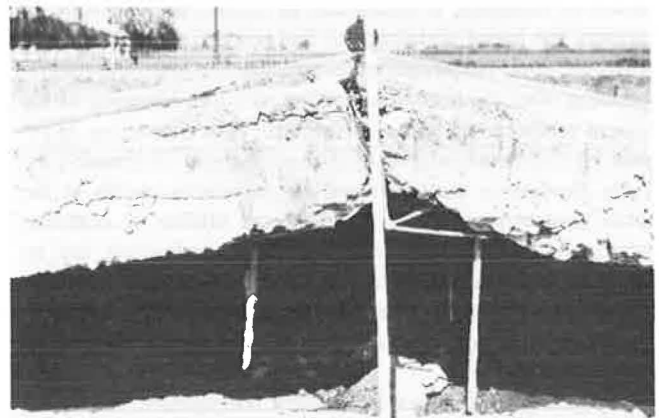
As manifestations of pavement distress, such as pavement fracturing and pavement blowups, are so widespread, there is little need to illustrate them in this paper. Nevertheless, one photograph and a brief account of the problem seems appropriate. The term blowup is generally understood to mean an instantaneous fracture or buckling of pavement or both. It is sometimes triggered by the movement of vehicular traffic but it is caused by the high residual compression stresses within the pavement itself. The stresses are relieved or released by the blowup. The size of blowups has not been quantified. They can consist of minor localized joint fractures and slight buckling, major fractures with little or no buckling, and occasionally minor fracturing with significant buckling. An example of the latter is shown in Figure 3. This blowup occurred on Route 25 in Butler County, Ohio, in 1963. The apex of the buckle is close to 2 ft above the original pavement elevation.

FIGURE 3 Pavement blowup.

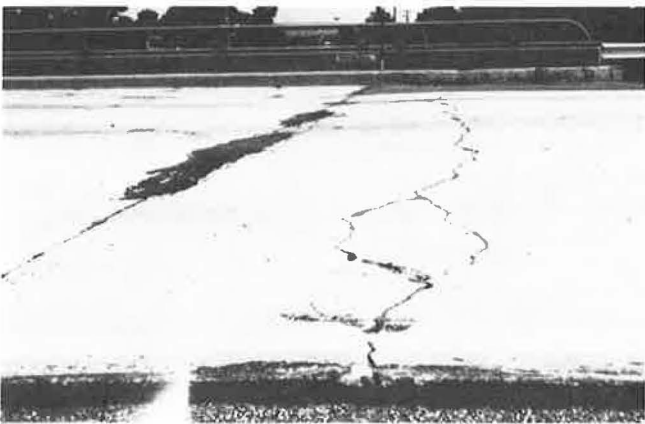
Figure 4 shows a cracked approach slab of a bridge on Route 271 in Cuyahoga County, Ohio. This bridge is a three-span continuous-concrete slab supported on capped pile piers and abutments, a rather commonplace type of bridge used in Ohio since 1946 for small stream crossings and minor grade separations. As shown in Figure 5(a), the deck slab of this and many of its companion bridges is keyed to what are considered flexible abutments. Flexible abutments are supported on a single row of piles that can flex back and forth without substantial resistance as the bridge deck lengthens and shortens in response to daily and seasonal temperature changes. Consequently, this bridge, which is constructed without deck joints to facilitate its longitudinal cyclic movement, is an early example of the integral type of bridges that are now being given more and more consideration by bridge engineers throughout the United States.

FIGURE 4 Approach slab distress.

adjacent to the joint begins. Evidence of this initial fracturing is suggested by the bituminous patches and sealant placed over and adjacent to the construction joint visible in Figure 4.

The transverse approach slab crack visible in Figure 4 and illustrated in Figure 5(b) is a characteristic of similar approach slabs located throughout the State of Ohio. In fact, these approach slabs can be used as indicators of pressure generation, as this cracking is a harbinger of other and more extensive pavement and bridge fracturing. As pavement pressure generation continues, the forces squeezing these approach slabs and the integral bridges between them culminate in either an extensive deterioration of the pavement joints, blowup of the approach pavements, or blowup of approach slabs. One such blowup is shown in Figure 6.

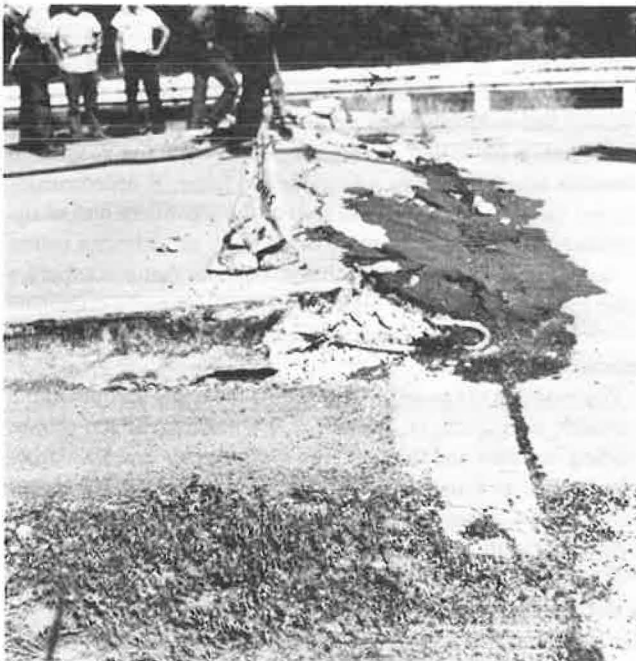
Shown in Figure 6 is one of the approach slabs of an integral type of continuous-concrete slab bridge located on Route 21 in Summit County, Ohio. In the right side of the photograph is the deck slab of the bridge. A joint between the deck slab and the abutment backwall is indicated by the line of sealant. Paralleling this joint and located at the apex of the approach slab, the remnants of the initial approach slab crack can be seen. Of significance in this photograph is the extensive bituminous patching on both the approach slab and the bridge deck slab, clear evidence of the fracturing that preceded the blowup. At the other end of this bridge, the approach slab has the characteristic transverse crack, and both the approach and deck slabs show evidence of extensive bituminous patching. The approach slab also contains a large longitudinal fracture, suggesting significant differential pressures being generated in the two parallel lanes of the approach pavement.

FIGURE 6 Approach slab blowup.

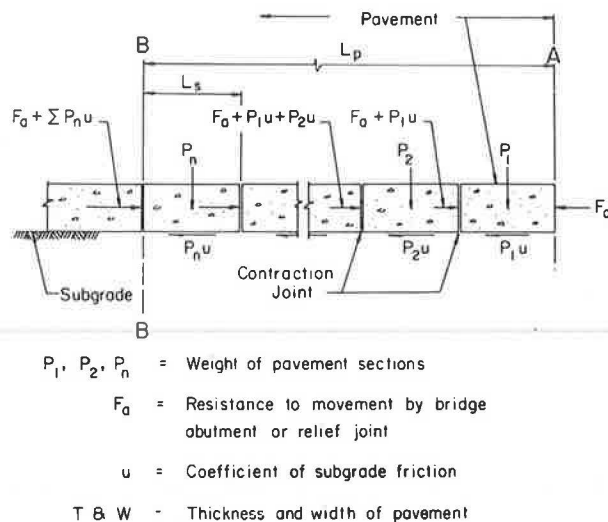
In Figure 9, line *A-A* represents the location of a pressure relief joint or a deck joint at a bridge abutment. Line *B-B* represents a location along the length of pavement where the pavement can be assumed to be fully restrained. The movement of the pavement sections within the length L_p is toward *A-A*, or it should be said that the maximum movement of the pavement because of the accumulated growth of the pavement occurs at line *A-A*. Resisting this growth is the force F_a at line *A-A* representing the resistance of the relief joint filler to compression or the resistance of a bridge abutment to longitudinal movement. Also resisting the growth are the forces due to

FIGURE 9 Forces associated with pavement growth.

subgrade friction, $P_1 u$, $P_2 u$, and so on. The summation of these forces must equal the total force generated at line B-B by restrained compression, Δ_{cp} , of the pavement at that location [see Figure 1(d)].

Since it has been shown how the restrained compression at a location such as B-B can equal or exceed a pressure of 1,000 psi, the total force in two lanes of pavement at such a location, $F_a + \sum P_n u$, can equal or exceed 1,300 tons.

As $\sum P_n$ equals the total weight of the pavement sections between lines A-A and B-B, the length of the pavement between these lines, L_p , can be computed as follows:

This length is the same as the length of pavement contributing to the growth of the approach pavements of the Stanley Avenue Bridge. Of course, pressures greater or less than 1,000 psi would be capable of sustaining growth in pavements longer or shorter than 1,000 ft. Similarly, it can be shown that at the center of 1,000-ft length of pavement, the pressure would be about 500 psi. At locations closer to line A-A, the pressures would be proportionally less.
