**TRANSPORTATION RESEARCH RECORD**

*Bridge Needs,  
Design, and  
Performance*

**TRANSPORTATION RESEARCH BOARD  
NATIONAL RESEARCH COUNCIL  
WASHINGTON, D.C. 1987**

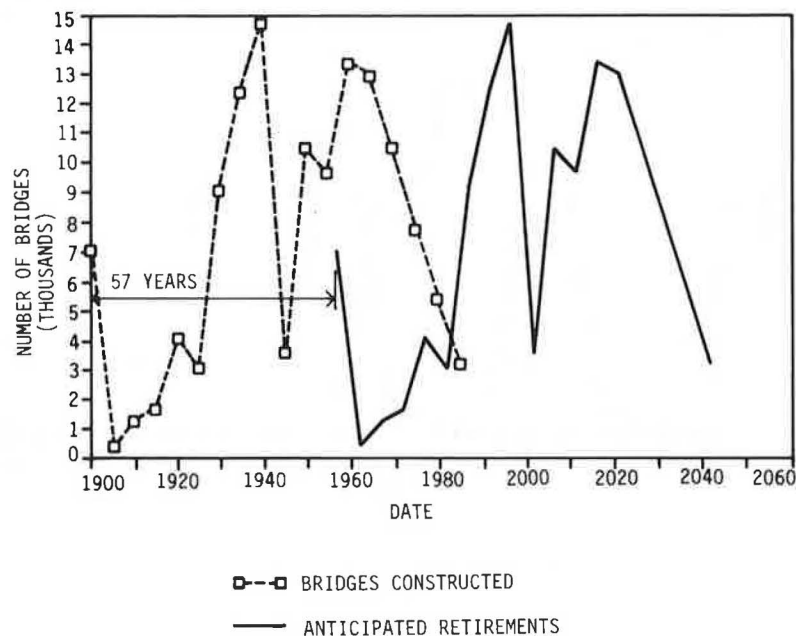
FIGURE 6 Numbers of steel stringer bridges constructed, and anticipated retirements by 5-year periods, NBI.

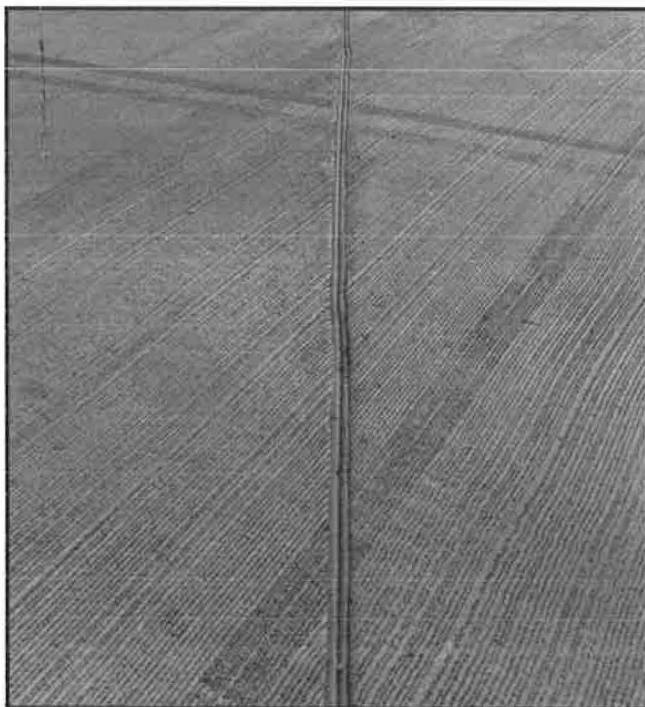
FIGURE 10 Preformed neoprene is twisted—probably a construction defect.

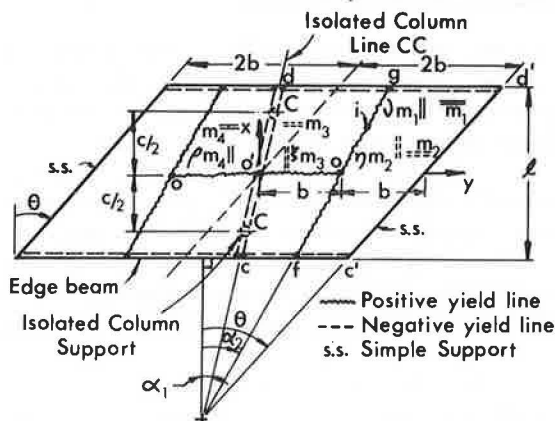
FIGURE 3 Assumed yield line pattern for continuous-skew bridge with  $\alpha_1 \neq \theta$ .

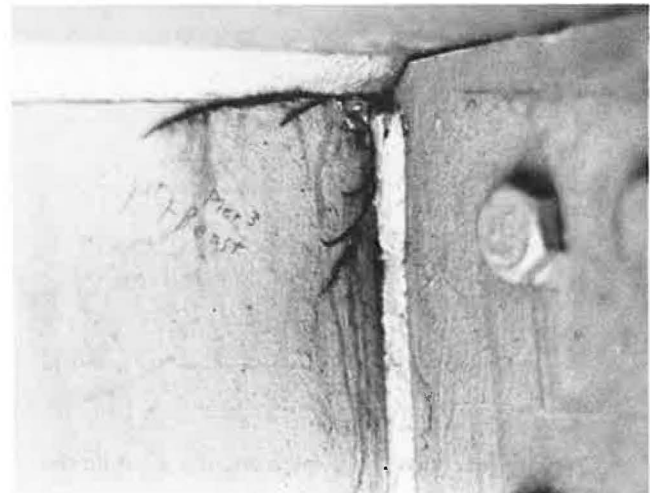
FIGURE 1 Typical cracks in web at floor beam-to-girder connection.

Extensive cracking has developed in girder web plates at the ends of floor beam connection plates. Results of studies indicate the cracking to be the direct result of cyclic, secondary bending stresses that are generated through relative out-of-plane movement. These displacements, though often less than 0.005 in. (0.130 mm), concentrate in gaps between the floor beam connection plate and the girder tension flange. Figure 1 shows the crack developed in a web gap at a floor beam-to-girder connection plate in the girder's negative moment region. As is common practice, the connection plate is cut short of the

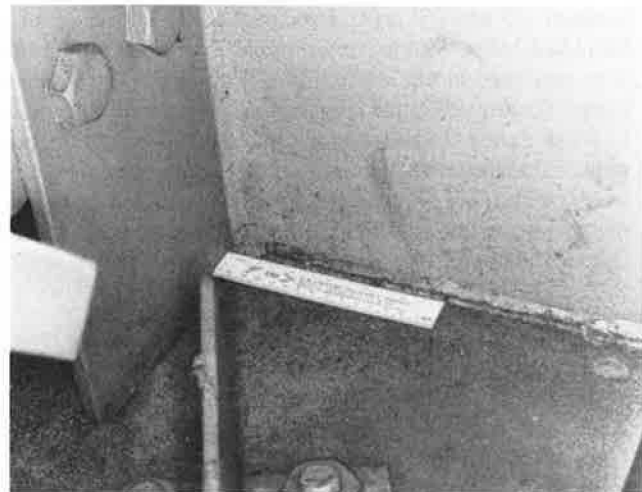
**FIGURE 15** I-79 Bridge 2682 lateral gusset plate connection detail.

Cracking in web plates at the lateral gusset plate gaps has developed in I-79 Bridge 2682 over Big Sandy Creek (4). The twin bridge is supported by two main steel girders with four stringers resting on transverse floor beams. The continuous girders have three spans of 120, 130, and 120 ft (36.6, 39.6, and 36.6 m). The lateral bracing members at a floor beam location are bolted to a gusset plate welded to the girder web, but not to the floor beam connection plate, forming gaps such as that shown in Figure 15. The gaps vary from 1/4 to 1 in. (6.4 to 25.4 mm) in length. The prevailing condition has resulted in the formation of vertical cracks on the outside surface of the web plate along weld toes of the transverse stiffener.

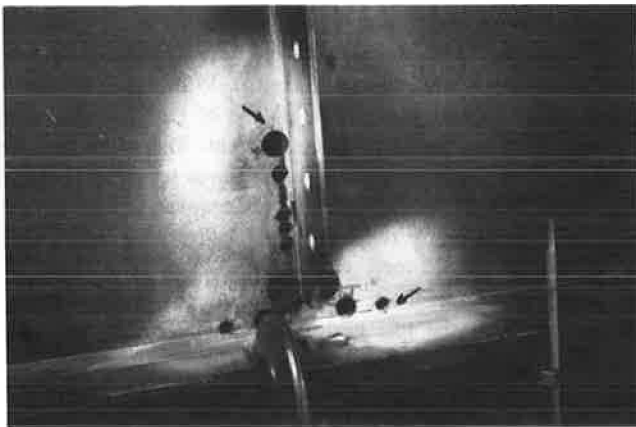
FIGURE 9 Retrofitting distortion-induced web cracking.

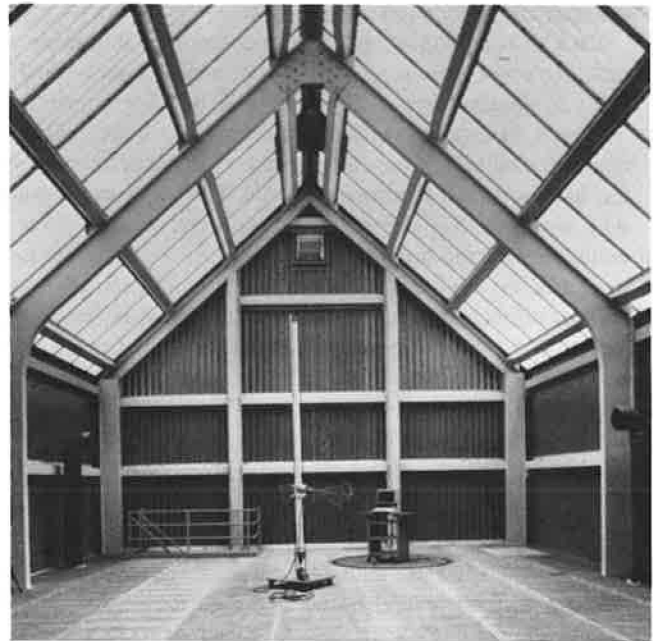
FIGURE 1 Interior of building made entirely of glass-fiber-reinforced composites.

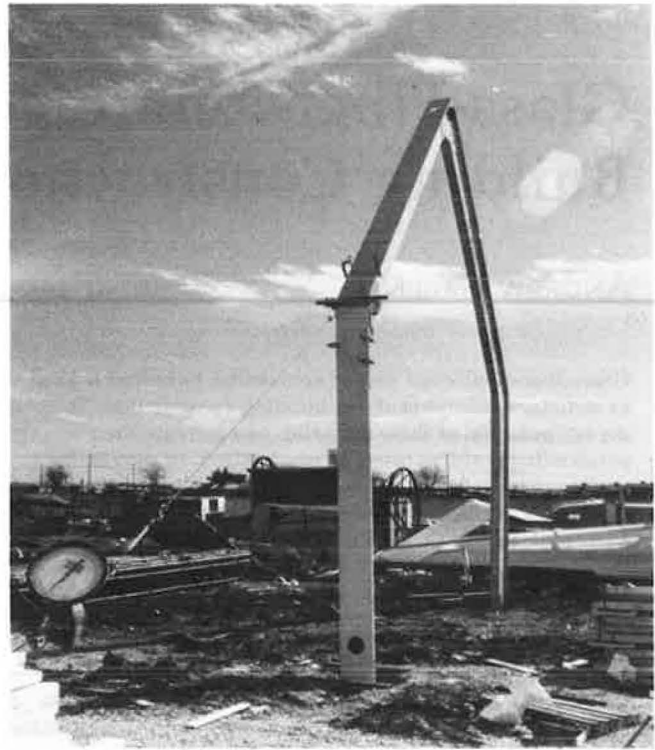
**FIGURE 3** This rigid frame is being tested with an 8,000-lb lateral load at the eave to check for stiffness of the frame and fixity of the base. Box section yields good stiffness in both planes, therefore, lateral support is not needed (a real advantage in erecting operations).

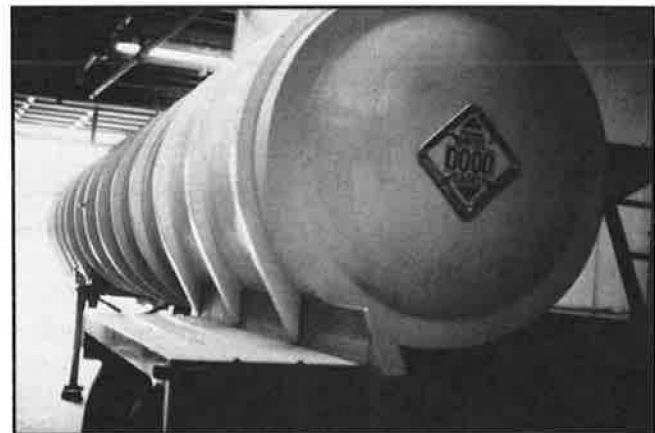
**FIGURE 2 End view of the first prototype.**

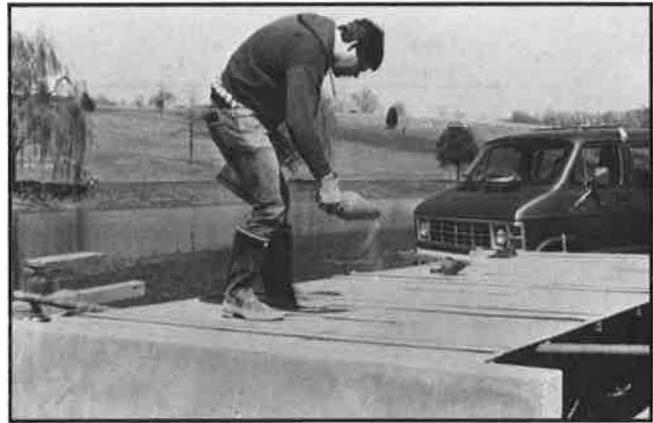
FIGURE 4 Sand aggregate applied to polyester resin to form polymer concrete wearing course.
