Acoustic Monitoring of Landslides

DAVID M. JURICH AND RUSSELL J. MILLER

Three active landslides located in Eagle County, Colorado, were monitored with an acoustic emission (AE) recording device for an 8-month period beginning in January 1985. AE monitoring devices are used to detect the transient elastic waves generated by the release of energy within a material undergoing failure. The slides were also instrumented with groundwater observation wells and inclinometer boreholes. Groundwater data and displacement measurements gathered from these devices and data collected from surface movement observations were correlated with the AE data. Significant increases in levels of AE activity were recorded at least 30 days before the observation of movement at each of the slides. Rises in groundwater levels recorded at many of the observation stations appear to have triggered the slides. AE signals recorded after the initial failure of the slides correlated with the rates of movement measured at surface displacement observation stations. This study has successfully demonstrated the ability of a properly installed AE monitoring system to detect premovement stresses in soil slopes. AE can be

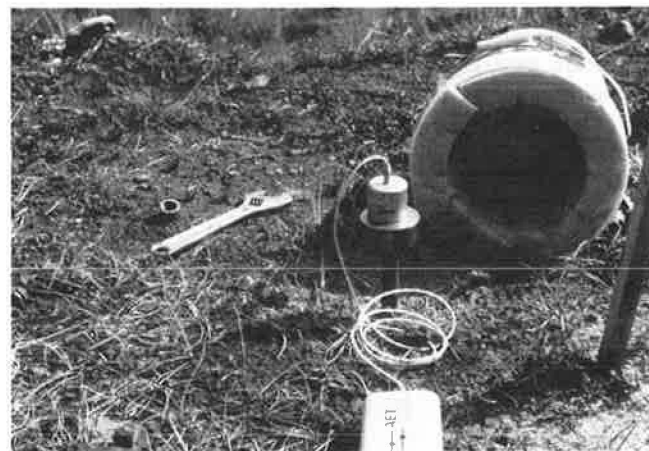
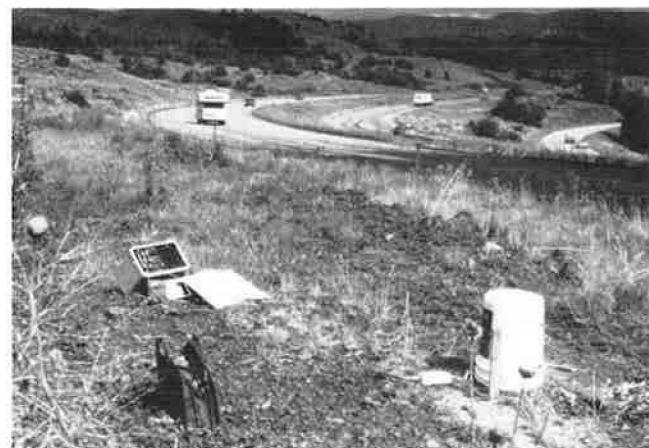
FIGURE 6 Photographs of typical AE monitoring station.

The AE monitoring system used for this project consisted of (a) an accelerometer with a 30-kHz resonance frequency, (b) a 15- to 45-kHz bandpass filter, and (c) a signal conditioning and analyzing unit. The system was equipped with variable gain and sampling rates, an adjustable threshold setting, and a digital display. Steel pipes $\frac{1}{2}$ in. in diameter were chosen as waveguides for this investigation and doubled as groundwater observation wells. The accelerometer was shielded from stray airborne acoustic signals. Figure 6 shows photographs of a typical AE monitoring station.
