Concrete Slabs and Blocks for Car Park Paving

T. F. FWA

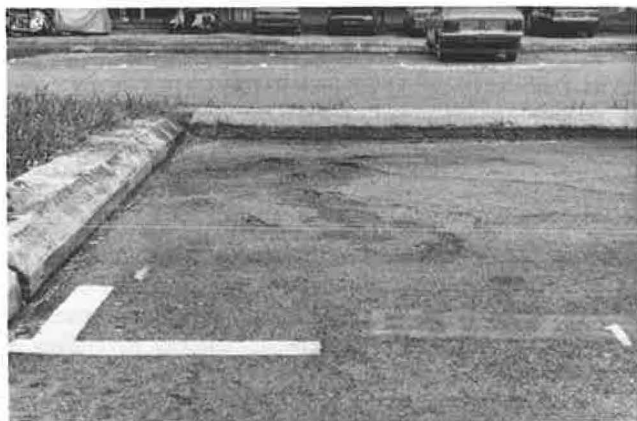
The continued use of bituminous pavements for parking areas was questioned when problems began to surface as the tree-planting policy was implemented. The adverse impacts of planting trees within a bituminous car park area were highly noticeable in the form of heaving and cracking of the bituminous pavement (Figure 2), which is caused by upward growth of tree roots. This is a direct consequence of the presence of the impervious bituminous pavement, which cuts off the surface water supply to the tree roots.

FIGURE 2 Asphalt pavement damaged by tree-root heaving.

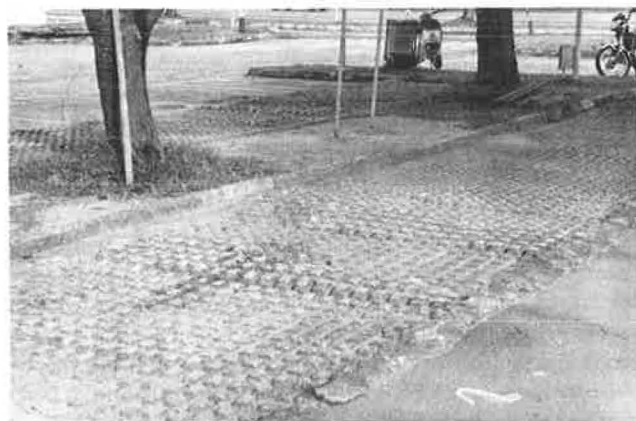
The versatility of concrete that allows it to be cast into different shapes and its durability under exposed environmental conditions make it a logical choice of material for the problem at hand. A studded-concrete-slab paving method (Figure 3) was a popular form of construction during the 1970s.

FIGURE 3 Studded-concrete-slab pavement construction for parking areas.

Two structural components of a studded slab can be differentiated, although in actual construction the two components are always cast together monolithically. The main component is the base slab from which the rigidity of the pavement is derived. The base slab acts to distribute vehicular loads to underlying base and subbase layers in the same way that a conventional concrete pavement does. It is the component that provides structural resistance to applied loads and temperature stresses. As such, the structural design of the base slab of a studded concrete pavement and the underlying base and subbase layers is the same as that of conventional concrete pavement.

Vertical concrete studs protruding from the base slab are the second component of a studded slab. The main functions of

these studs are to provide a stable contact surface for vehicular wheels and to transmit the wheel loads to the base slab below. The spacing of the studs has to be sufficiently close so that vehicles can maneuver smoothly in and out of a parking area, but it must be wide enough to provide space for grass to grow.

The studded-slab construction in Figure 3 separates the surface grass-growing soil from the load-bearing base and subbase materials by means of a base slab. This is desirable from an engineering point of view because fines and organic soils could be harmful to the structural properties of load-bearing layers. Field applications in the 1970s showed that grass could grow well on studded concrete parking areas, and structural failures of the base slab due to vehicular loads were rare. Unfortunately, just as a bituminous pavement seals off surface water, studded slabs also prevent surface runoff from entering the subsoil. Tree-root heaving remains a problem to be solved. Figure 4 shows a studded concrete pavement that was damaged by tree-root heaving.

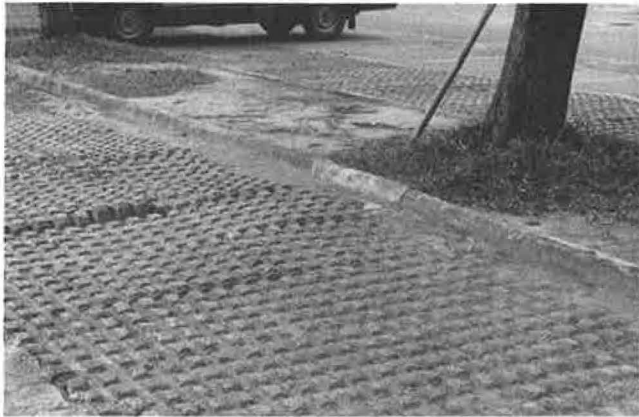
FIGURE 4 Studded-slab pavement damage by tree-root heaving.

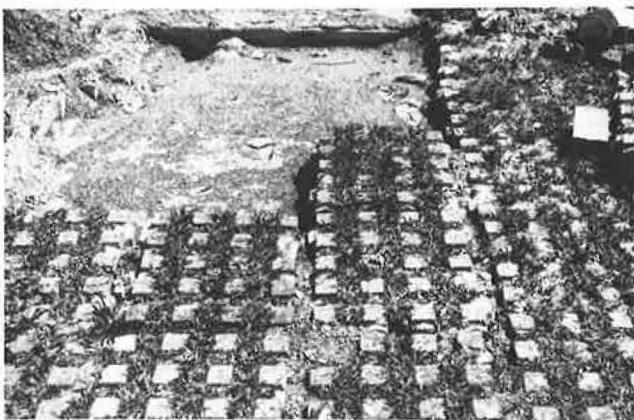
A modified construction process utilizing precast studded-slab units was subsequently tried. Each precast slab unit shown in Figure 5 is 585 mm (23 in.) long and 370 mm (14.5 in.) wide, with a base thickness of 100 mm (4 in.). The main purpose of using the precast-slab paving construction was to maintain joints between slab units through which surface water

FIGURE 5 Precast studded-slab construction.

could enter the subsoil. The construction method also had the advantage of easy repair or replacement of individual damaged slab units and easy installation and maintenance of underground utilities. This modified construction process, unfortunately, did not produce the expected improvement in pavement performance problems with tree-root heaving. Heaving of slab units continued to occur even when a joint as wide as 50 mm (2 in.) was used.

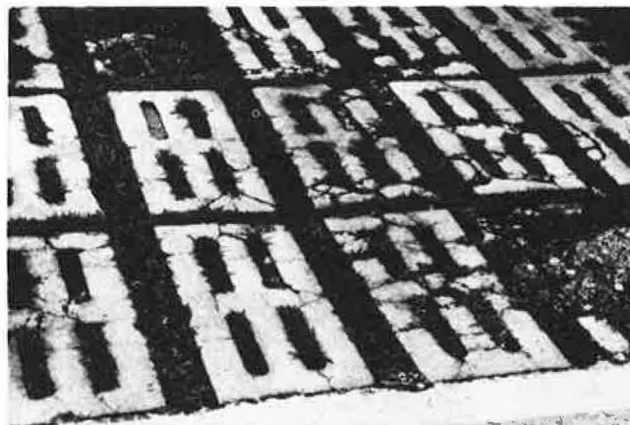
Figure 7 shows some cracked slabs. Typically cracks are found across longitudinal ribs adjacent to slab openings. In a number of cases, slab cracking was found to be related to upside-down placement of slabs. The reinforcement layout of Type A slabs is such that an upside-down slab could have its bending capacity reduced by more than 60 percent. It is therefore of importance to mark the top face when the slabs are cast in a fabrication yard to avoid placement mistakes in the field. Another frequent cause of slab cracking is nonuniform supporting conditions due to uneven compaction of underlying layers.

FIGURE 7 Cracked precast perforated slabs.

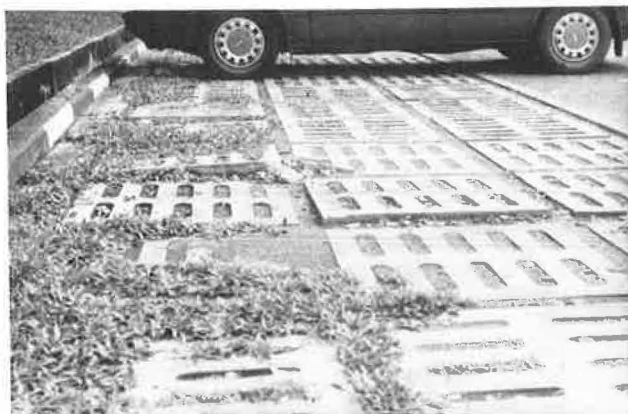
FIGURE 9 Tilted Type B perforated slabs.

Another merit of using Type B slabs is that they would help to reduce the occurrences of edge loading along longitudinal joints. As with Type A slabs, the structural performance of Type B slabs depends very much on the soundness of the foundation construction. Furthermore, the problems of interlocking between slabs and possible contamination of bedding sands that affect Type A slabs are also present with Type B slabs. Figures 9 and 10 reveal that instabilities similar to those experienced with Type A slabs are also found in Type B slab pavements. The long-term field performance of Type B slabs is being monitored, and relevant data are being collected to determine whether occurrences of slab tilting and rocking will decrease.

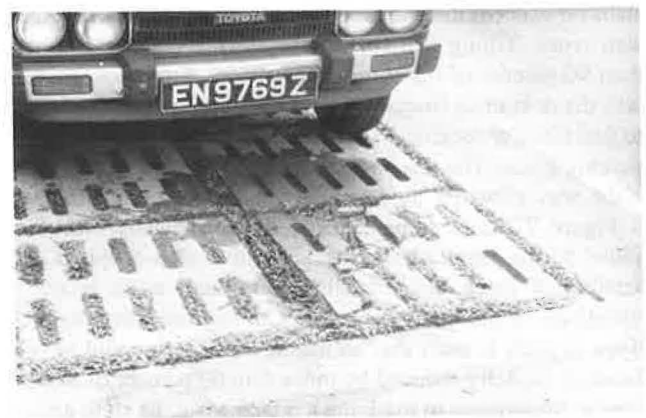
FIGURE 10 Rocking and cracked Type B perforated slabs.

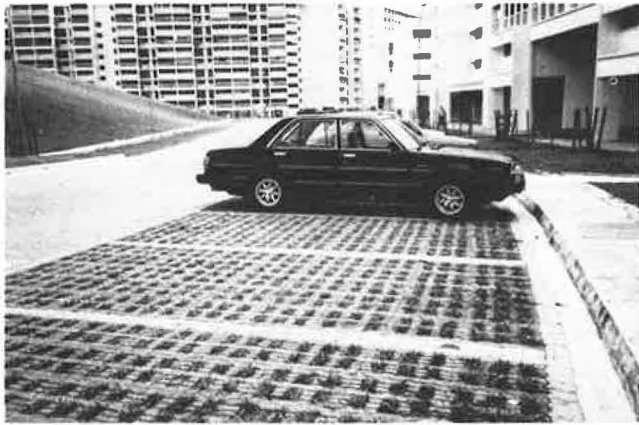
A patented design, known as Turf-Pave (4), was used in Singapore in 1984 in a private housing estate to pave parking areas. It combines the concept of the perforated concrete slab with interlocking-block paving construction. Each Turf-Pave block is 470 by 470 mm (18.5 by 18.5 in.) and 120 mm (4 in.) thick. They are much bigger and heavier than ordinary interlocking paving blocks. They weigh 30 kg (66 lb) each, whereas an ordinary paving block weighs about 5 kg (11 lb). As shown in Figure 11, each Turf-Pave block has a 35 percent perforation area to cater to tree planting. The blocks are constructed of 35-MPa grade concrete and no steel reinforcements are used.

FIGURE 11 Interlocking-perforated-block pavement.
