# Guardrail–Bridge Rail Transition Evaluations

This paper addresses the design of transitions between W-beam or thrie-beam approach guardrail and rigid bridge rail parapets or wingwalls. Crash test evaluations of selected current designs and new modified designs were accomplished with 4,500-lb (2000-kg) cars striking at 60 mph (95 km/hr) and a 25-degree angle. Results of these evaluations included the identification of desirable transition characteristics and the evaluation of a large number of designs for both straight and tapered bridge ends. Conclusions and recommendations are offered for satisfactory guardrail–bridge rail transition performance.

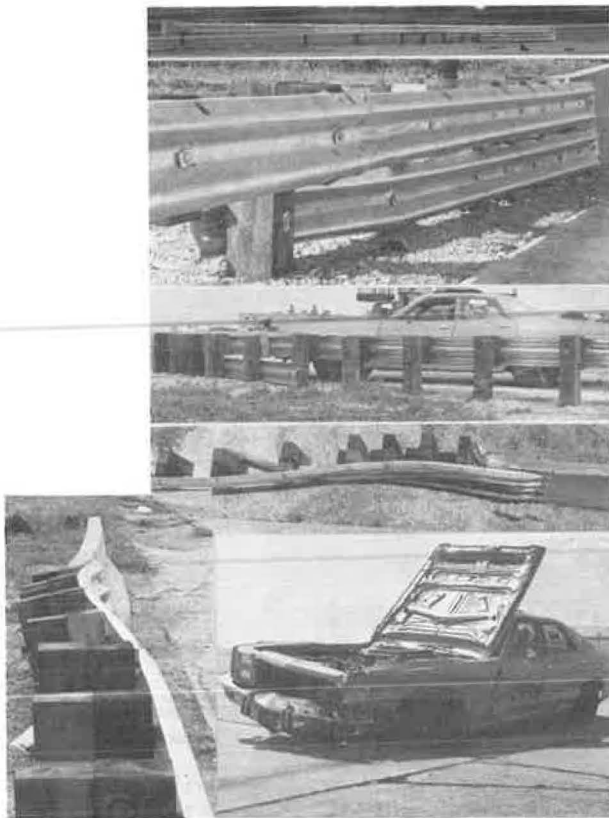
FIGURE 3 Test LA-1M.

**Test LA-1M** In order to minimize the wheel snagging observed in Test LA-1, a single 12-ft 6-in. (3.8-m) W-beam element was added below the beam as shown in Figure 3; in addition, two more posts were added between the first two spaces at the bridge end. Tapered blocks between the lower beam and the posts were used and the lower beam was field bent about the fifth post from the end as shown in Figure 3.

The test vehicle struck the transition at 60 mph and 25 degrees and was smoothly redirected as shown in Figure 4. There was some rotation of the simulated wingwall or parapet, but no evidence of wheel snagging on the wingwall end. Photographs after the test are shown in Figure 3.

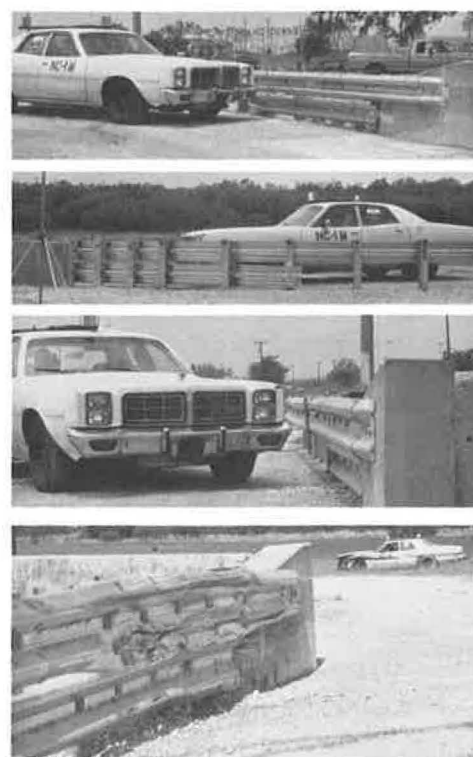
FIGURE 9 Test NC-1M.

**Test NC-1M** Although the vehicle was redirected in Test NC-1, the wheel snagging observed in the test was of some concern. Accordingly, a retrofit design using one 12-ft 6-in. (3.8-m) panel of W-beam for a lower rail was constructed as shown in Figure 9. The lower beam was bolted to all the posts as shown; no attachment of the beam to the wingwall was made, because this was considered unnecessary. The flare or taper screens the lower W-beam end from vehicles striking from opposing directions of traffic.

The test vehicle struck at nominal 60-mph, 25-degree angle conditions and was smoothly redirected as shown in Figure 10. The lower beam element was effective in minimizing wheel snagging. Photographs after test are shown in Figure 9.

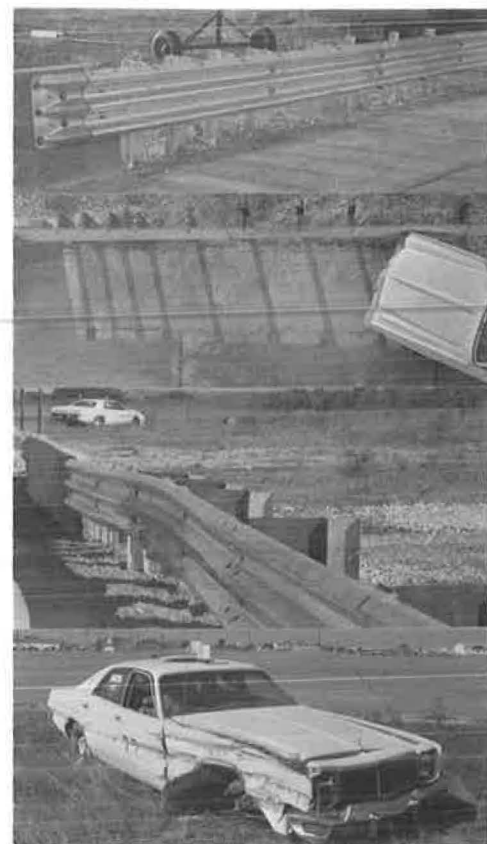
FIGURE 17 Before-and-after photographs, Test T-7.

**Test T-7** Design details for Test T-7 were similar to those for Test T-1 with the exception of substitution of standard steel posts or blocks for the standard wood posts or blocks, as shown in Figure 17. Also, additional reinforcement was added to the wingwall construction to minimize the damage observed in Test T-1.

The test vehicle was smoothly redirected as shown in Figure 18 with negligible wheel snagging at the wingwall edge. Damage to the wingwall was limited to scraping, as shown in Figure 17.
