Design and Construction of Interstate 10 Drainage Tunnels in Phoenix

TIMOTHY P. SMIRNOFF

Drainage of the depressed Interstate 10 inner-loop extension in Phoenix, Arizona, required the construction of a conveyance system composed of pressure tunnels, 14 to 21 ft in diameter, beneath the city. The geologic and engineering parameters specific to this project and the method of construction used in stream-transported alluvial soils are described. Minimization of surface settlement and concern for lowering of the groundwater table, which is almost completely controlled by the nearby Salt River, influenced construction methods and contractual provisions.

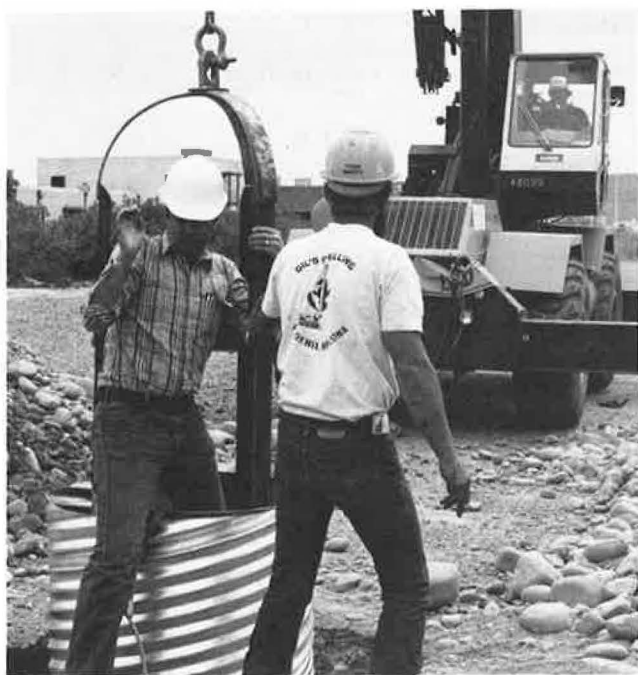
FIGURE 3 Inspection of large-diameter exploratory boring.

During the prebid phase of this project, prospective bidders had the opportunity to inspect the ground within the project area from four large-diameter observation holes. These holes were drilled using a 36-in.-diameter helical auger to a depth of approximately 60 ft. A 36-in.-diameter steel casing with observation ports placed approximately every 5 ft below a depth of 20 ft was installed to provide safe entry. More than 40 prospec-

tive bidders and consultants were lowered into each of these holes (Figure 3).

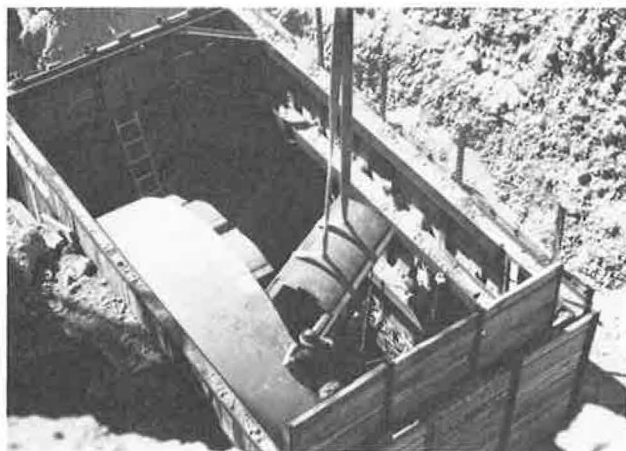
FIGURE 6 Installation of poling plates.

Subsequently, the contractor modified his tunneling equipment, as shown in Figure 6, to include the addition of poling plates, breasting boards, and a breasting table to his shield to increase the lead or hood of his machine. The poling plates and other face control mechanisms, when properly advanced, generally appeared to have improved the contractor's ability to minimize ground movements and stabilize the excavated face.

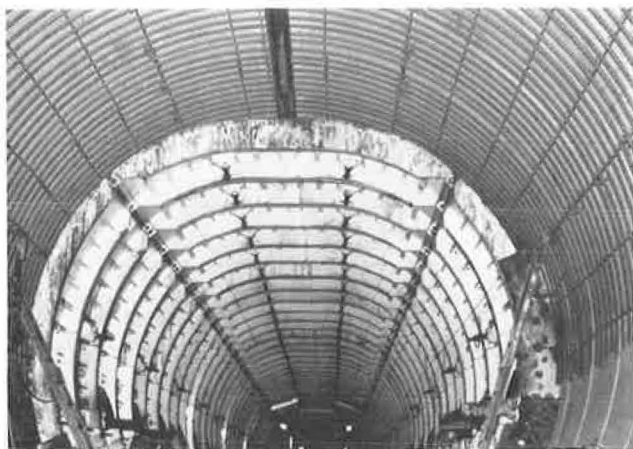
FIGURE 8 Final lining placement.

of the east tunnel was completed in March 1986, as shown in Figure 7. Shortly thereafter, concrete lining was begun. Concrete was placed by conventional tunneling techniques: telescoping metal forms were used and placement was done on a continuing three-shift basis—pour, set steel and forms, strip and move ahead (Figures 7–9). The tunneling shield was moved to the west tunnel and rebuilt. The shield and equipment were modified, including installation of larger cutting teeth on the poling plates and an increase in the overcutter. Tunneling progress on the west tunnel, now under way, is approximately

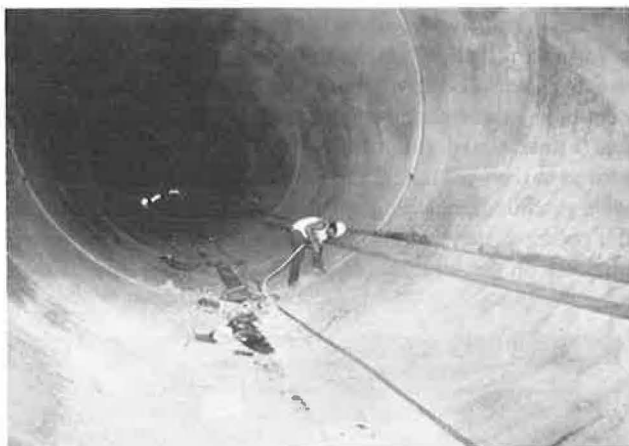
FIGURE 9 Finished tunnel.
