# Experience with Wick Drains in Highway Construction over Soft Clay—Storz Expressway, Omaha, Nebraska

STEVEN R. SAYE, CHARLES N. EASTON, WAYNE D. SMITH, KENNETH H. NASS, AND CHARLES C. LADD

Wick drains were installed along portions of the 2-mi-long highway embankment crossing up to 50 ft of soft highly plastic clay deposited in a cutoff oxbow of the Missouri River in Omaha, Nebraska. About 1,650,000 lineal feet of 4-in.-wide band-type wick drains were installed in a triangular pattern at spacings ranging from 3.25 to 5.5 ft to facilitate strength gain of the foundation clays during stage construction and to pre-compress the clays under a surcharge before paving. The wick drains have allowed the excess pore water pressures generated by fill placement to dissipate. Apparent horizontal coefficients of consolidation calculated from pore pressure and settlement observations range from about one-half to several times the values estimated for design. Measurements during three consolidation intervals to date have shown that the wick drains continue to function without significant changes in the apparent horizontal coefficient of consolidation after vertical strains greater than 15 perce

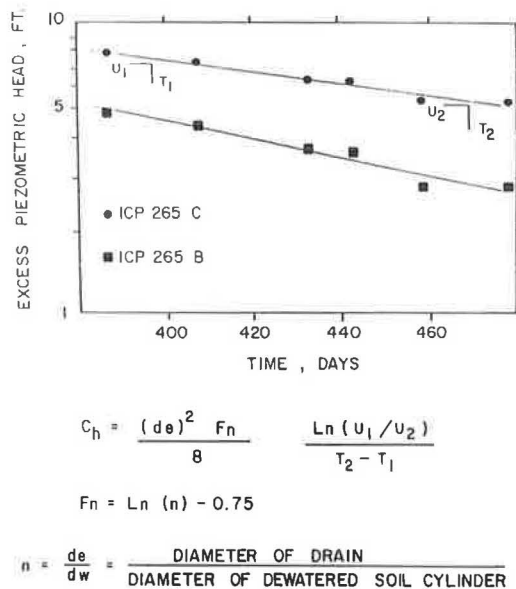
FIGURE 14 Orleach evaluation of  $C_h$ , Station 265.

The rates of pore water pressure dissipation and settlement measured during the consolidation periods after each of the three loadings were analyzed to back calculate ( $C_h$ ) for the foundation clays. Analyses of the piezometer data used the method developed by Orleach (5), as illustrated in Figure 14, which is a plot of the excess piezometric head on a log scale versus natural time. The data should form a straight line

for a constant  $C_h$ , negligible effects of vertical drainage, and constant load. The slope of this line should give a unique  $C_h$  independent of the plan location of the piezometer tip relative to the vertical drains.
