TRANSPORTATION RESEARCH RECORD

Prefabricated Vertical Drains and Pavement Drainage Systems

TRANSPORTATION RESEARCH BOARD
NATIONAL RESEARCH COUNCIL
WASHINGTON, D.C. 1988

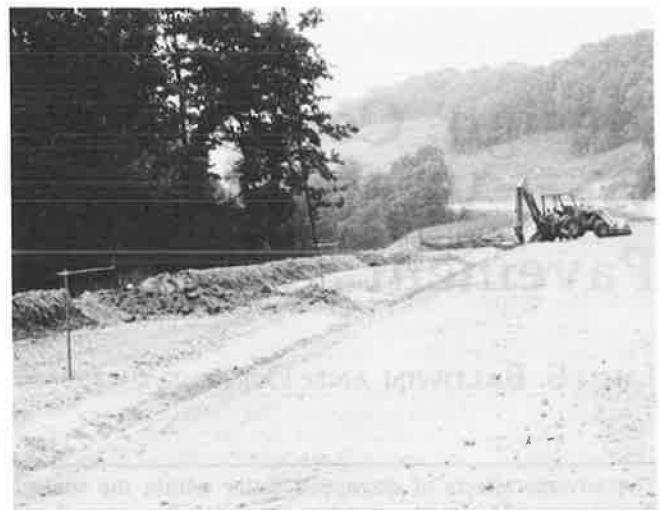
FIGURE 3 Cutting of the underdrain trenches.

Next, the contractor installed the aggregate-filled fabric underdrains. He cut a narrow trench into the subgrade of the shoulder at a 45 degree downgrade angle to the roadway alignment. The trenches were then lined with engineering fabric and backfilled with uncrushed pea gravel as shown in

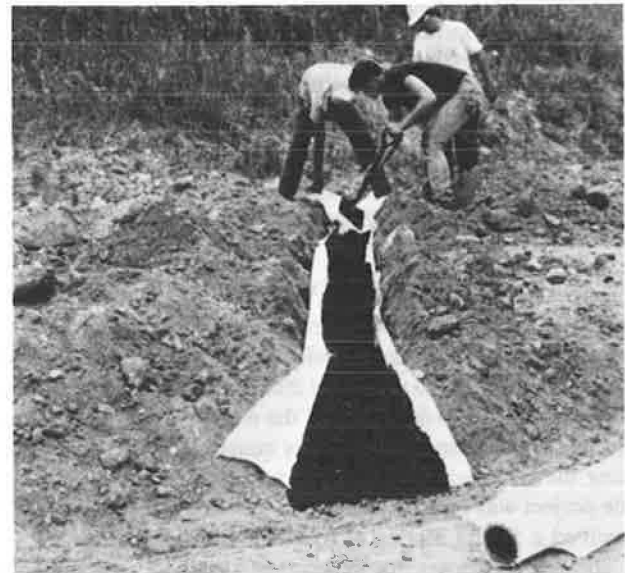
FIGURE 4 Installation of the aggregate-filled fabric underdrains.

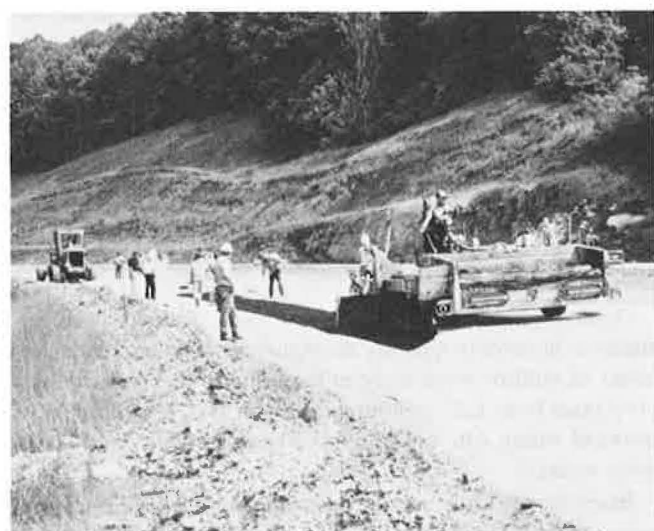
FIGURE 6 Filling of the "V" ditch with free-draining base.

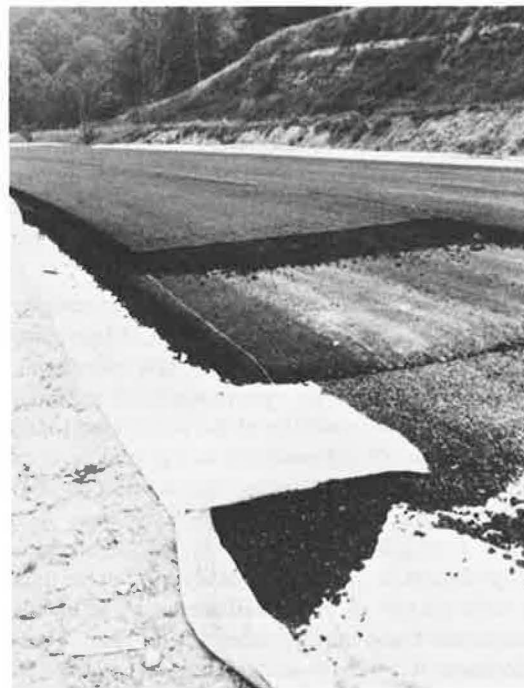
FIGURE 7 Cross section of pavement under construction.

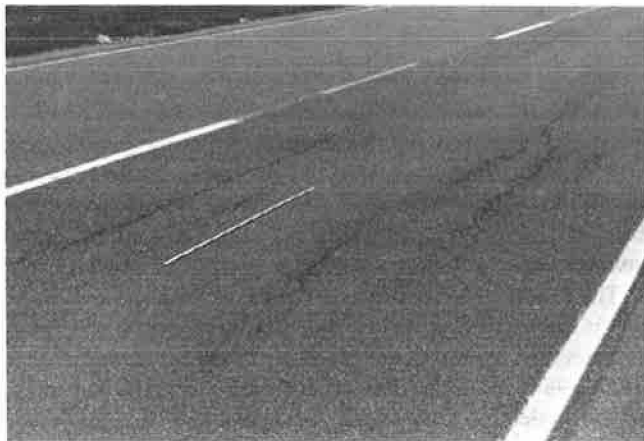
The most noticeable surface anomaly that affected the appearance of the pavement was the occurrence of longitudinal cracks in the surface of the pavement. These cracks were prominent in several areas of the project and were mostly confined to the wheel paths of the outside lane as is shown in Figure 9.

FIGURE 9 Longitudinal surface cracking.

In 1986, several of the areas exhibiting the longitudinal cracks were core drilled. Examination of the cores indicated that the fractures generally extended only through the top inch of the wearing surface. The probable cause of the fractures has been attributed to an excessively hot liquid asphalt which was used in the batching of the wearing course. Consequently, this resulted in a thin coating of the aggregate particles and a relatively brittle mix.

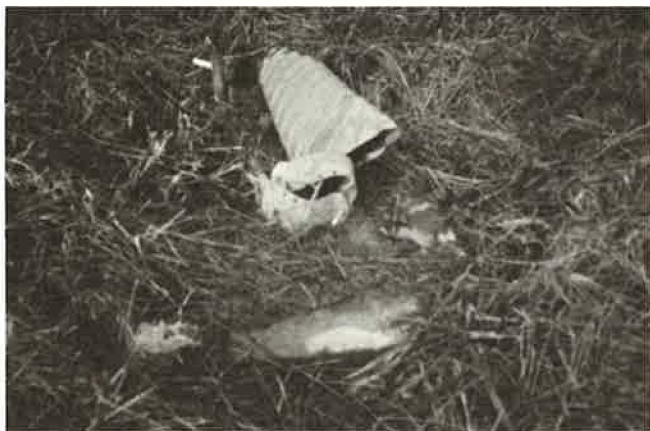
FIGURE 7 Animal guard (collar style).

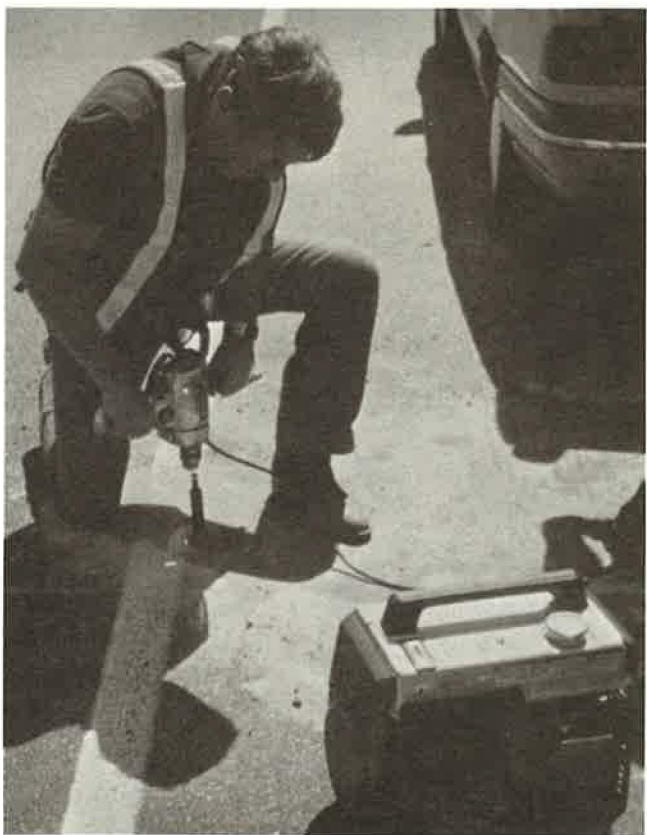
FIGURE 11 Drilling into the edgedrain.

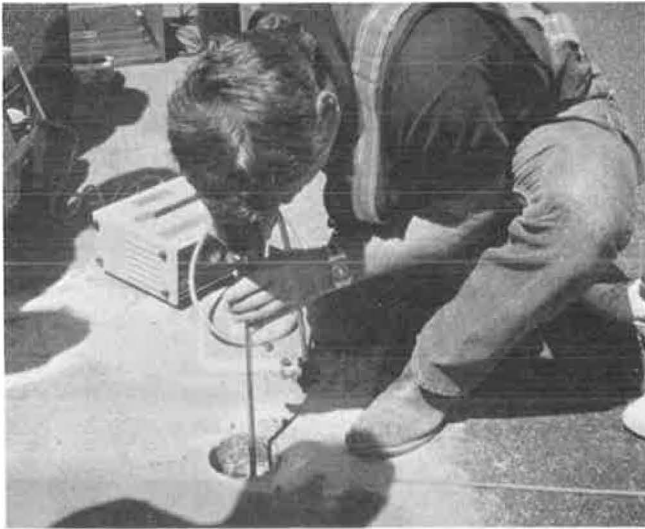
FIGURE 13 Borescope.

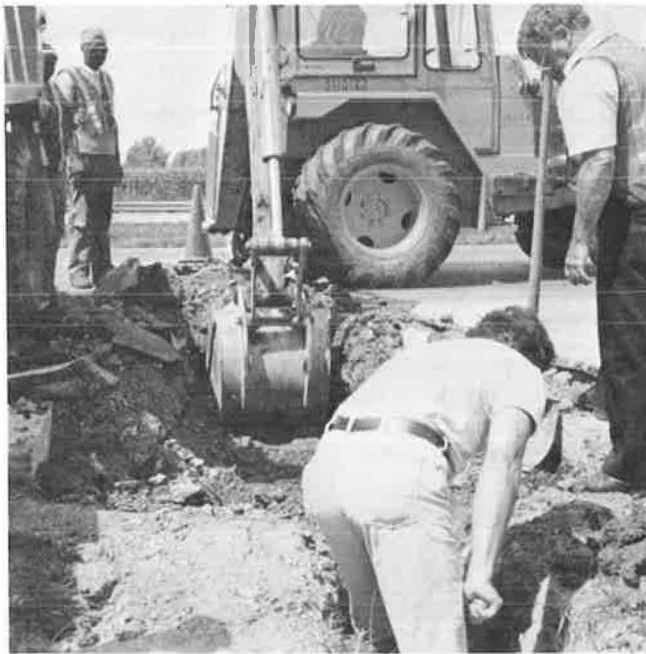
FIGURE 14 Digging up an outlet.

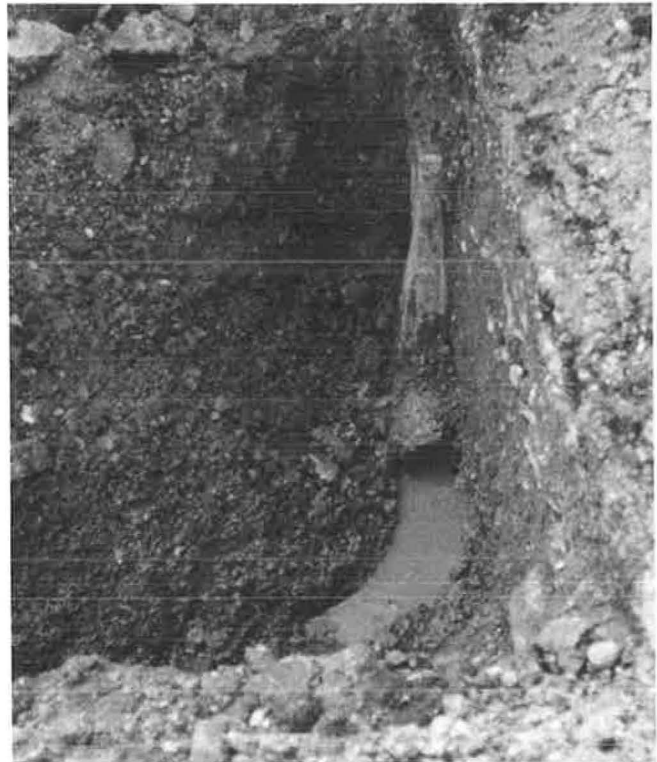
FIGURE 15 Outlet pipe removed.

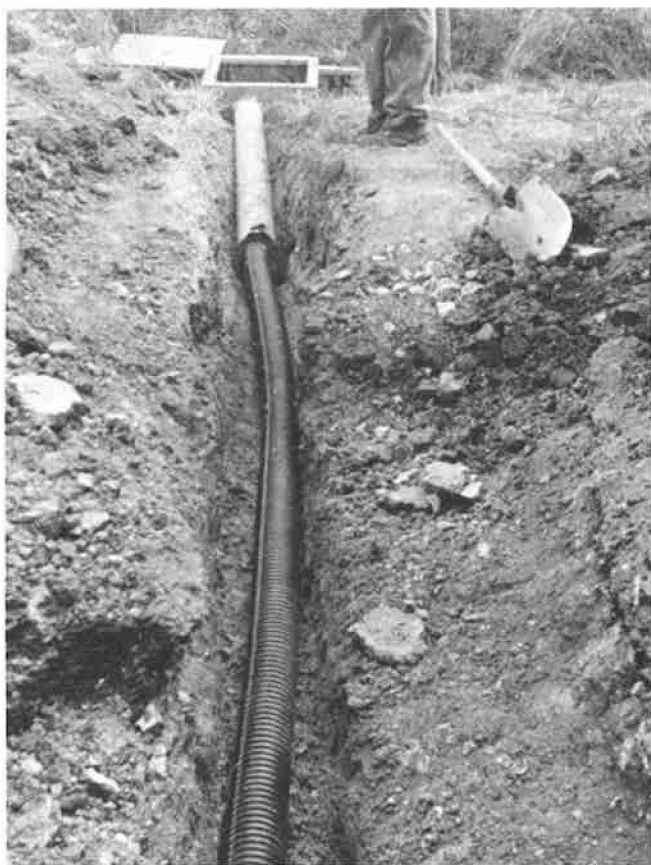
FIGURE 16 New outlet pipe.

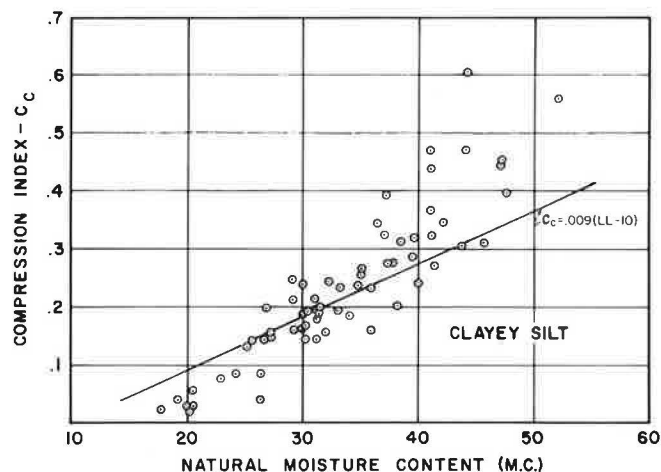
The compression indices, C_c 's, for the clayey silts and marls were obtained from the oedometer tests and are plotted versus the natural moisture contents. These results are shown in Figures 4 and 5. Coefficients of vertical consolidation, c_v 's, for the clayey silts were plotted versus the natural moisture contents and are shown in Figure 6. Consolidation tests on the marl indicated that the c_v would be greater than 1.0 ft^2 per day. The consolidation parameters presented in Figures 4, 5, and 6 represent the entire project area and not just the area under investigation (i.e., other undisturbed laboratory testing results from drill holes not in the immediate vicinity of the 35-ft-high embankment were also included in the summaries). This was done because the subsoils throughout the area are very similar.

FIGURE 4 Compression index for clayey silt versus moisture content (total project area).

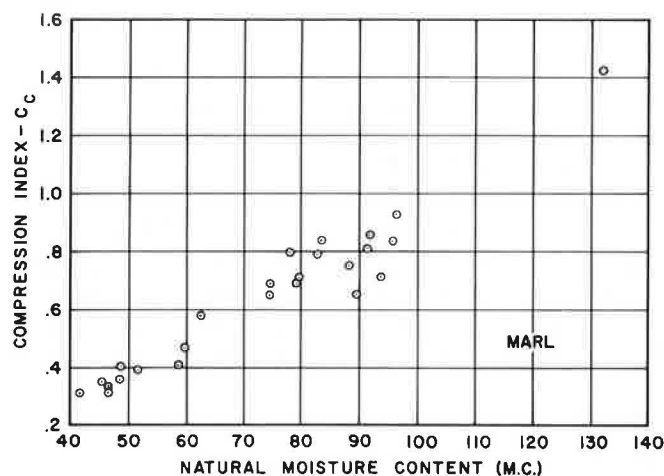
FIGURE 5 Compression index of marl versus moisture content (total project area).

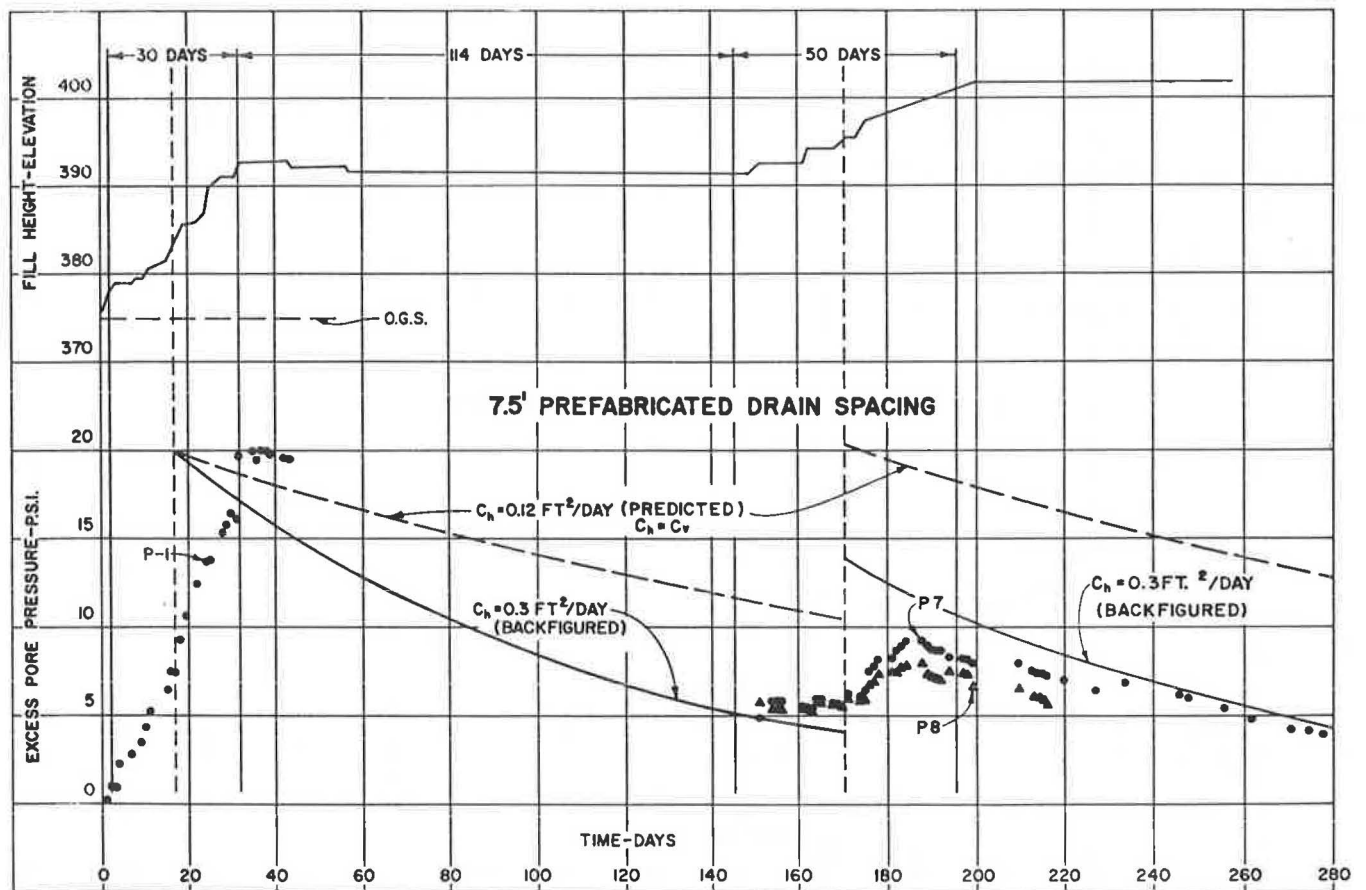
FIGURE 14 Predicted and measured excess pore pressure with 7.5-ft prefabricated drain spacing.

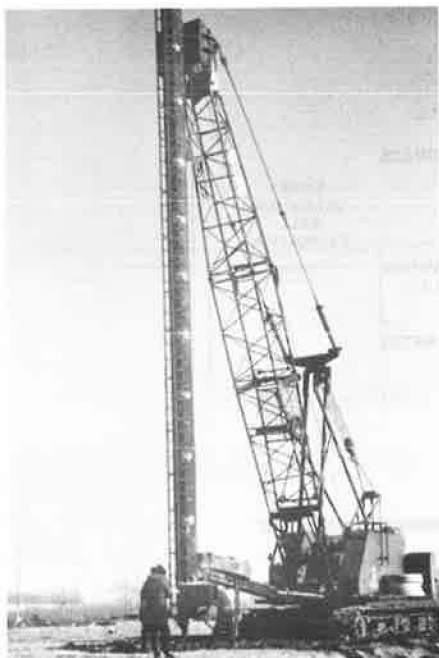
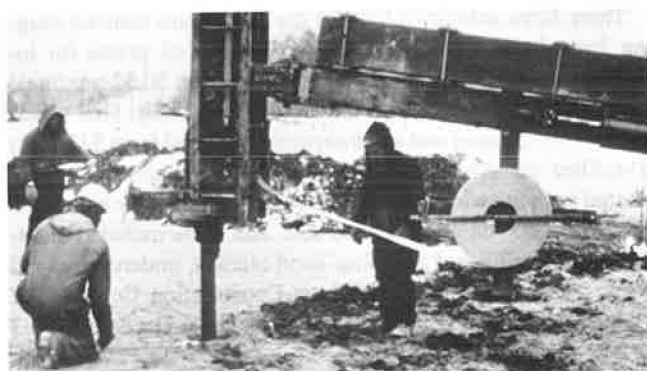
FIGURE 7 Wick drain installation equipment.
