Technical and Financial Appraisal of a Contemporary Repair Technique for Rails and Crossings

R. S. JOHNSON

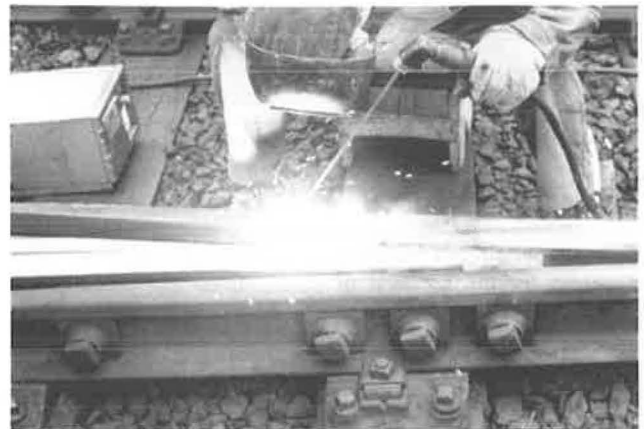
FIGURE 1 Crossing nose undergoing maintenance welding.

Maintenance repair involves the removal of deformed and defective material, which results from the impact loading of passing traffic, and its replacement with sound material (Figure 1). This type of repair is carried out in track, generally before the amount of wear on the crossing exceeds 6 mm in depth. Both the wing rails and the crossing nose (frog) are treated at the same time and in the same manner.

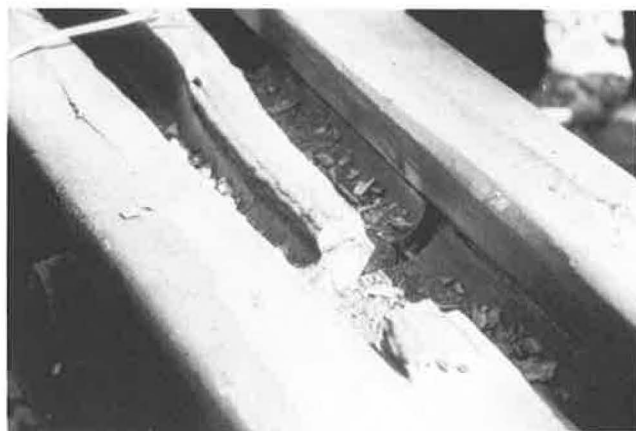
FIGURE 2 Crossing nose requiring repair welding.

Structural repairs to crossings are usually executed out of track and can involve large weld repairs to fatigue cracks or fabrication defects anywhere within the body of the crossing (Figure 2). The objective of both types of crossing repair is to enhance the life of the crossing at minimal cost. Whereas most maintenance welding can be undertaken with the crossing in situ, larger repairs necessitate the removal of the unit before its repair, either at lineside or in a workshop.

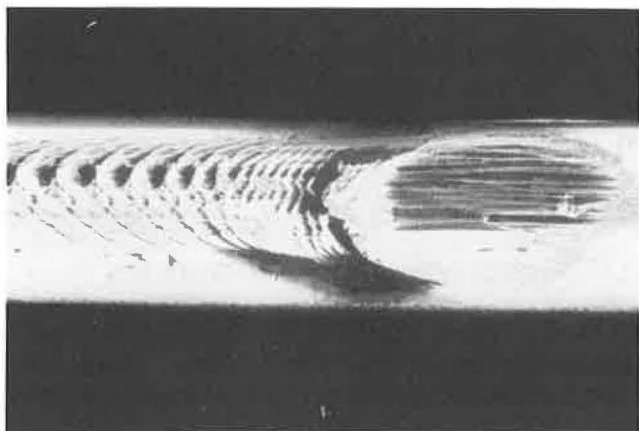
FIGURE 3 Typical wheelburn.

Initially repairs were restricted to inherent rail defects (rolling defects) or wheelburns (Figure 3). However, the identification of large numbers of RCF defects (Figure 4) in the mid-1970s (1) enhanced the cost-effectiveness of repairs by welding as an option to rail replacement. Procedures have been developed for the repair of plain-line defects, either with or without possession of the line, to remove cracked or defective material and restore a smooth-running surface with sound, defect-free weld metal.

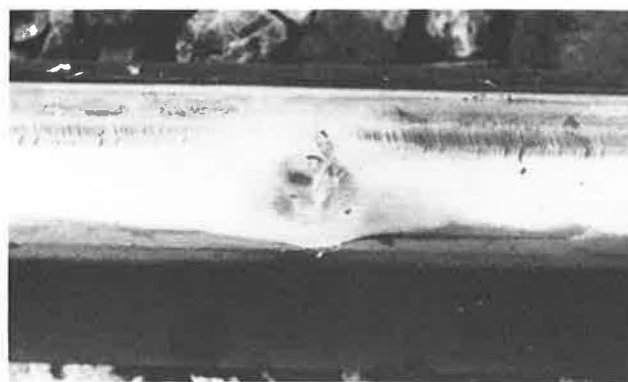
FIGURE 4 Rolling contact fatigue ("squat") defect.

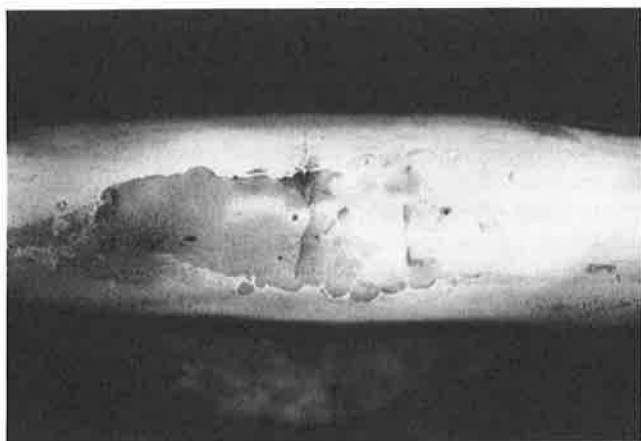
FIGURE 5 MMA repair of cracked plain line.

Following the adoption of these electrode types, a number of reports were received as to the performance of the repairs. Some reports indicated that the stainless electrode exhibited poor resistance to batter, whereas other reports revealed that although the low-alloy types were more resistant to deformation, problems were encountered with cracking, either as a result of inadequate preheat (4) or as a result of weld defects (5) (see Figures 5 and 6).

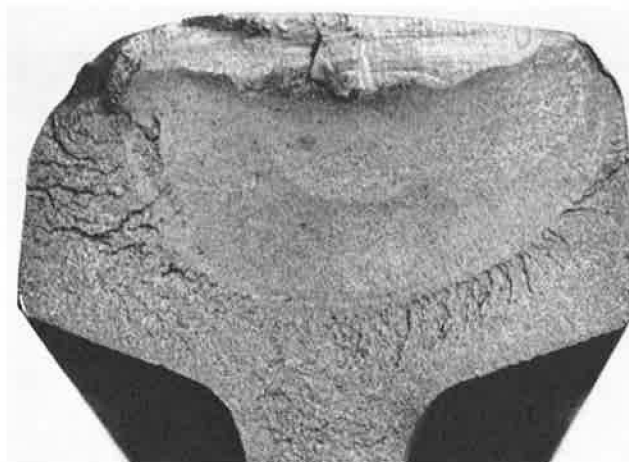
FIGURE 6 MMA repair of fractured rail.

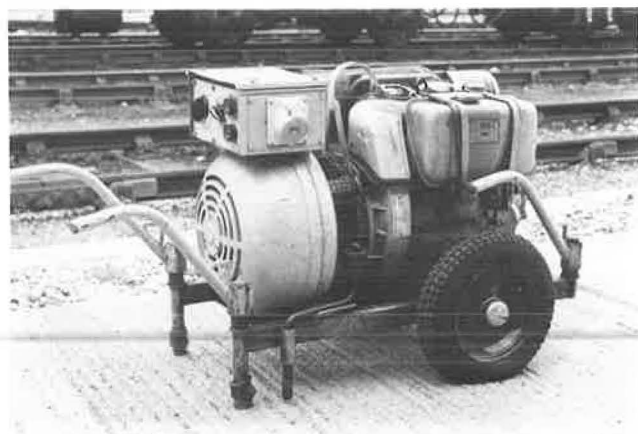
FIGURE 7 Hayter "Mighty Midget" 250a AC welding machine.

The most common type of MMA welding machine used by BR is the Hayter 250a AC "Mighty Midget" alternator, of which approximately 400 are currently in service. The majority are diesel powered (Figure 7). The unit operates nominally at 427 Hz, and the output is rated as 250 A maximum at 60 percent duty cycle. Machine tests have shown that the

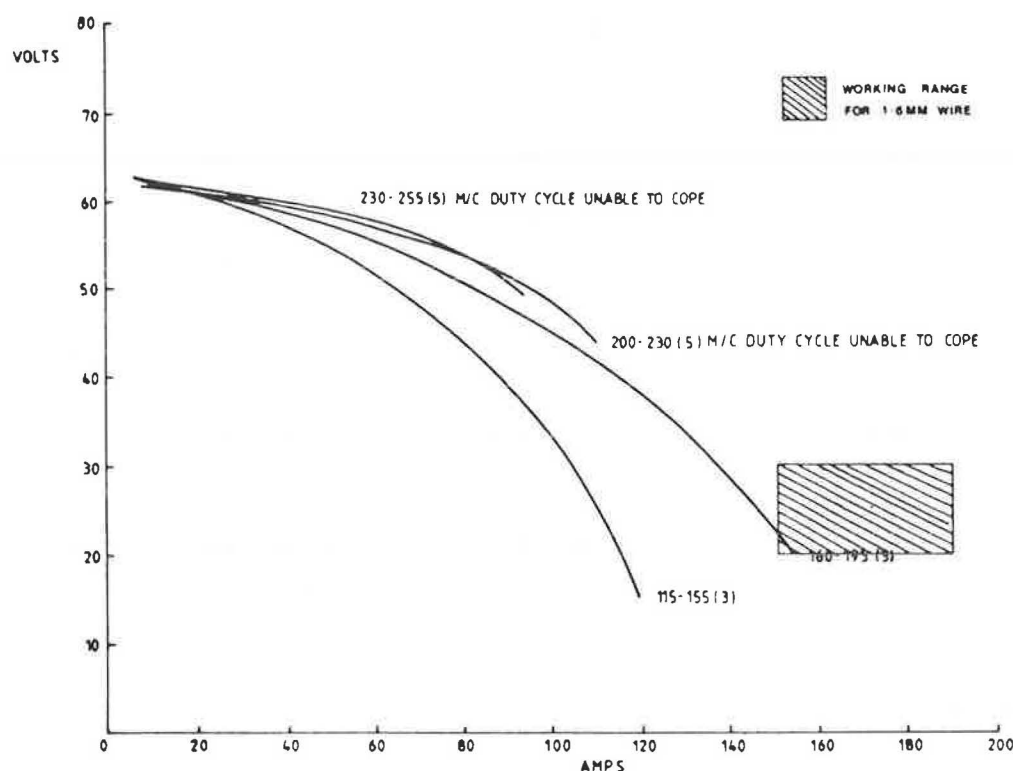
FIGURE 8 Current-voltage relationship for the "Mighty Midget" operating on ac.

maximum current at 100 percent duty cycle, which would be required for a continuous wire process, can be as low as 160 A, particularly if deterioration of the equipment is taken into consideration. In common with other MMA welding plant, the curve of machine output has a "drooping" characteristic, effectively producing constant current over the normal working range (see Figure 8).

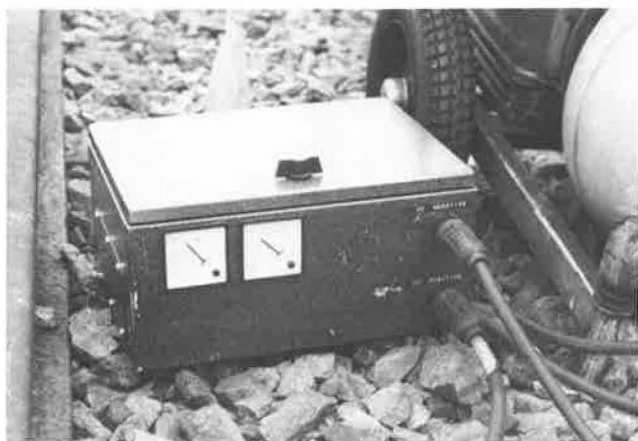
FIGURE 9 Example of an ac-dc rectifier.

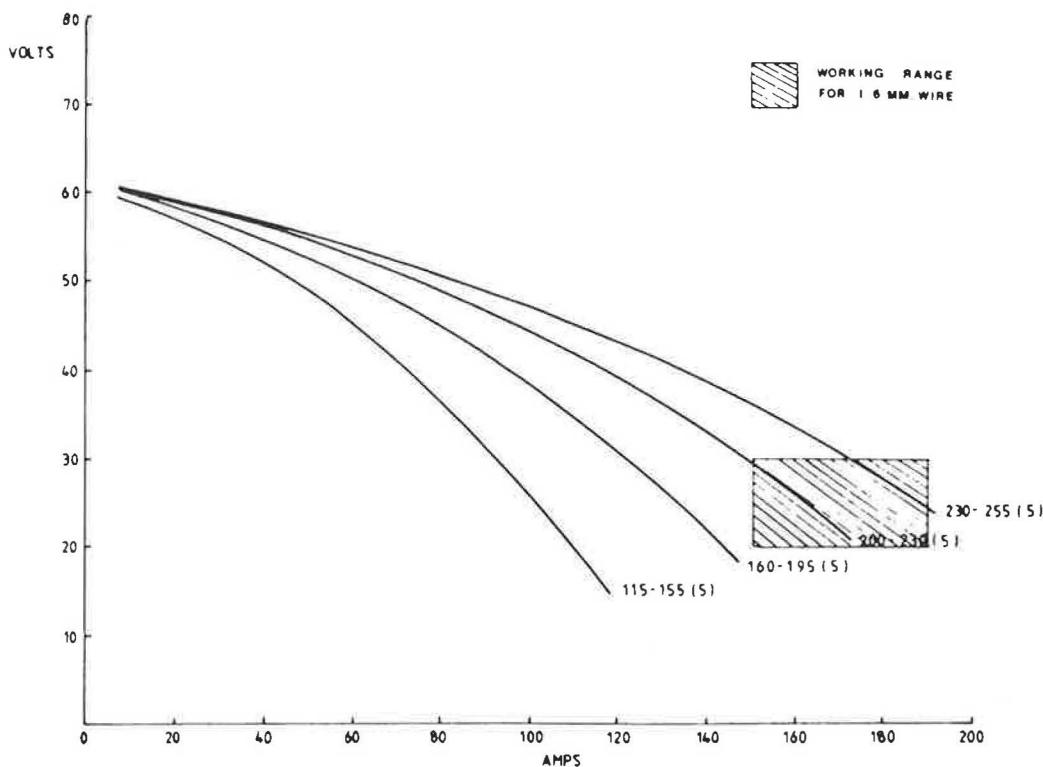
FIGURE 10 Current-voltage relationship for "Mighty Midget" and rectifier.

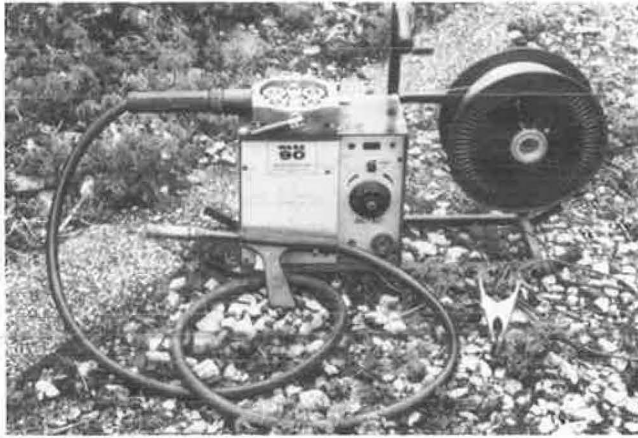
FIGURE 11 Welding Alloys WSHA 90 wire feed unit.

The WASA 70, operating from a rectified ac supply, was subsequently used for the first site trials with the process, and certain modifications became desirable for the production model, which have subsequently been incorporated into an improved unit, the WASA 90 (Figures 11 and 12).

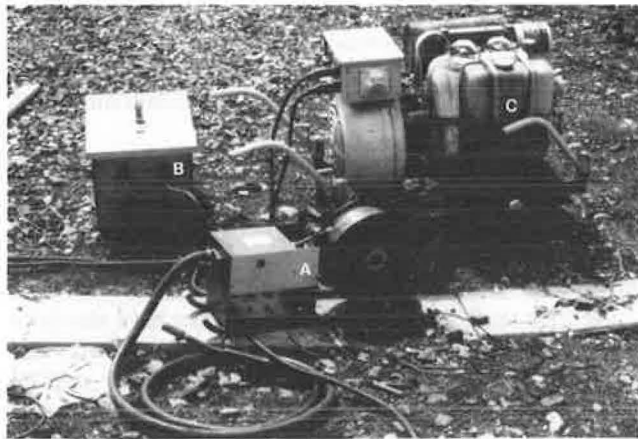
FIGURE 12 Equipment arrangement consisting of (A) welding torch, (B) converter, and (C) ac welding machine.

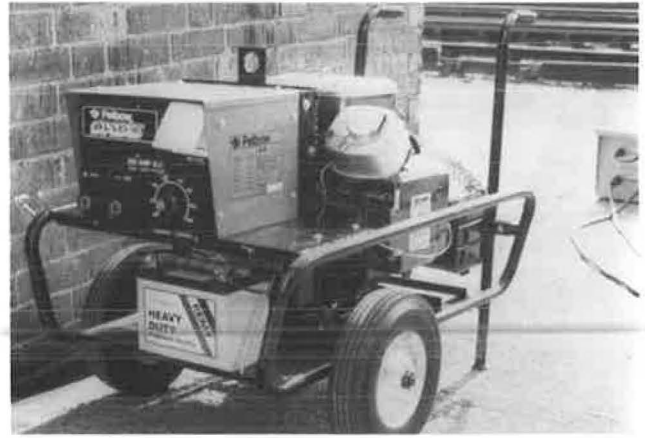
FIGURE 13 Petbow Arc Centre 200 dc welding machine.

Rectified three-phase ac welding machines have also been investigated and are now recommended as the preferred and more economical alternative to the purchase of new ac plant with a separate rectifier. An example of one such unit is shown in Figure 13; its output is shown in Figure 14.

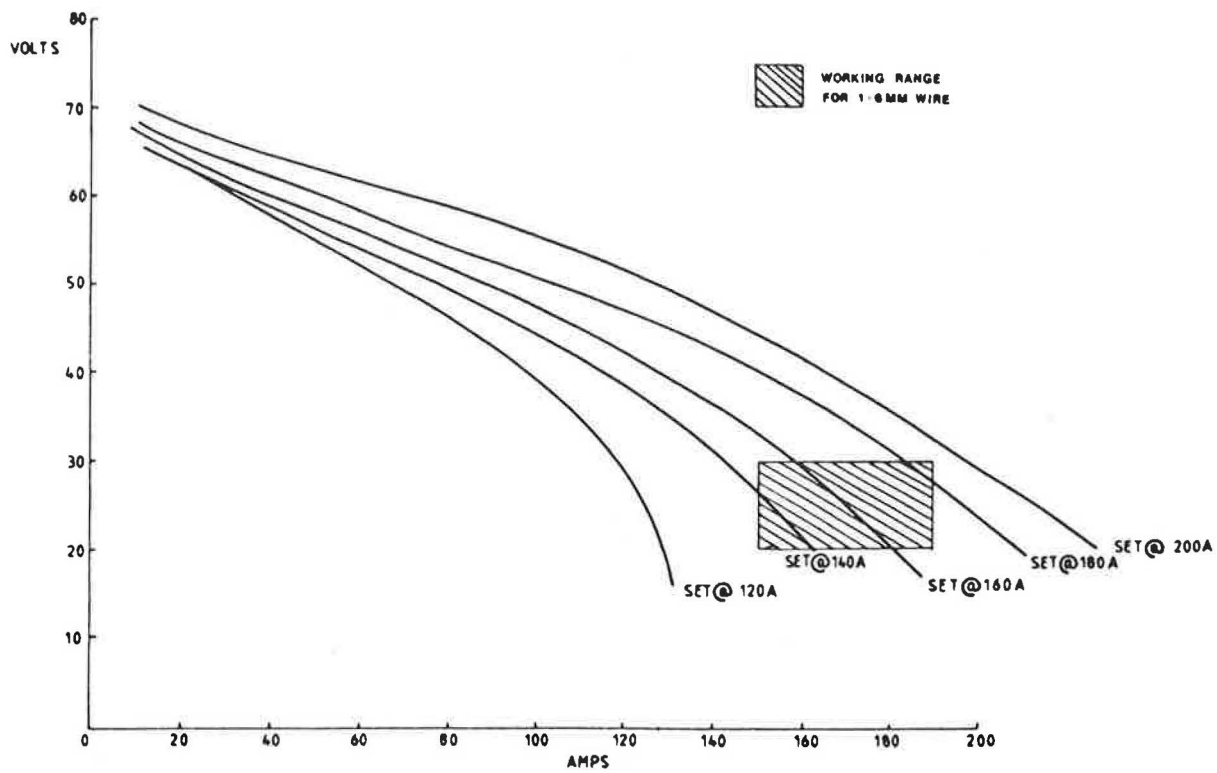
FIGURE 14 Current-voltage relationship for Pethow Arc Centre 200.

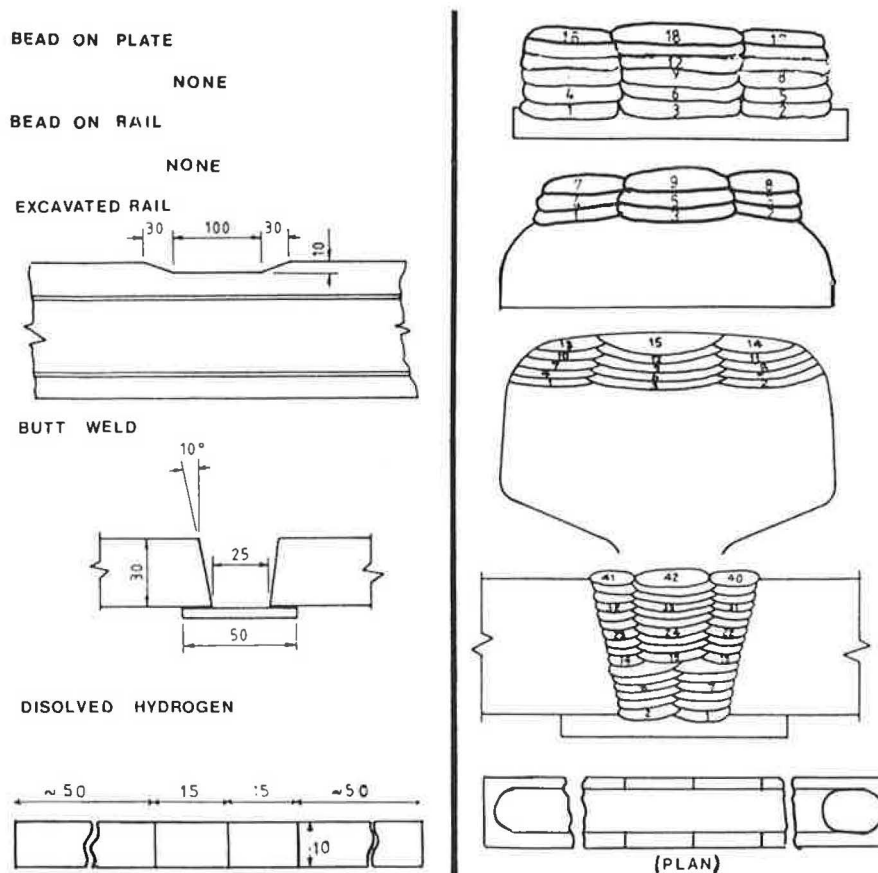
FIGURE 15 Preparation (*left*) and welding sequence (*right*) for test samples.

Before any test samples were prepared, “exploratory” weld deposits were produced to determine the welding parameters. All welds were made using rectified ac, a 25-mm weave, and a run length of approximately 90 mm. All the welds on normal-quality rail were deposited using 250°C preheat.

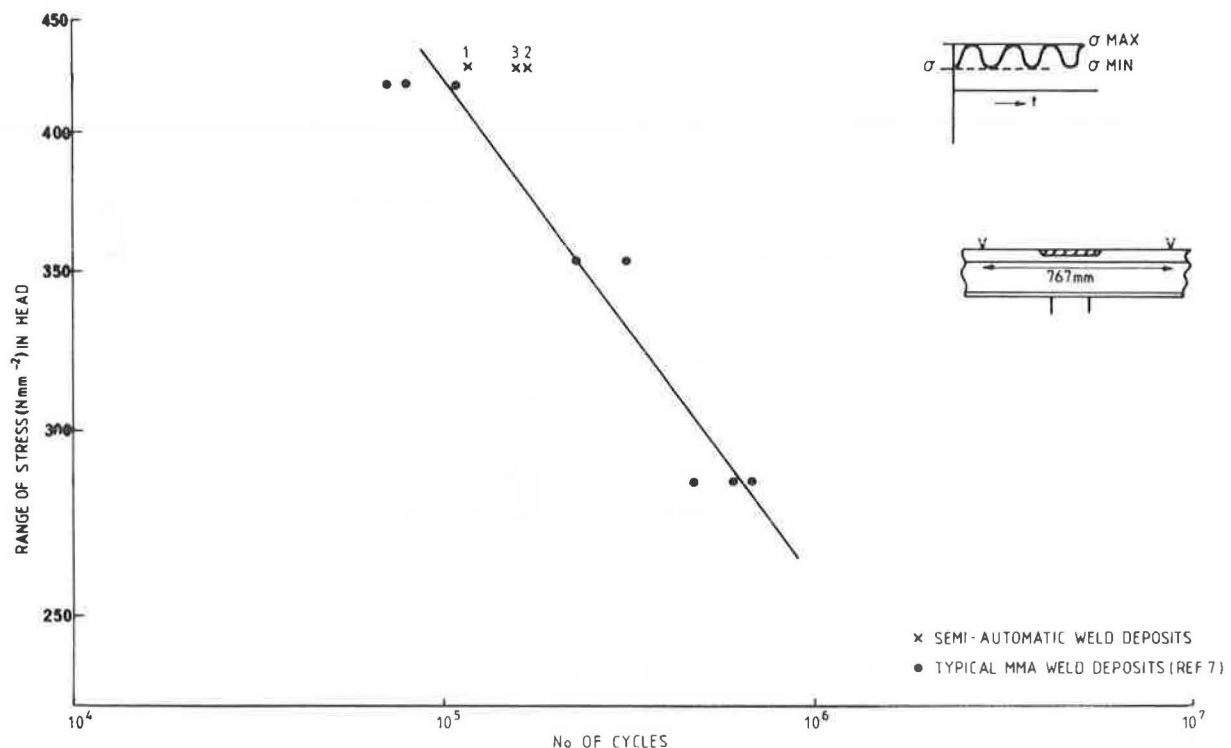
FIGURE 16 Fatigue test results for semiautomatic repairs compared with MMA repairs.

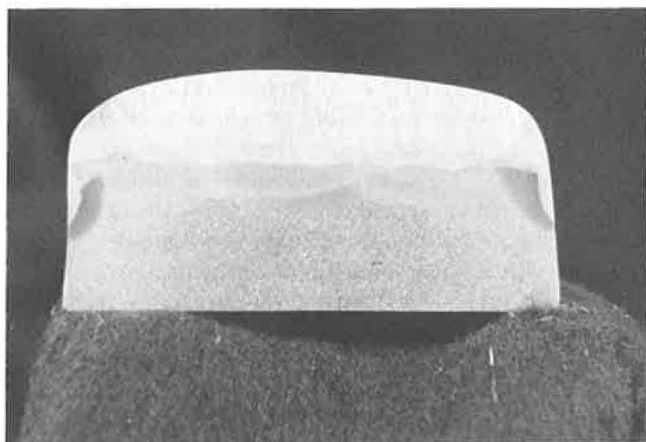
FIGURE 17 Transverse section through fatigue test specimen.

Metallographic examination of the weld metal in the undiluted form revealed a coarse dendritic structure (Figure 17) with a very low level of nonmetallic inclusions and no visible porosity. The microstructure of the weld metal consisted of coarse bainite and ferrite (Figure 18). The heat-affected zone in normal-quality rail steel (250°C preheat) showed no evidence of any brittle transformation products.

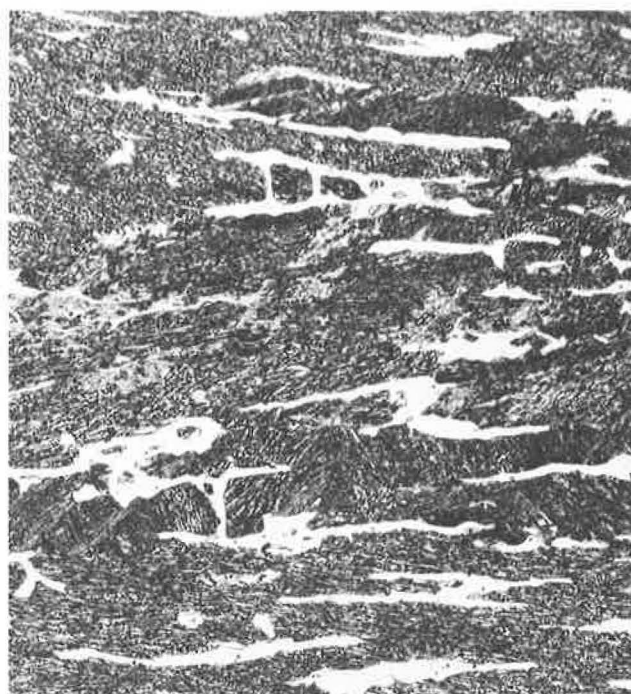
FIGURE 18 Photomicrograph of undiluted Cr/Mn weld metal.

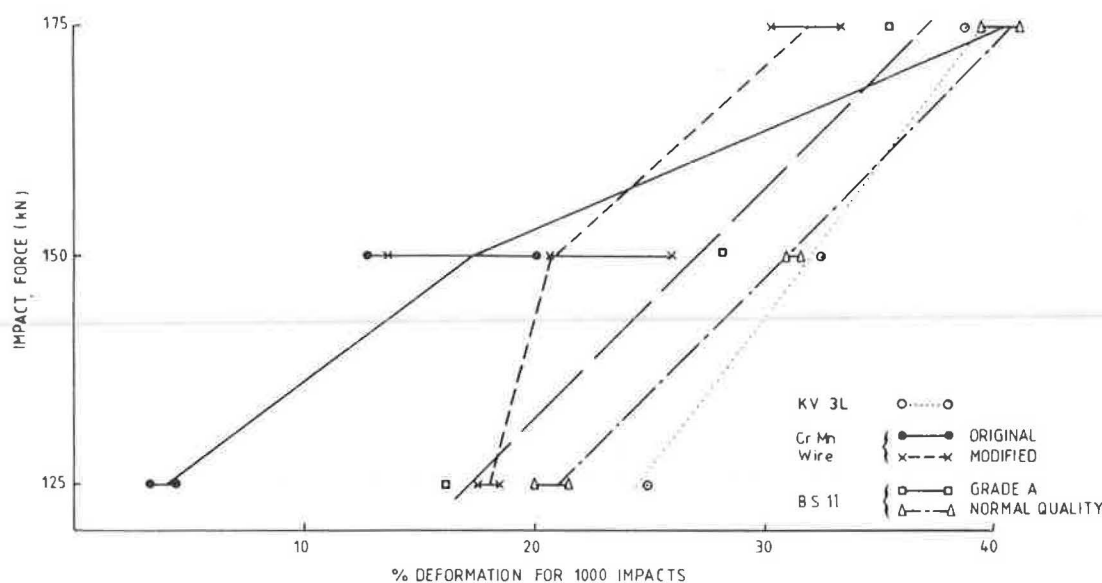
FIGURE 19 Deformation test results for semiautomatic flux-cored weld metals.

The "modified" wire was subsequently subjected to the full laboratory assessment, apart from the diffusible hydrogen determination and fatigue tests. The results are summarized in Table 10 with comparative data from the original experimental batch. The results of the deformation tests are included in Figure 19. It can be seen that the modified weld metal was still more resistant to deformation than the parent rail steel and the equivalent MMA repair weld metal.

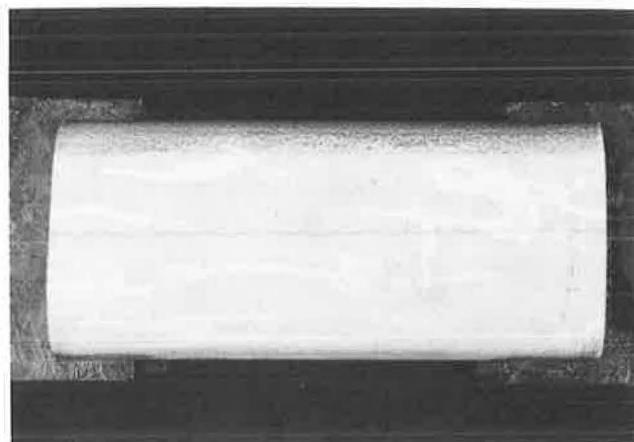
FIGURE 20 Transverse cracks in a repair on the Derby-Birmingham route.

An examination of the sites showed that the cracks occurred some time after welding (when the deposit was cold), whether the repair had been exposed to traffic or not. Cracked deposits were found in both continuous welded rail and bolted track and in relatively new as well as in old rail.

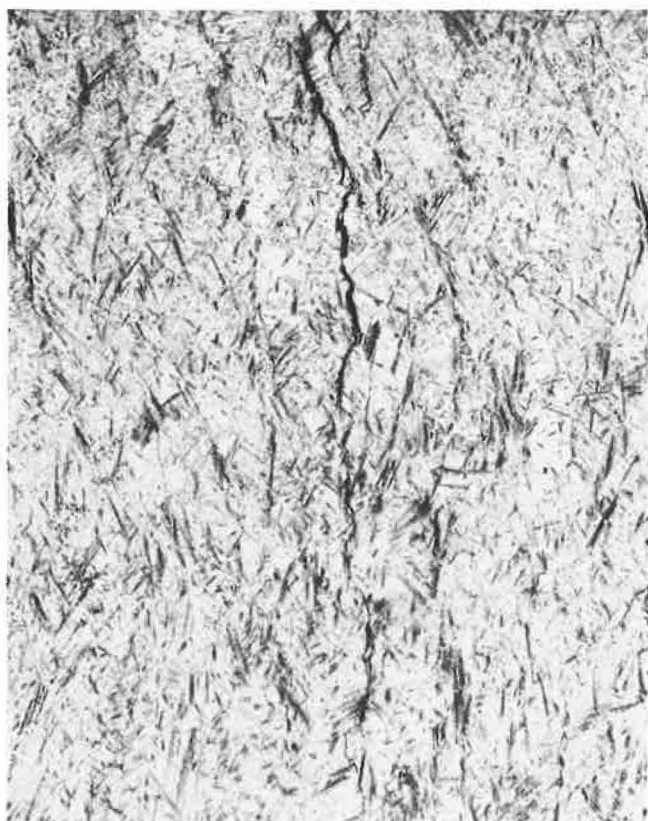
FIGURE 21 Photomicrograph of transverse cracks associated with a brittle martensitic weld metal.

Following removal of the defective rail from track, a number of the cracked deposits were broken open for scanning electron microscopy, which confirmed that the cracks were of a delayed, "cold" type. Optical microscopy of sections prepared through the cracked deposits showed that the weld metal exhibited a coarse, acicular structure consisting of high carbon bainite and martensite with a band of martensite adjacent to the fusion line (see Figure 21). It was concluded that the cracking was caused by hydrogen in the weld metal aggravated by a microstructure with inherently low levels of ductility and toughness.

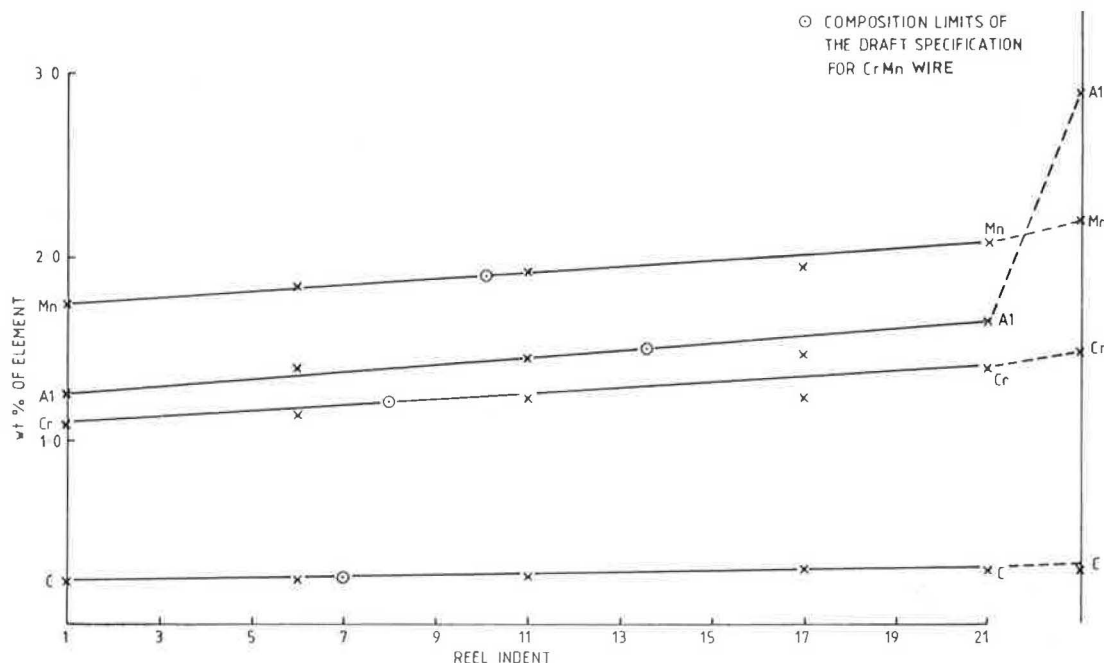
FIGURE 22 Variation in weld metal composition through a batch of Cr/Mn wire (21 reels).

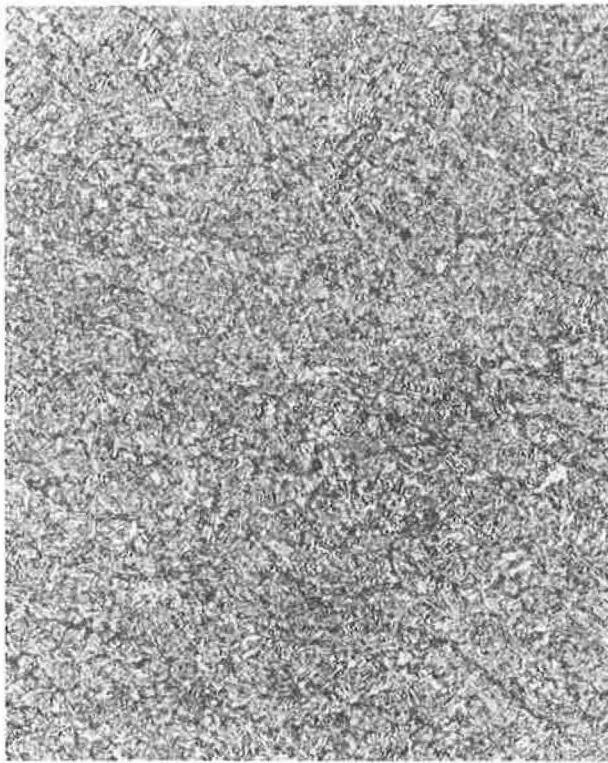
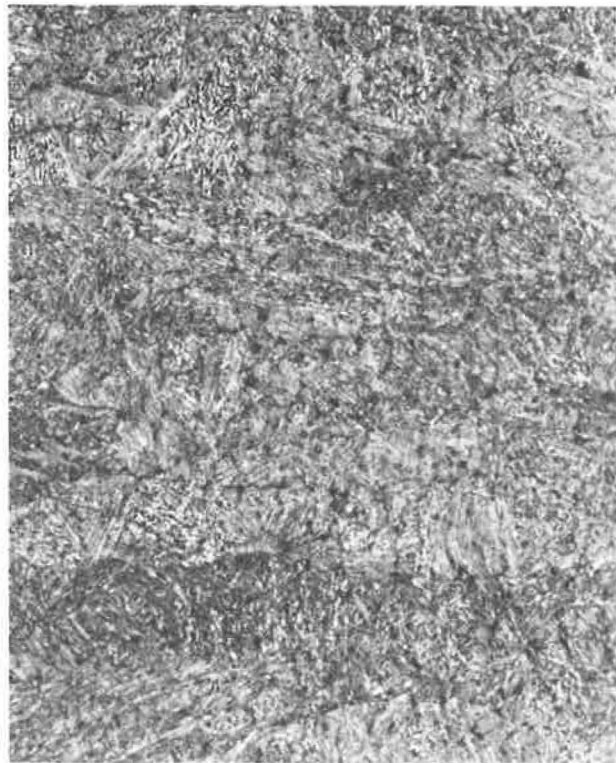
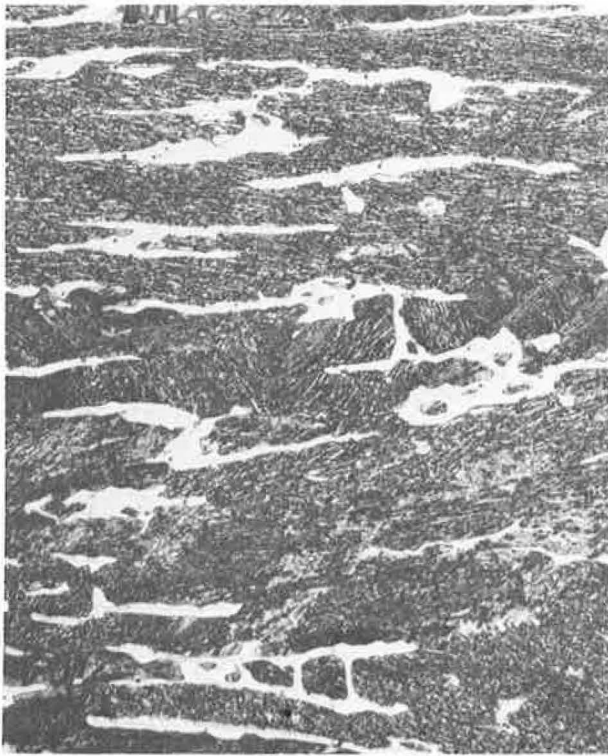
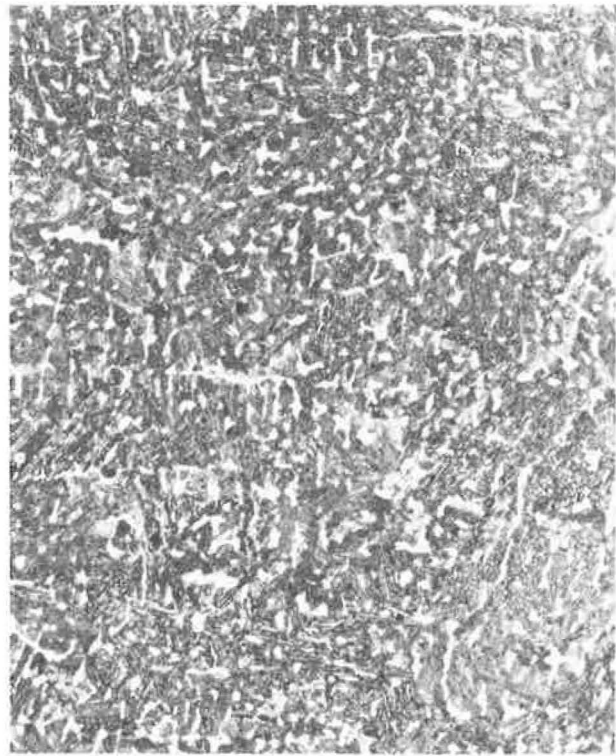
FIGURE 23 Photomicrographs of undiluted MMA and flux-cored wire weld metals ($\times 149$). *Top left:* Phillips kV3L; *top right:* Cr/Mn/Ni wire; *lower left:* original Cr/Mn wire; *lower right:* modified Cr/Mn wire.

300-A capacity (220 A dc at 100 percent duty cycle). Samples of the wire were subsequently drawn down to 1.6 mm-diameter for laboratory assessment using the evaluation program described earlier. The results of the laboratory work are given in Table 10. The microstructure of the undiluted weld metal was found to be similar to the MMA weld metal produced using kV3L electrodes (see Figure 23).

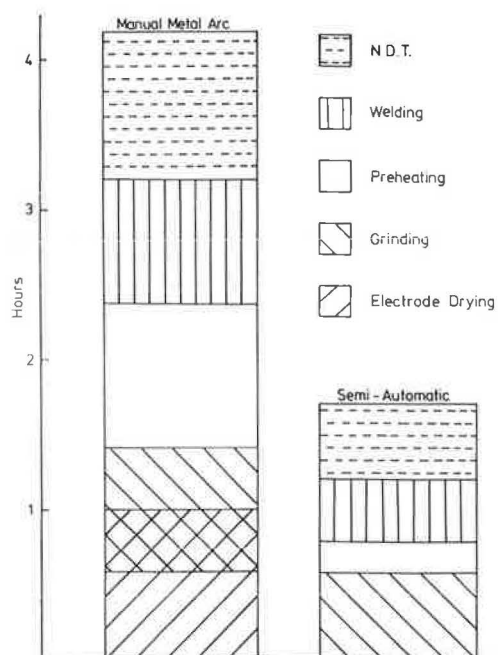
FIGURE 25 Comparison of times for wheelburn repairs.

timed, and a breakdown is given in Table 11. The times are also presented as a bar chart (Figure 25) and converted to costs per unit volume of weld metal (Figure 26). This conversion is based on the information presented in the next section of this appendix.

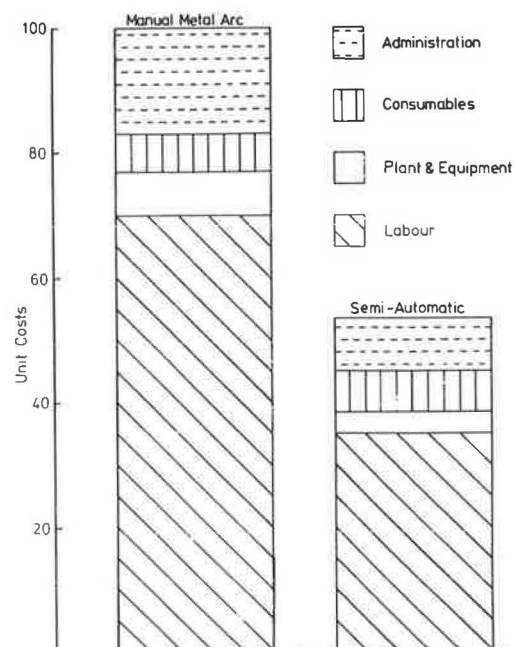
FIGURE 26 Comparison of costs for track repairs per unit volume of deposited weld metal.
