Response of Timber Bridges Under Train Loading

A. S. UPPAL AND S. H. RIZKALLA

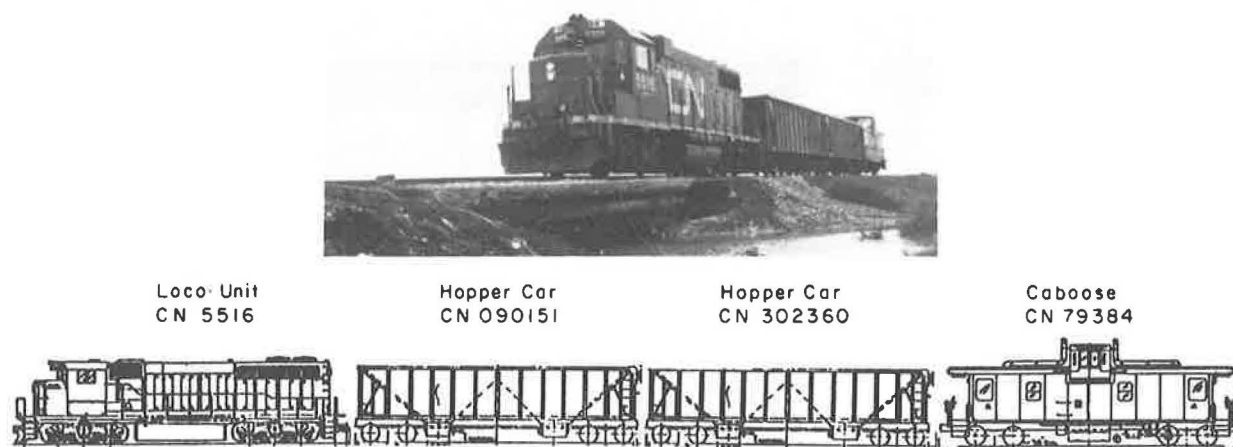
FIGURE 2 Typical test train.

The trains used for the tests were similar to the trains normally operated on this line for hauling limestone from Steep Rock, Manitoba. Because trains were required on two different occasions, they differed in car numbers and car weights. However, both of them were made up of a GR-20 series four-axle diesel locomotive, two ballast-loaded open-top hopper cars, and a caboose as shown in Figure 2. The hopper cars had transverse beams situated at their midlength just below their bodies, which facilitated jacking for static tests. The test trains were scale weighed by their trucks at the local tower scale in CN's Symington Yard before they left for the test sites. Table 1 gives the scale weights of locomotives and cars in the test trains.

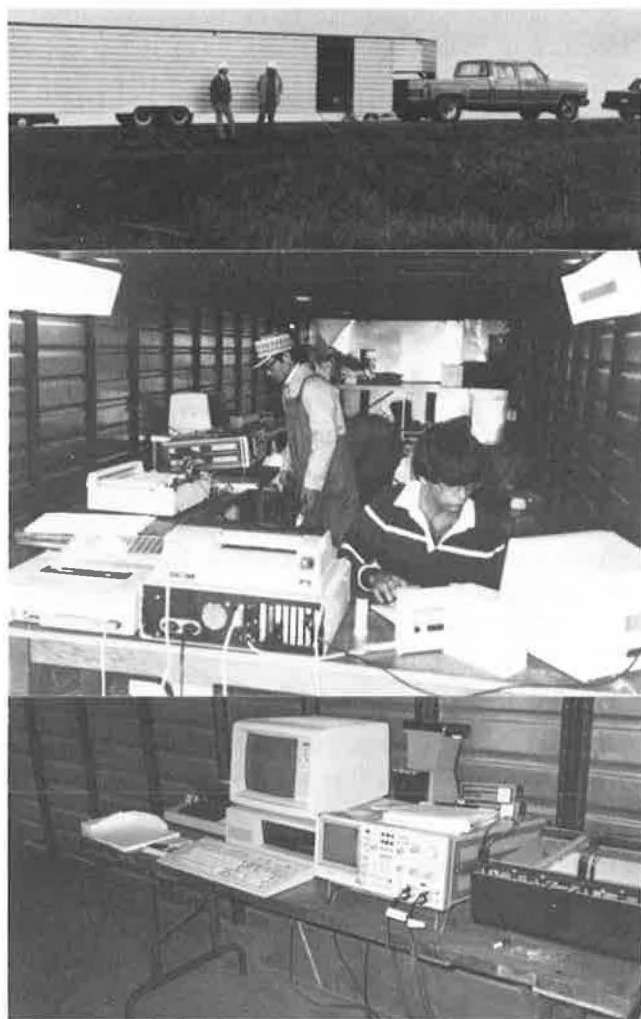
FIGURE 7 Test equipment in truck trailer.

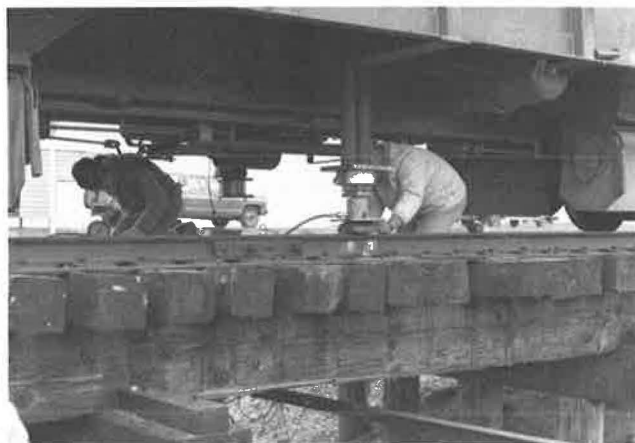
FIGURE 9 Calibration test in progress.

The midpoint of one of the hopper cars was centered over one of the load measurement locations. A load well, a jack, and a segmented railway car wheel were placed between the transverse beam of the carbody and the rail at each of the two rail points, as shown in Figures 8 and 9. The segmented wheels were used on rails to simulate the actual wheel-rail load conditions for static situations. This system was used to calibrate all of the shear circuits installed at both locations. The loads were applied by hydraulic jacks operated by a hand pump to a maximum of 30 kips per rail.
