Deep Impregnation of Concrete Bridge Decks

RICHARD E. WEYERS AND PHILIP D. CADY

The deep monomer impregnation (depth of impregnation 3 to 4 in.) and in situ polymerization of a bridge deck using the grooving technique is presented. The study shows that the process is commercially feasible and the work can be successfully completed to a set of specifications by contractors with no experience with the monomer impregnation and in situ polymerization process. Laboratory estimates of operation times are compared with field performances. Field operation times were significantly less for the impregnation time and the polymerization time but slightly greater for drying times. Safety procedures and cost estimates are also presented. The deep impregnation process is shown to be cost competitive with cathodic protection.

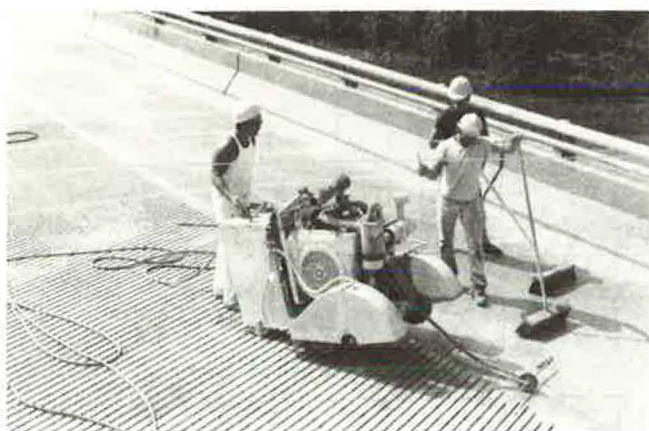
The contractor used a standard water-cooled concrete saw with two diamond set blades sandwiching a smaller diameter abrasive cut-off wheel to cut the groove width in one pass. The grooves were cut one at a time with snap lines set about every 5 ft for controlling the groove orientations. A wheel and guide on the front of the machine assisted in maintaining proper groove spacing between adjacent grooves. The groove-cutting operation is illustrated in Figure 2.

FIGURE 2 Groove-cutting operation.

Some early problems were experienced by the contractor's forces in maintaining the direction and spacing of the grooves. However, after cutting about five grooves (about 60 lineal ft), they became accustomed to the operation and were producing acceptable work at a rate of 120 ft/hr. The groove spacing and depth were within specifications for the entire job. However, the groove width was generally 0.125 in. narrower than the 0.75 specified width, or about 0.6 in. narrower than the lower specification limit. This

deviation was considered acceptable because the depth of the grooves was 0.1 in. greater than 1.50 in. (the depth and width deviations offset each other).

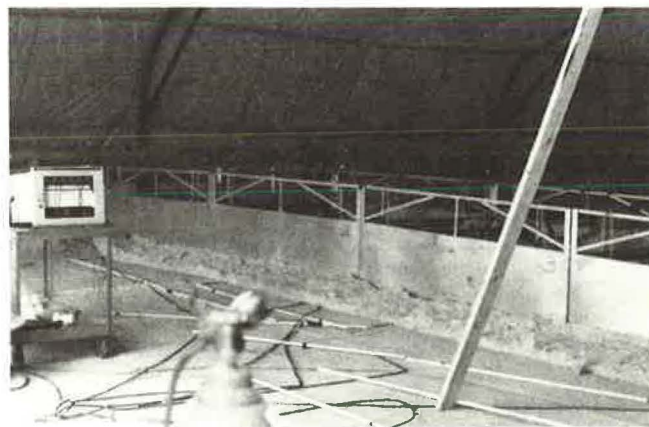
by bolting the six units together was able to dry a 43-ft long section (the full width of the 44-ft wide deck) covering 5 ft of the bridge at a time. Each unit housed three 120,000 BTU/hr, propane-fired, infrared radiant heaters operating at 3 psi pressure. Pressure regulators were installed in the fuel line of each heating element and permitted individual heating adjustments for the 18 heater elements.

To minimize thermal gradients and thus thermal stresses, the heating rate was controlled by surface temperatures in accordance with the specifications presented in Table 2. In addition, the dried areas were covered with R-19 glass wool insulation immediately after the heaters were removed to reduce thermal gradients during cool down. A 24-in.-wide strip of R-19 glass wool insulation was placed on the deck in front of the heater to reduce heating losses and to reduce thermal gradients in front of the heating train. The front side of the heating train is shown in the photograph in Figure 3.

FIGURE 3 Front side of heating train during drying.

Small scale laboratory drying trials with a 600°F surface temperature showed that drying to a depth of 4 in. below the surface took about 3.5 hr at an ambient temperature of 75°F (18). The drying times on the trial deck impregnation took somewhat longer and ranged from 3.9 hr to 6.0 hr, with an average of 4.6 hr for the 14 drying operations (4.5-ft advance with 0.5 ft overlap per setup). The mean ambient temperature was somewhat lower than 75°F and ranged from 57°F to 82°F, with a mean ambient temperature of 60°F.

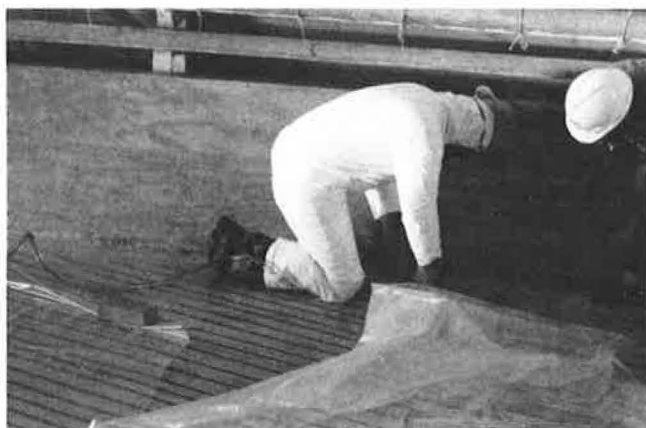
FIGURE 5 Two-man crew filling individual grooves.

Laboratory experiments indicated that 0.75-in.-wide by 1.5-in.-deep grooves cut to impregnate to a depth of about 4 in. would empty in about 16 hr (18). The filling of the grooves with monomer was carried out by three 2-man crews working simultaneously. Groove filling was done at the ends of the grooves; polyethylene sheets covering the deck were folded back just enough to expose the groove ends, thus minimizing direct exposure of the monomer to the atmosphere. All the grooves were filled in about 4 hr. The grooves were refilled as the concrete absorbed the monomer. Refilling continued until all 14 drums (5,600 lb) of monomer were used (4,000 lb or 10 drums was the estimated amount required to impregnate to a depth of 4 in.). The entire process, from mixing of the first drum until the last drum was emptied, took about 6.5 hr. A two-man crew filling the grooves is shown in Figure 5. The monomer was allowed to soak for an additional 15 hr. However, it appeared that all of the monomer that was going to soak in did so within the first 4 hr.

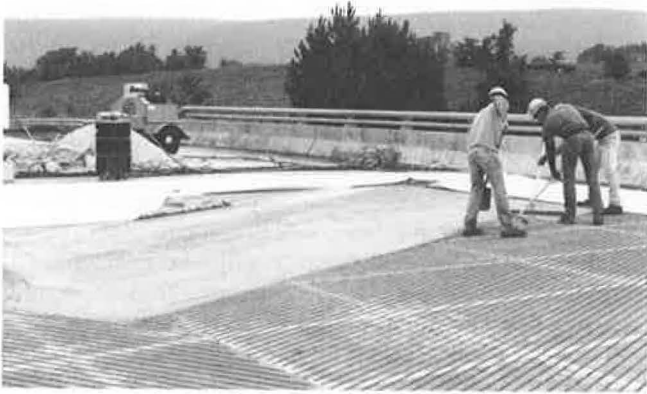
The grooves were backfilled with a latex-modified mortar with a 10-in. slump using rubber-edged squeegees to distribute and compact the mortar. The grooves were easily filled in 1 working day. The groove-filling operation is shown in Figure 7 and a close-up of the surface after 1 day is shown in Figure 8.

FIGURE 7 Groove-filling operation.

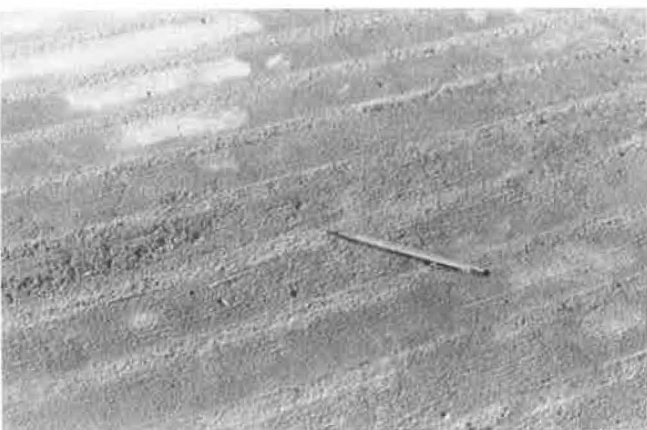
FIGURE 8 Deck surface 1 day after groove filling.
