# Load Test Report and Evaluation of a Precast Concrete Arch Culvert

TIMOTHY J. BEACH

A report on and an evaluation of a full-scale load test performed on a Con/Span culvert are presented in this paper. Because of its intended use, it was important that this three-sided box-arch shape's field performance be evaluated extensively, in addition to rigorous theoretical analysis. A load test procedure was devised to evaluate the structural integrity of this unit and to examine to what extent its field performance compared with its predicted behavior. The finite element program CANDE was used for the detailed analysis of the structure. CANDE is a program especially written for the evaluation of soil-structure interaction conditions, and is ideally suited to evaluate the effect of the conditions that exist in field testing. The evaluation revealed a good correlation between the performance of the culvert and the finite element analysis used. Perhaps more impressive was the culvert's capacity to sustain an extreme overload.

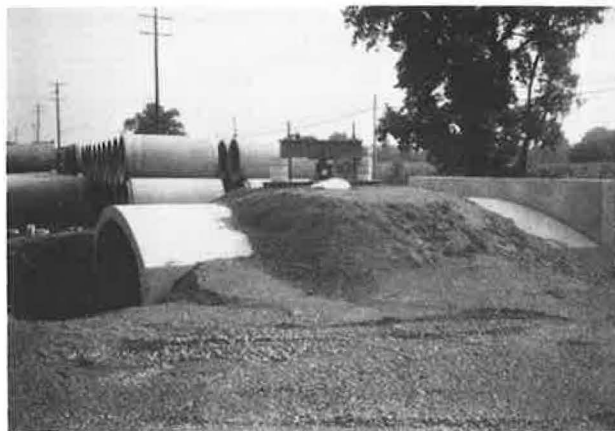
FIGURE 6 External view of test unit.

As shown in Figures 5 and 6, three culverts were installed end to end on a cast-in-place base slab. The width of the excavation between the culvert leg cast-in-place base slab. The width of the excavation between the culvert leg and the existing soil was a minimum of 3 ft. After the culverts were plumbed and leveled on shims, the space between the bottom of the culvert's legs and the footer was grouted with a cement grout. A 12-in.-wide strip of filter fabric was placed over the joints. The connection plates normally installed between the units were omitted to allow the test unit to function independently.

Wide cracks had opened up in the ground surface above both culvert legs indicating horizontal movement of the backfill. Mounding the fill over the culvert in place of complete burial reduced the capacity of the soil to resist the horizontal thrusts. This mounding is apparent in Figures 5 and 6.
