# Full-Scale Vehicle Crash Tests on Guardrail-Bridgerail Transition Designs with Special Post Spacing

EDWARD R. POST, RICHARD J. RUBY, DALYCE F. RONNAU, AND MILO D. CRESS

Full-scale 4,500-pound vehicle impact tests at 60 mph and 25 degrees were conducted on four new guardrail-bridgerail "transition" designs for use in Nebraska in which the first wood post from the bridge end was left out. The post was left out to represent a common field problem in which a concrete footing prevents installing the post. To compensate for the missing post, a stronger beam member and heavier wood posts were used in addition to a 4:1 tapered end on the concrete bridgerail. The tapered end was used to (1) reduce the unsupported span length and (2) provide a smooth guardrail deflection curve during vehicle redirection. All of the transition designs were identical except for the transition beam member. The designs consisted of two heavy 10 inch x 10 inch posts followed by four heavy 8 inch x 8 inch posts. The remaining posts were standard 6 inch x 8 inch posts. Over a guardrail length of 18 feet 9 inches, the posts were spaced 3 feet 1½ inches on centers, whereas, over the remaining length, a standard p

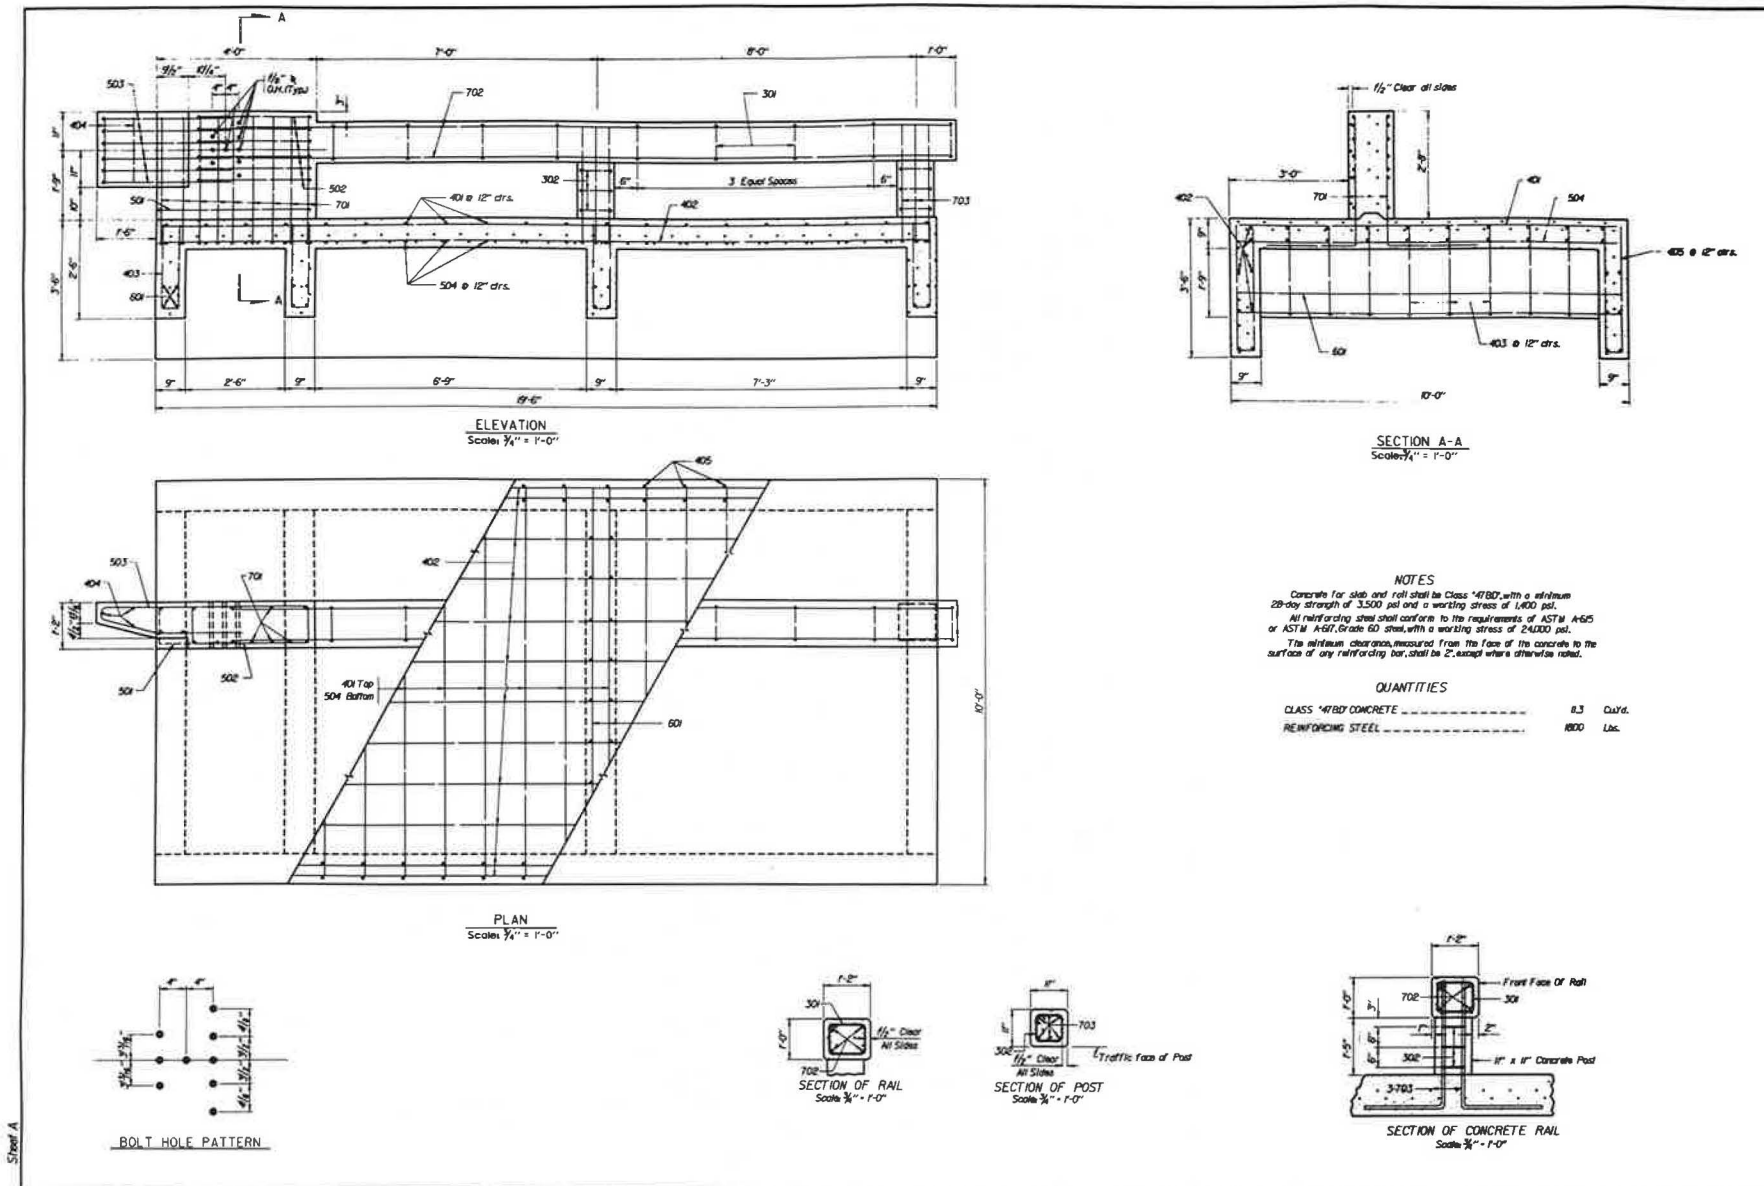
FIGURE 2 Design details of simulated bridge deck and railing.

The simulated concrete bridge railing and deck were designed by the NDR Bridge Division. Design details of the bridge railing and deck are shown in Figure 2, and photographs of the bridge railing are shown in Figure 4. The bridge railing and deck were constructed by a private contractor who was qualified to bid on NDR bridge contracts. The open bridge railing is a recent design currently in use in Nebraska to help keep the roadway clear of blowing and drifting snow and to facilitate snow removal operations. The cantilevered 4:1 tapered end section was a totally new design feature that was recommended by C. F. McDevitt of the FHWA as a method to (1) provide a smooth guardrail deflection curve in redirecting the test vehicle and (2) reduce the effective unsupported span length to help compensate for the first wood post (post No. 1) that was left out.

The concrete bridge railing and deck were designed to carry dynamic impact loads computed by the FHWA computer model, named BARRIER VII (2). The average 10 msec design impact loads were 120 kips lateral and 50 kips longitudinal. The lateral impact load is on the order of 12 times higher than the design load of 10 kips specified in the AASHTO Standard Specifications for Highway Bridges (3).

The concrete bridge railing, including the cantilevered 4:1 tapered end section, was 21.5 feet. The solid wall portion of the railing was 32 inches high, whereas the beam portion was 29 inches high. The vertical opening between the deck and railing was 17 inches. The two concrete posts were located approximately 8 feet on centers and were set back 2 inches from the traffic face of the railing to minimize vehicle snagging. The 1½-inch diameter bolt hole pattern in the railing wall was designed to accommodate the end shoes of both the Thrie Beam and the standard W-Beam guardrail sections. The ¾-inch recessed area adjacent to the 4:1 tapered end section was designed to accommodate the added width of the tubular thrie beam guardrail. On the other hand, a ¾-inch-wide wood filler block was cut to fill the recessed area and to extend along the length of the tapered end section to accommodate the other non-tubular guardrail designs. The railing was reinforced with No. 7 and smaller size rebar (Grade 60) to carry the vehicle impact loads.

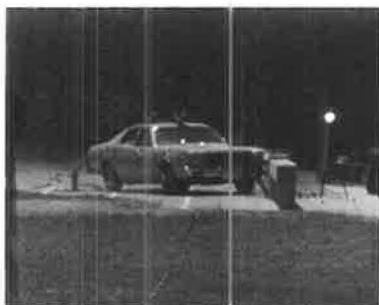
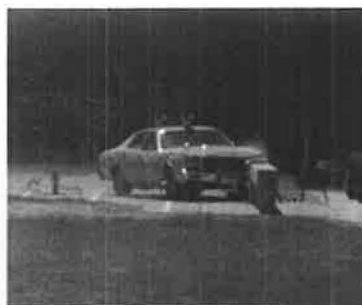
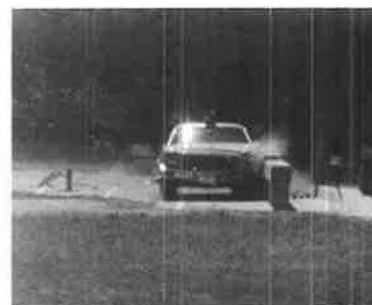
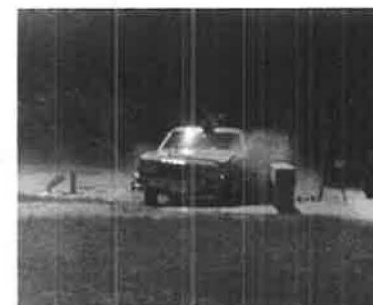
FIGURE 5 Summary of crash test No. 1.

A summary and sequential photographs of the full-scale vehicle crash test on the Tubular Thrie Beam Transition are presented in Figure 5. Due to technical problems with the tow

vehicle, the impact speed was 13 mph below the recommended target speed (60 mph) in NCHRP 230. The point of impact was between post Nos. 2 and 3. At 76 msec after impact, the vehicle reached its greatest depth of crushing into the guardrail. At 194 msec, the vehicle's "lateral" velocity component was zero as the vehicle became parallel to an extended center line of the traffic barrier. Somewhere between 76 and 194 msec, an occupant would have moved laterally 12 inches and struck the side of the vehicle.

The vehicle impact speed was 47 mph and the exit speed was 38 mph. The change-in-speed of 9 mph was well below the 15 mph limit recommended in NCHRP 230 (4).

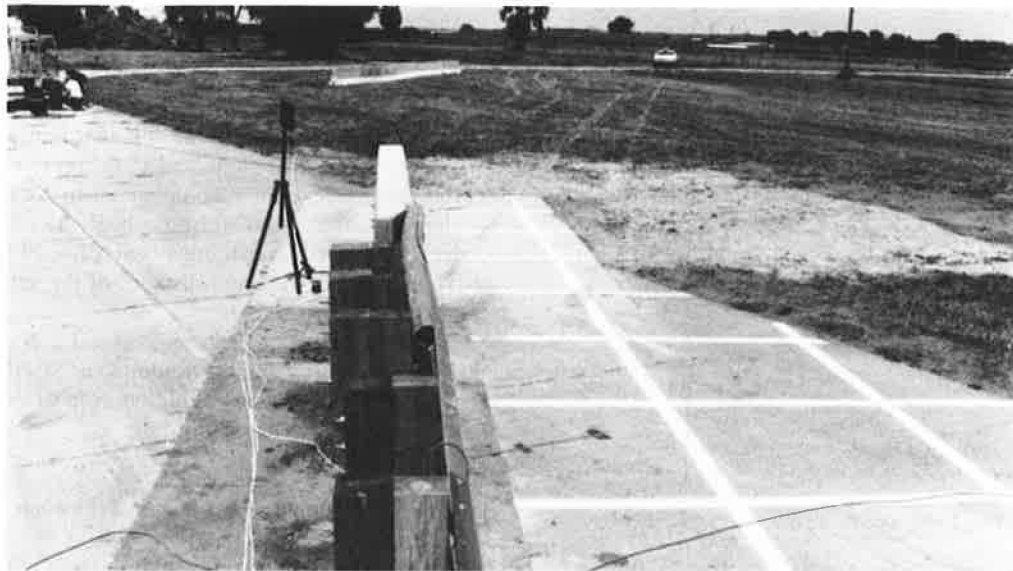
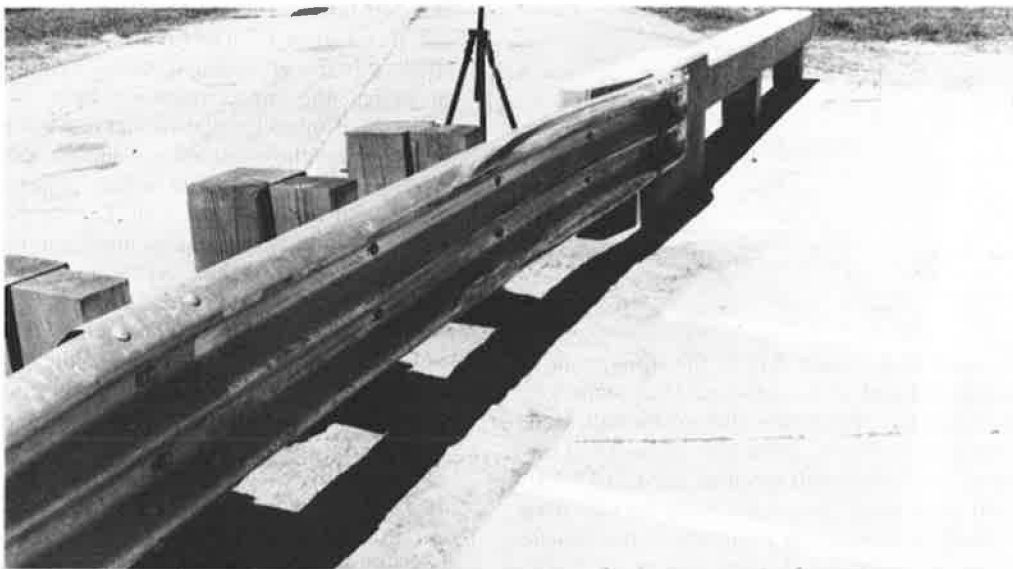
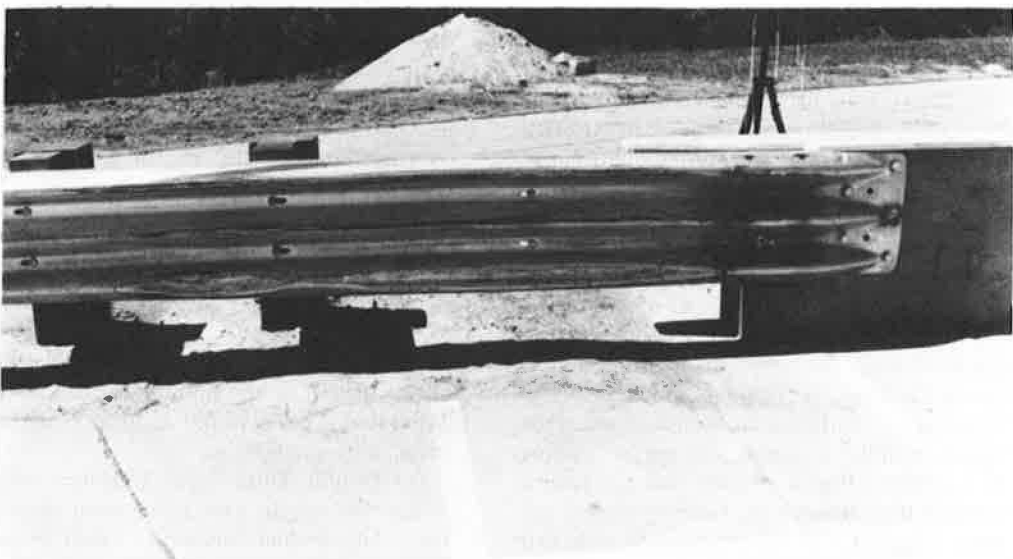
**FIGURE 6** Photographs of test No. 1 guardrail damage.

Photographs of the guardrail damage are shown in Figure 6. The Tubular Thrie Beam was fabricated by a local steel manufacturer by shop welding two thrie beams back-to-back (see Figure 1c). The end shoe was welded on the outside of the tubular thrie beam. As evident, the damage to the guardrail was very minor with a maximum guardrail permanent set of only 2½ inches. Due to a technical problem with the overhead camera, the maximum guardrail dynamic deflection was not measured. Assuming a typical impact factor of 1.5, an estimate of the maximum dynamic deflection would be 4 inches.

As can be seen in Figure 6, the vehicle tire marks were relatively straight after exit from the barrier. The vehicle exit angle was 15 deg, and the vehicle travelled 270 feet before it came to a stop without braking. The tire scuff marks were caused by the deformed inward alignment of the two front wheels. The vehicle rebound distance was 72 feet.

alent" impact conditions presented in table 1 by equating lateral kinetic energy. At an impact angle of about 20 degrees, the same guardrail damage shown in Figure 6 would have occurred under an impact speed of 60 mph. The equation to determine equivalent speeds is presented in Table 1.

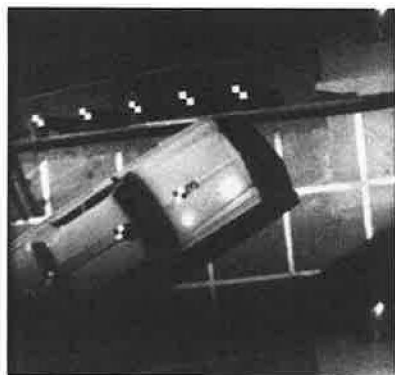
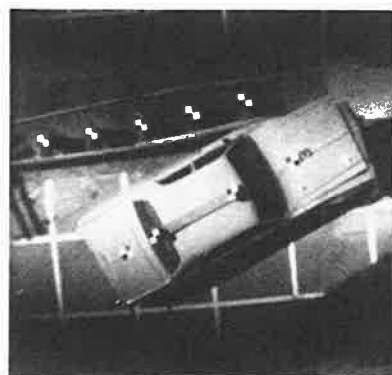
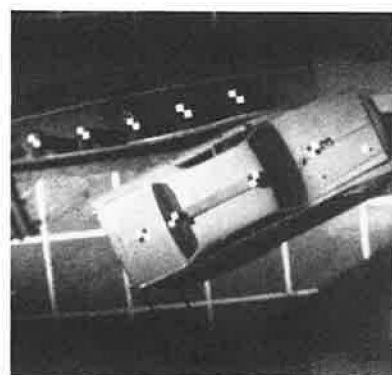
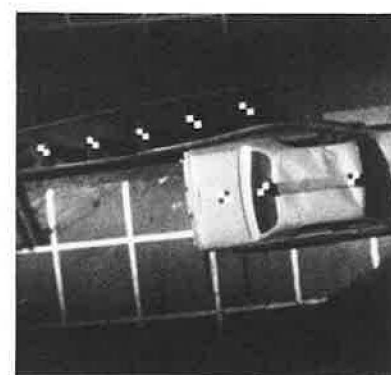
FIGURE 7 Summary of crash test No. 2.

A summary and sequential photographs of the full-scale vehicle crash test in the Single Thrie Beam Transition is presented in Figure 7. The point of impact was between posts Nos. 2 and 3. The vehicle impact speed was 60 mph, and the exit speed was 39 mph. During the primary (vehicle front-end) impact stage at 89 msec, the maximum guardrail deflection was 13 inches. At 108 msec, the lateral occupant displacement of 12 inches occurred nearly simultaneously to the time in which the front door sprung open under a dummy side impact loading force of 10 g. It was interesting to observe that the largest guardrail deflection of 14 inches occurred during the secondary (vehicle rear-end) impact stage at 231 msec. Vehicle exit from the barrier occurred at about 280 msec.

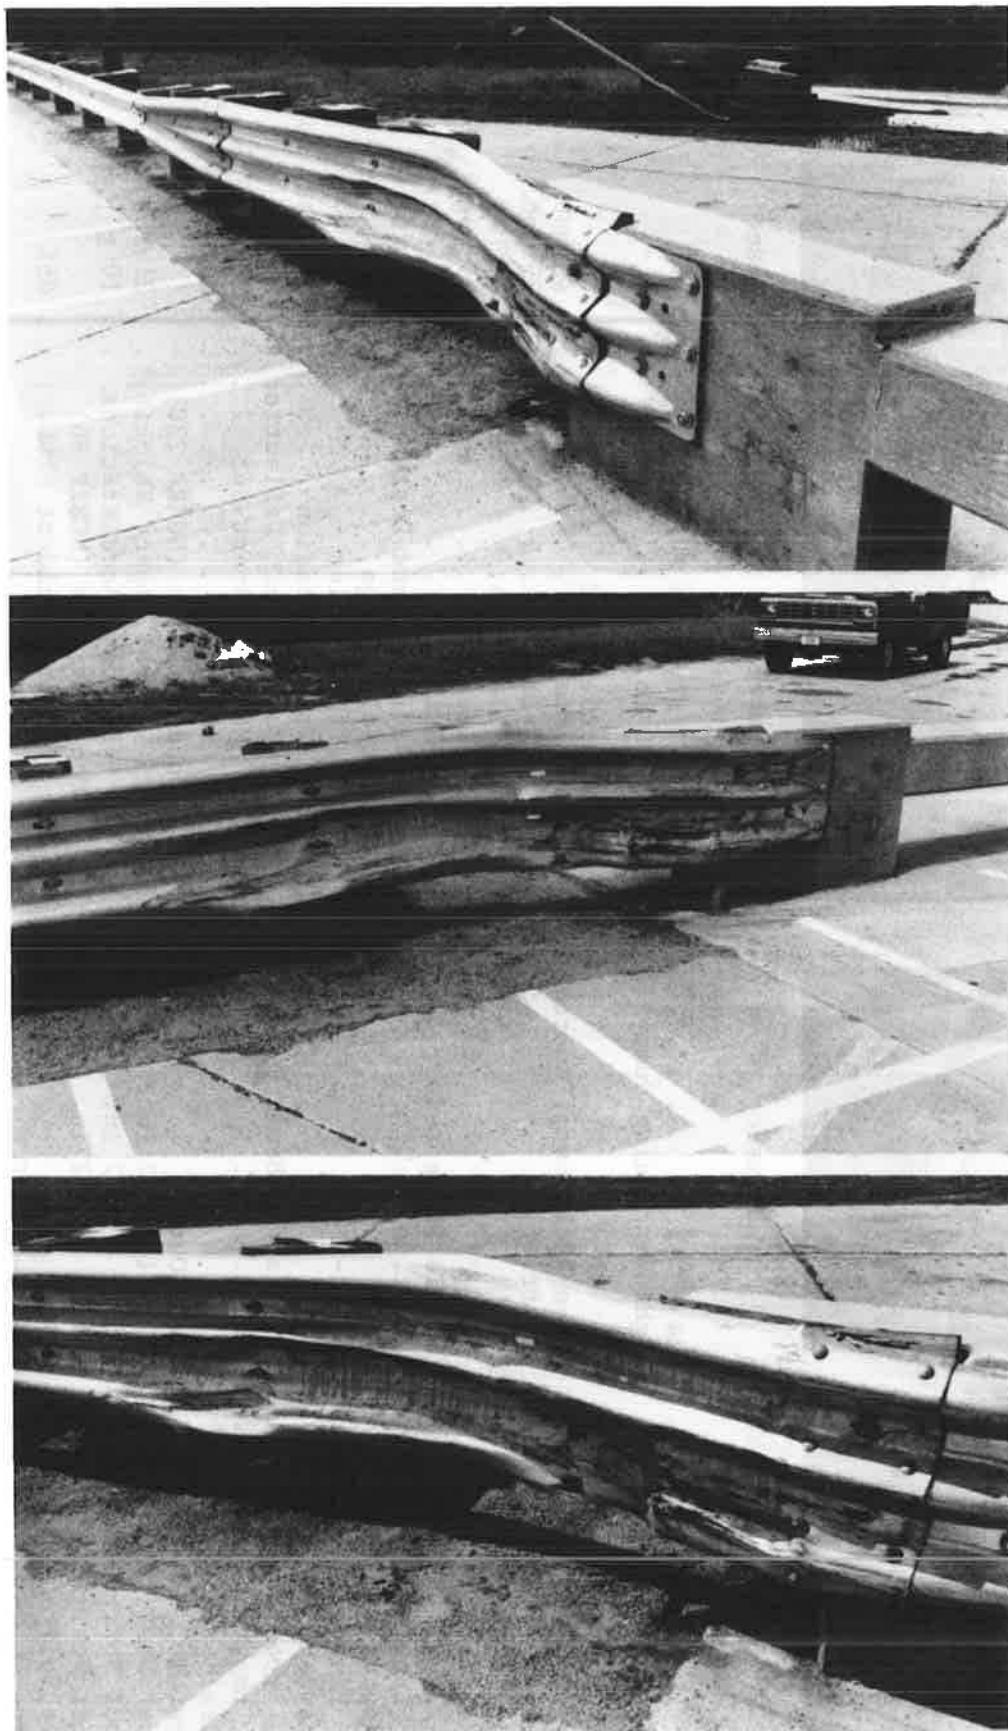
FIGURE 8 Photographs of test No. 2 guardrail damage.

Photographs of the guardrail damage are shown in Figure 8. The area where the upstream end anchor was bolted to the W-Beam guardrail buckled inward under the tensile loading of about 48 kips as computed by BARRIER VII. As clearly visible in the photographs, a moderate amount of vehi-

cle snagging occurred in the lower half of the thrie beam in the area of the tapered end of the concrete bridgerail. The vehicle change-in-speed of 21 mph was also a clear indication of a moderate amount of snagging as the change-in-speed was greatly in excess of the 15 mph limit specified in NCHRP 230.

In test No. 2 on the Single Thrie Beam transition, a moderate amount of vehicle snagging occurred in the lower half of the thrie beam adjacent to the tapered end of the concrete bridgerail. As a result, the test was considered to be unsatisfactory because the vehicle change-in-speed of 21 mph was significantly higher than the limit of 15 mph specified in NCHRP 230. Due to vehicle snagging on the Single Thrie Beam transition, NDR decided to run the next test on a Double Thrie Beam transition in favor of the much stronger and costly Tubular Thrie Beam transition that was used earlier in the study.

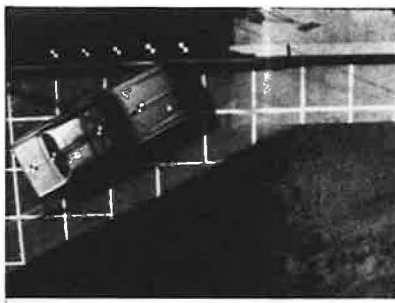
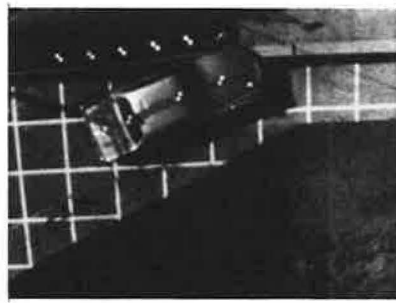
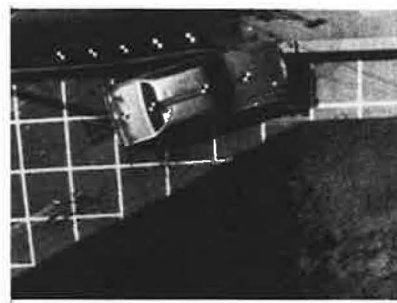
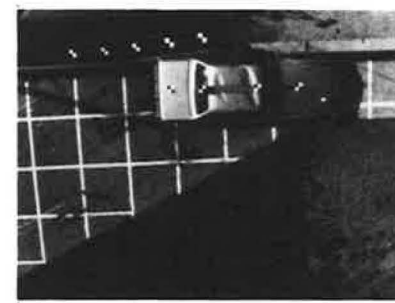
FIGURE 9 Summary of crash test No. 3.

A summary and sequential photographs of the full-scale vehicle crash test on the Double Thrie Beam Transition is presented in Figure 9. The point of impact was between posts Nos. 2 and 3. The vehicle impact speed was 61 mph, and the exit speed was 47 mph. During the primary (vehicle front-end) impact stage at 86 msec, the maximum guardrail deflection was 9 inches. At 114 msec, the lateral occupant displacement of 12 inches occurred nearly simultaneously to when the front door sprung open under a dummy side impact loading force of 10 g. It was interesting to observe that the largest guardrail deflection of 10 inches occurred during the secondary (vehicle rear-end) impact stage at 194 msec. Vehicle exit from the barrier occurred at about 250 msec.

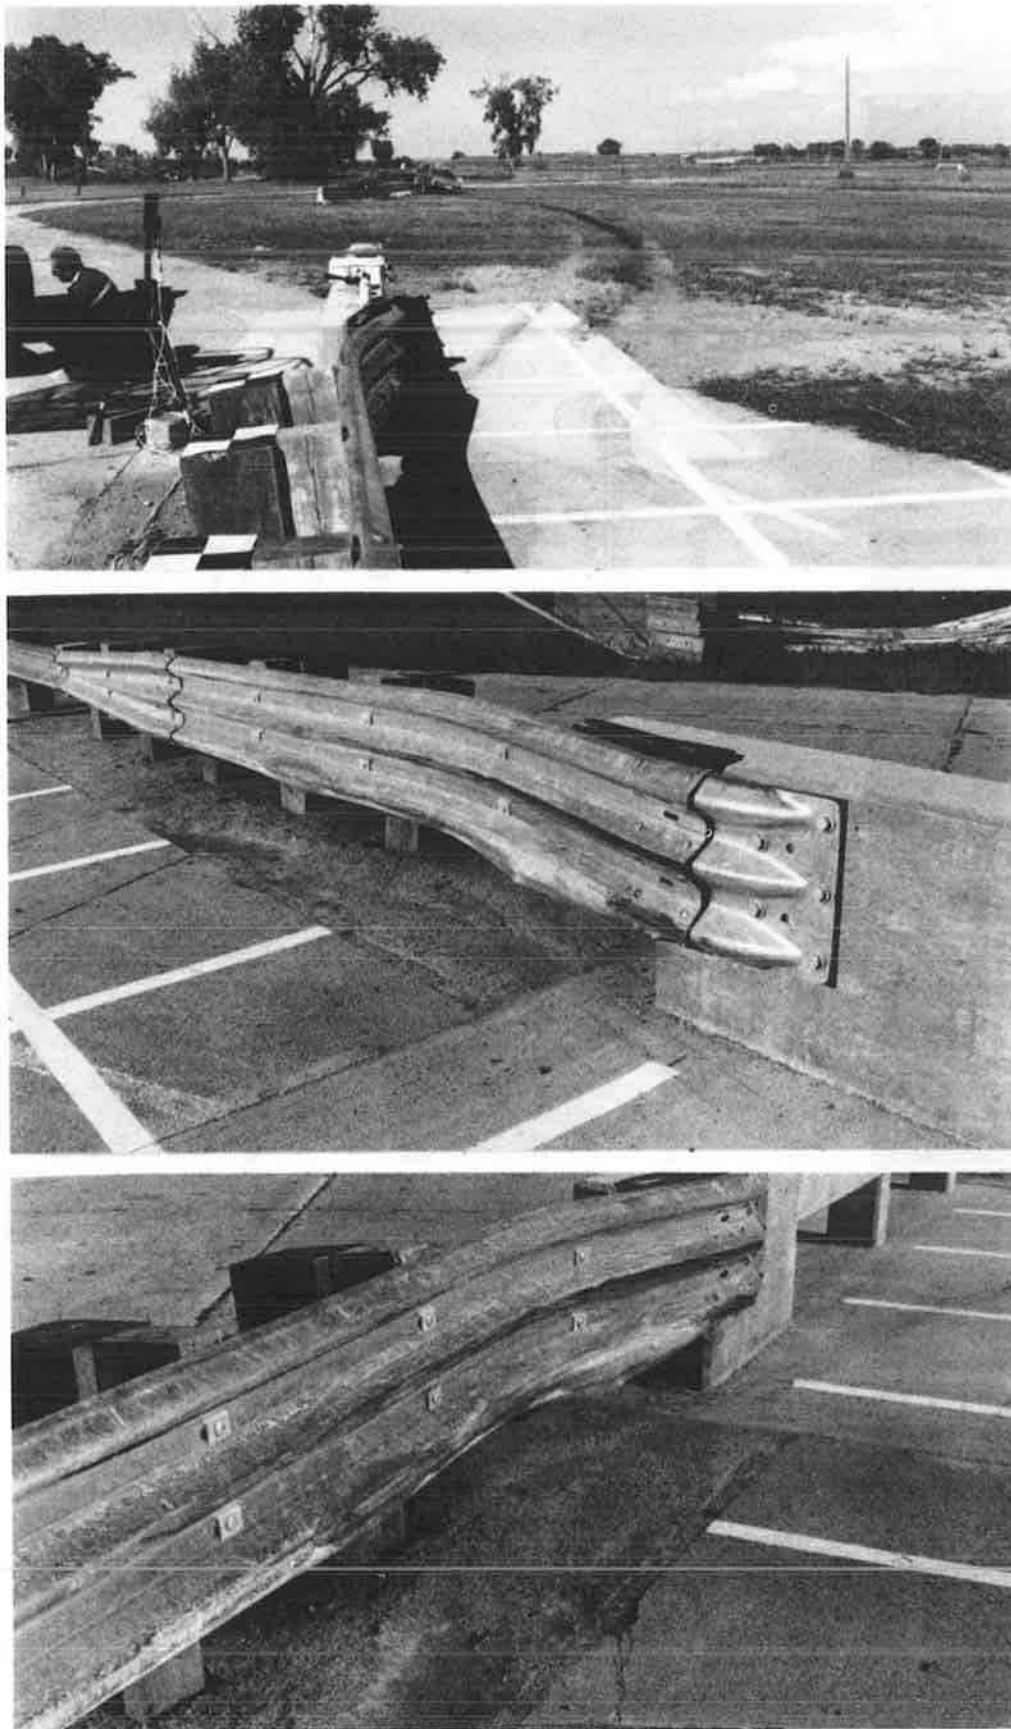
FIGURE 10 Photographs of test No. 3 guardrail damage.

10. The damaged guardrail shows no indication of vehicle snagging. The vehicle change-in-speed of 14 mph was also supportive of the fact that no snagging occurred as the change-in-speed was below the 15 mph limit specified in NCHRP 230. Overall, the guardrail "smoothly" redirected the vehicle. The maximum permanent set in the guardrail was 7½ inches.

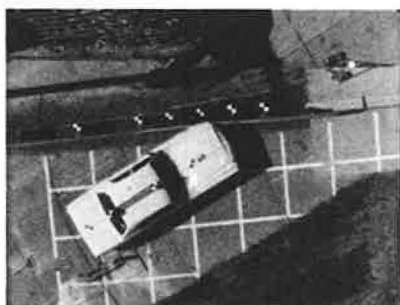
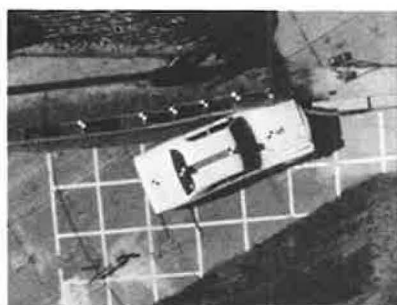
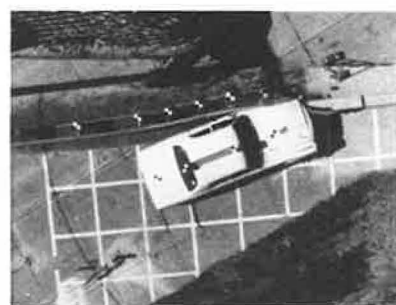
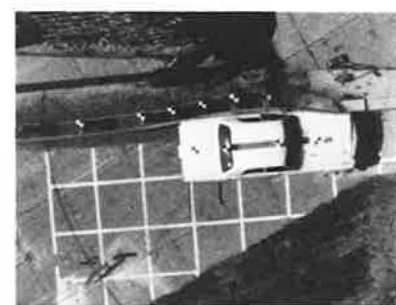
FIGURE 11 Summary of crash test No. 4.

A summary and sequential photographs of the full-scale vehicle crash test on the Double Thrie Beam Transition is presented in Figure 11. The point of impact was at post No. 4; whereas, in the preceding test (No. 3) on the identical guardrail design, the impact point was between posts Nos. 2 and 3. The decision to run the second test was based on the need to determine the most critical impact location in terms of guardrail performance. The vehicle impact speed was 61 mph, and the exit speed was 48 mph. During the primary (vehicle front-end) impact stage at 90 msec, the maximum guardrail deflection was 16 inches. At 99 msec, the lateral occupant displacement of 12 inches occurred nearly simultaneously to when the front door sprung open under a dummy side impact loading force of 8 g. It was interesting to observe that the largest guardrail deflection of 17 inches occurred during the secondary (vehicle rear-end) impact stage at 201 msec. Vehicle exit from the barrier occurred at about 283 msec.

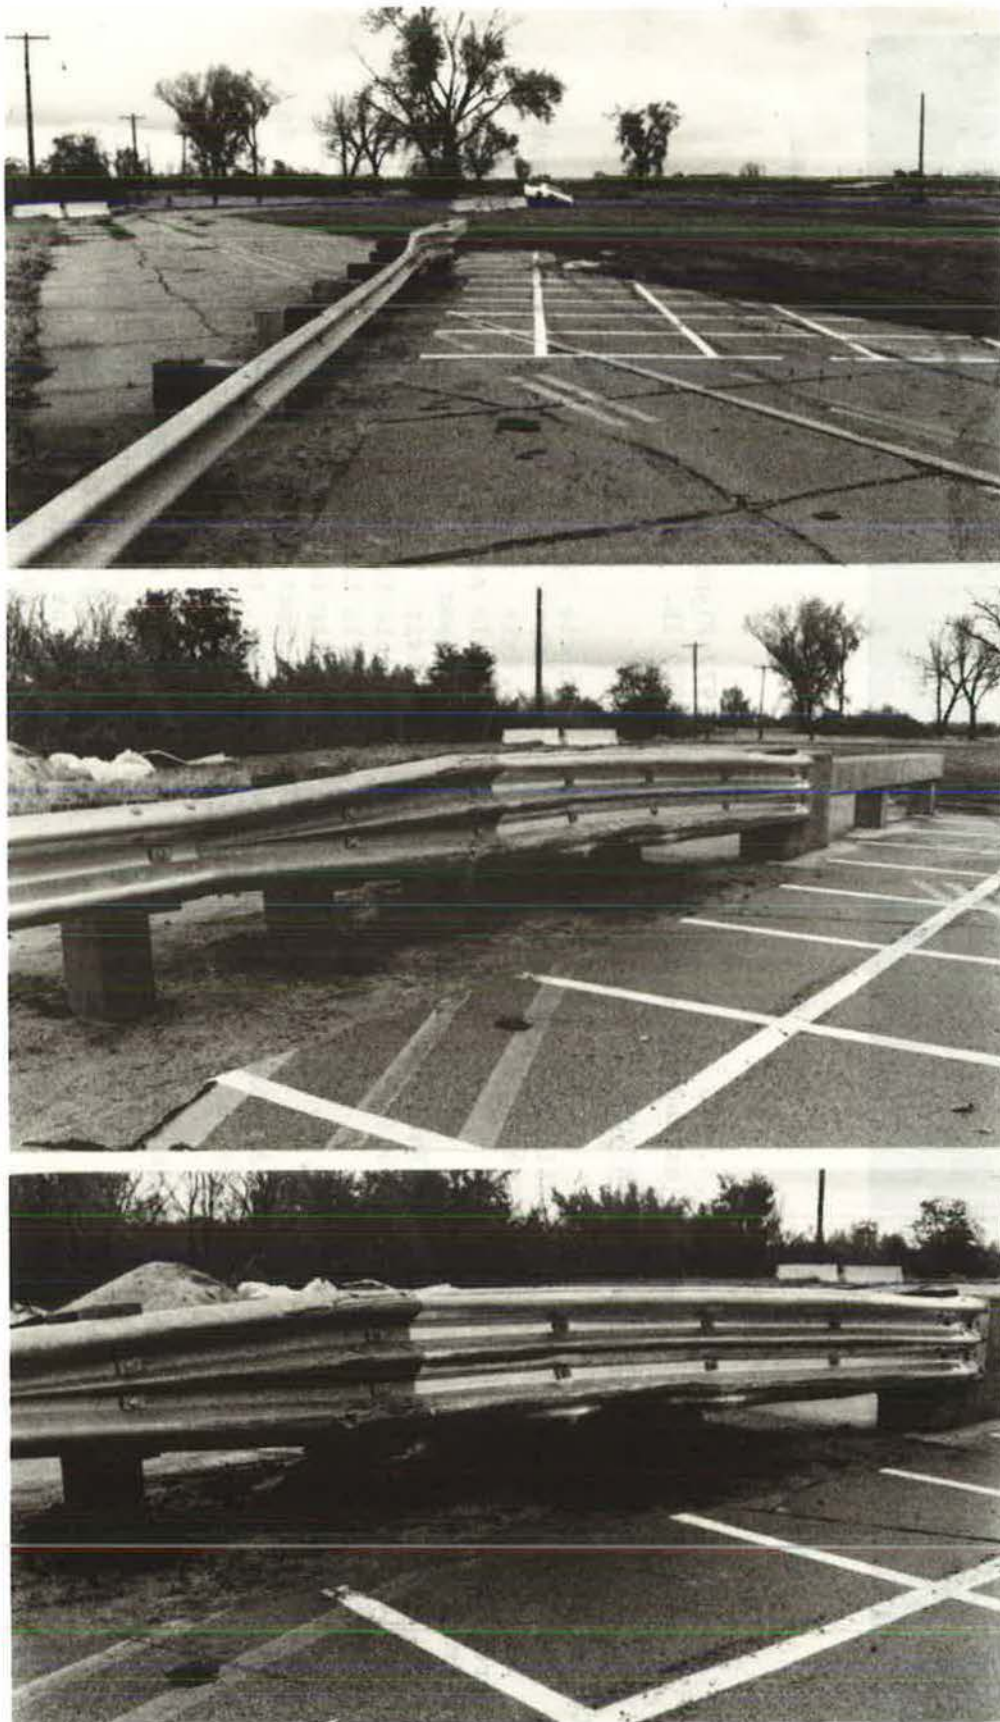
**FIGURE 12** Photographs of test No. 4 guardrail damage.

Photographs of the guardrail damage are shown in Figure 12. The soil was saturated from a heavy, two-day storm preceding the test. NDR decided to test under a saturated soil condition as this condition would be representative of the lowest possible soil shearing strength. The damaged guardrail shows no indication of vehicle snagging. The vehicle change-in-speed of 13 mph also supported the fact that no snagging occurred as the change-in-speed was below the 15 mph limit specified in NCHRP 230. Overall, the guardrail "smoothly" redirected the vehicle. The maximum permanent set in the guardrail was 11 inches.

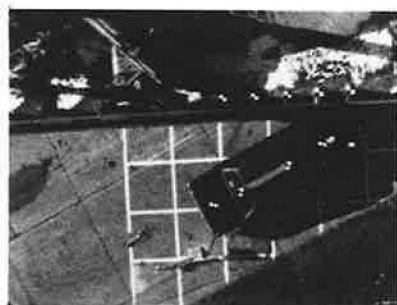
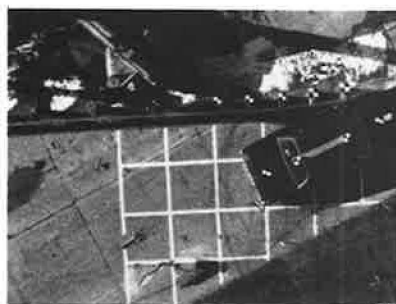
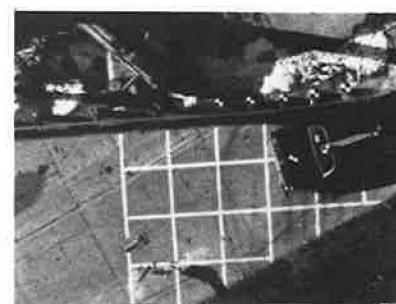
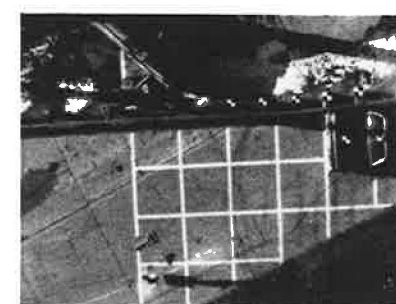
FIGURE 13 Summary of crash test No. 5.

vehicle crash test on the Double W-Beam Transition is presented in Figure 13. The point of impact was between posts Nos. 2 and 3. The vehicle impact speed was 62 mph, and the exit speed was 39 mph. During the primary (vehicle front-end) impact stage at 75 msec, the maximum guardrail deflection was 9 inches. At 113 msec, the lateral displacement of an occupant was 12 inches, however, there was no sign of the front door being sprung open under the side impact loading of the dummy as had occurred in three previous tests. The largest guardrail deflection of 10 inches occurred during the secondary (vehicle rear-end) impact stage at 212 msec. Vehicle exit from the barrier occurred at 262 msec.

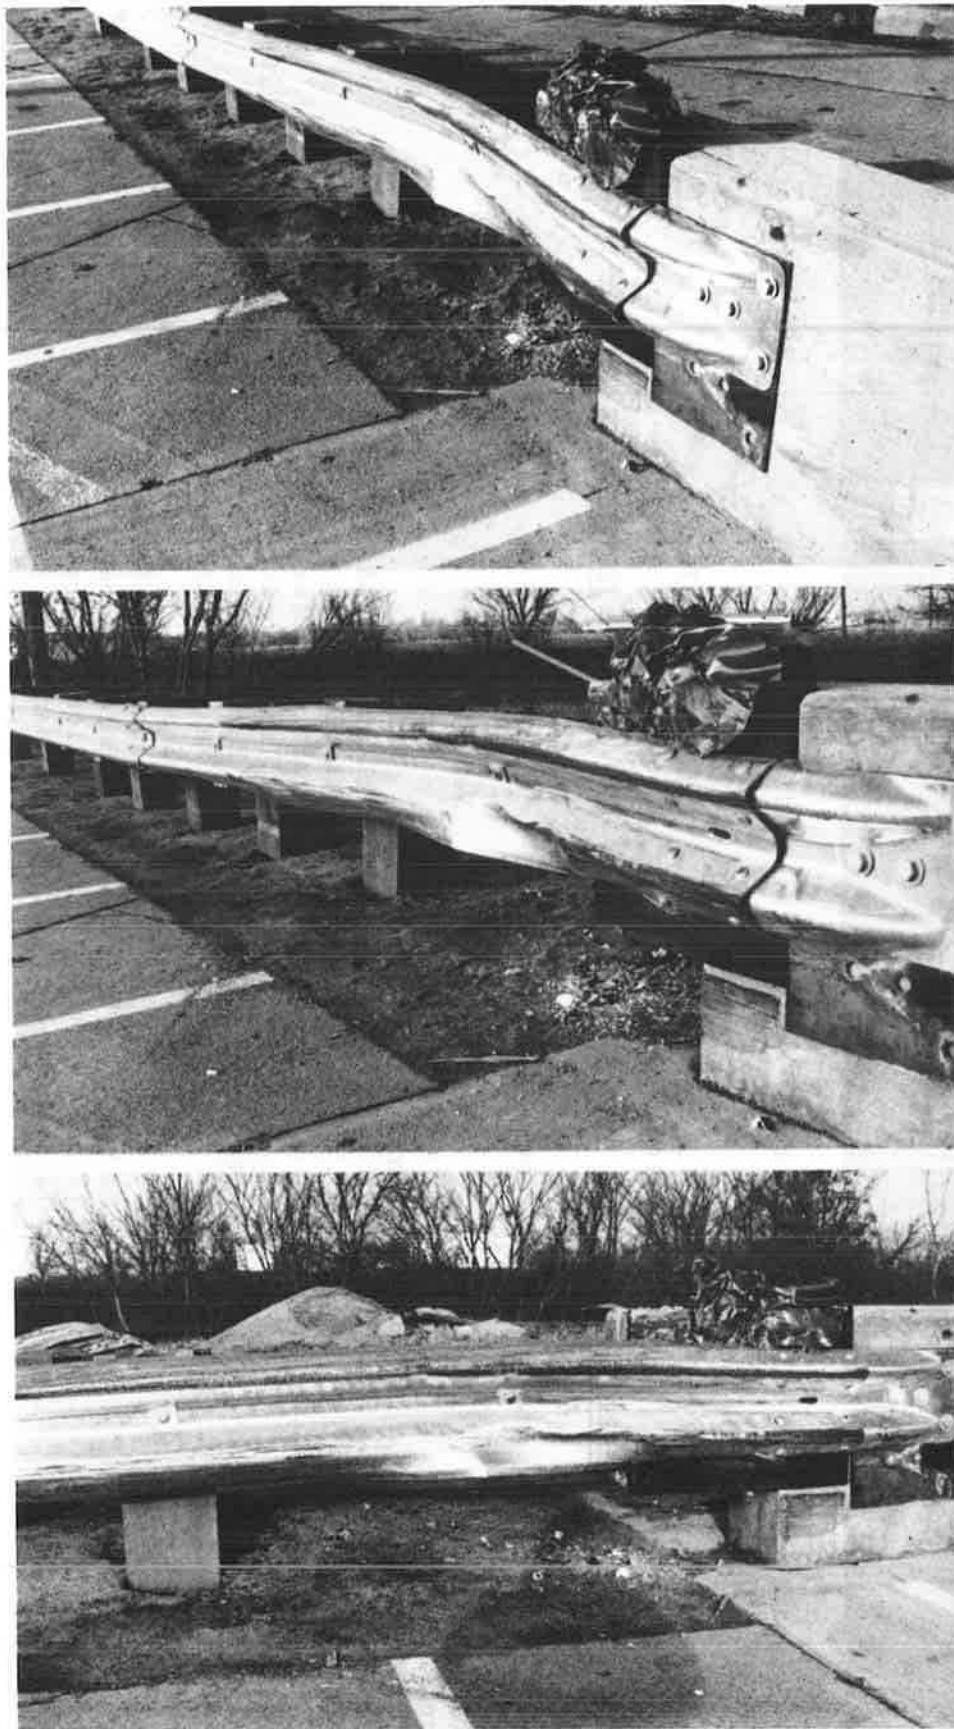
**FIGURE 14** Photographs of test No. 5 guardrail damage.

Photographs of the guardrail damage are shown in Figure 14. The soil was frozen 6 to 8 inches deep. The effect of the frozen soil was readily apparent by comparing the permanent set deflections in test No. 3 with this test. Aside from the fact that the strength of the Double Thrie Beam in test No. 3 was much stronger than the strength of the Double W-Beam, the permanent set deflections of the Double W-Beam were much less. The damaged guardrail in Figure 13 shows severe vehicle snagging. The vehicle change-in-speed of 23 mph also supported the fact that severe snagging occurred as the change-in-speed greatly exceeded the 15 mph limit specified in NCHRP 230. Snagging resulted when the vehicle frame and wheel assembly got under the guardrail and impacted the tapered end of the concrete bridgerail. As shown in Figure 14, sheet metal was torn from the vehicle and wedged between the guardrail and the wood filler block in the recessed area of the bridgerail tapered-end.

In test No. 5 on the Double W-Beam transition, an amount of vehicle snagging occurred under the guardrail on the tapered end of the concrete bridgerail. As a result, the test was considered to be unsatisfactory because the vehicle change-in-speed of 23 mph greatly exceeded the limit of 15 mph specified in NCHRP 230. In addition, the integrity of the passenger compartment area in terms of occupant risk (Item *E*) was considered to be marginal as the engine firewall was pushed backward on the side of the driver. The last item of concern was the soil that was frozen to 6 to 8 inches deep. It is predicted that if the soil had not been frozen, the vehicle would have penetrated deeper under the flexible guardrail, and as a result, the vehicle would most likely have abruptly stopped and spun-out on the tapered end of the concrete bridgerail.

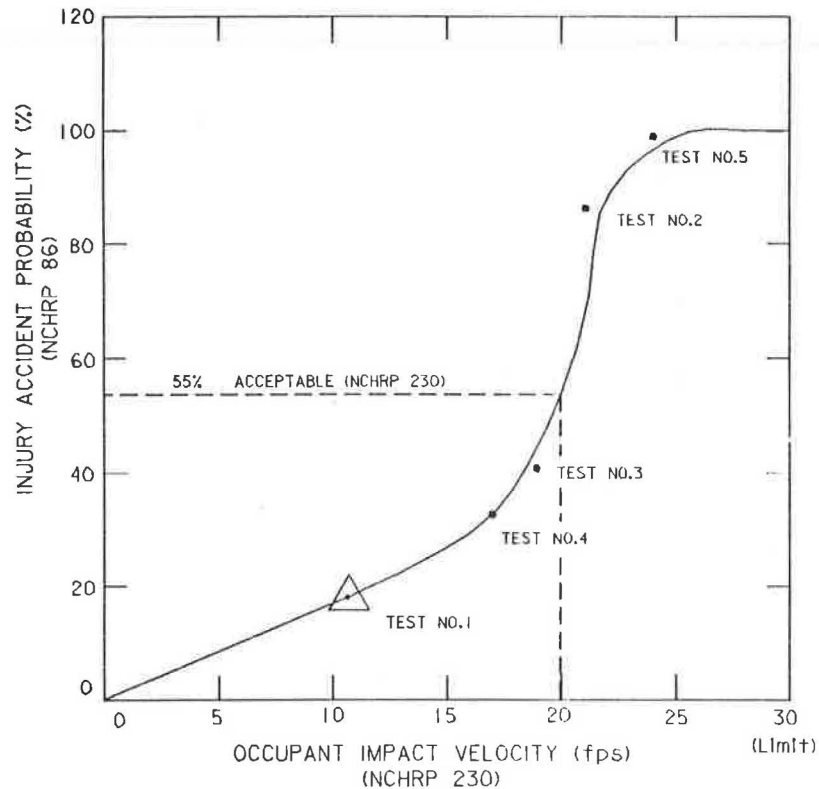
FIGURE 15 Relationship between occupant velocity and injury accident probability.

NCHRP 230 does not specify any evaluation guidelines for conducting tests on a guardrail transition in regard to the "Impact Velocity of a Hypothetical Front Seat Passenger Against the Vehicle Interior." However, data on occupant impact velocity were presented in this study because it was felt that the data provided further insight into the evaluation of the transition designs tested. To supplement the NCHRP 230 data on occupant impact velocity, data on "Injury Accident Probability" contained in NCHRP 86 (6) were also presented in this study. The two sets of data on the tests are presented in Table 2, and a graphic relationship between the two sets of data is presented in Figure 15. An occupant impact velocity of 20 feet per second (fps) is recommended in NCHRP 230 as an "acceptable" design value, whereas, a value of 30 fps is a recommended design "limit." The effects of vehicle snagging are very evident in Figure 15.
