# Improved Preventive Maintenance: Sealing Cracks in Flexible Pavements in Cold Regions

G. J. CHONG AND W. A. PHANG

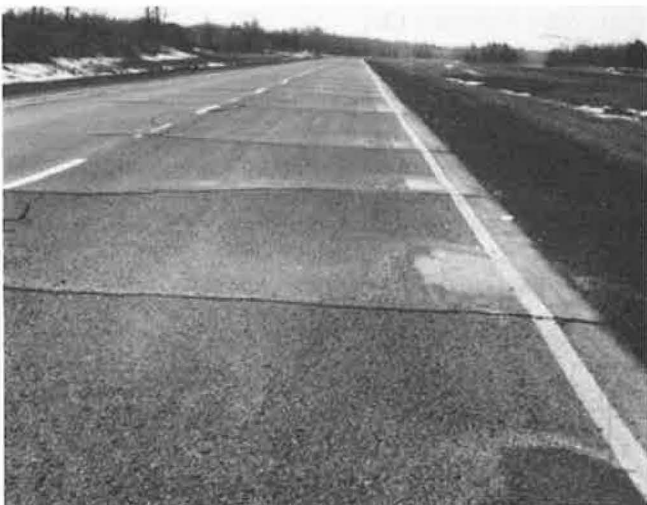
**FIGURE 2** Lipping of transverse cracks in winter.

Cracking of asphalt pavement in cold regions has always been a problem because it can directly affect pavement rideability and, therefore, service life. A prime example is the transverse cracks that, if left untreated, will develop permanent deformation in the form of lipping or cupping at the crack. Lipping is the upheaval of the pavement profile at the crack (Figure 2), and cupping is a depression of the pavement profile at the crack (Figure 3). These deformations are irreversible, and they are a major factor in pavement surface roughness.

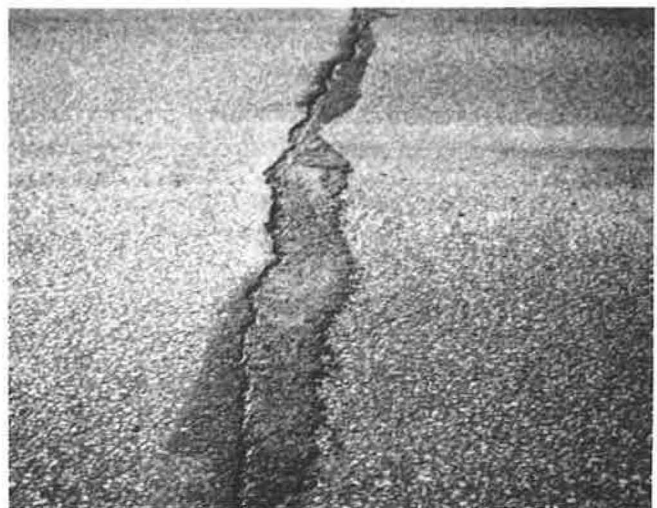
**FIGURE 4** Spray patch of crack with emulsion and sand aggregate—crack remains unsealed.

less than acceptable, however, not only because of the treatment itself but because it is inappropriate for the distress (Figure 4). In many instances, the presumed cure is worse than the disease; the treatment can, and generally will, create additional roughness on an otherwise acceptable pavement riding surface, thus lowering its serviceability (Figure 5).

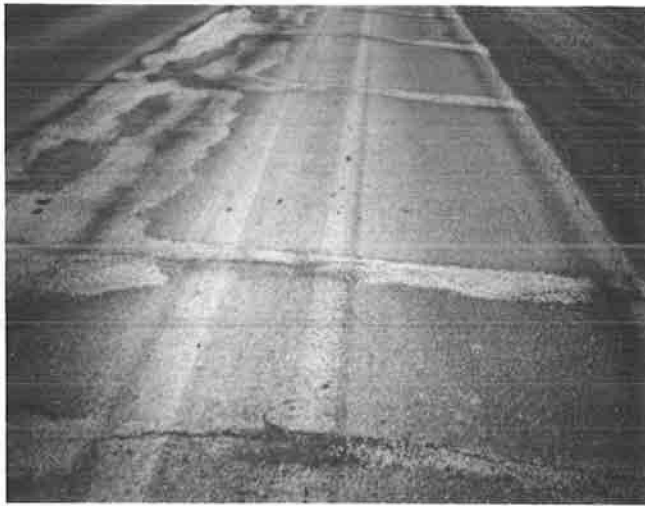
**FIGURE 5** Spray patch of cracks with emulsion and sand aggregate—created small ridges at cracks that are detrimental to rideability.

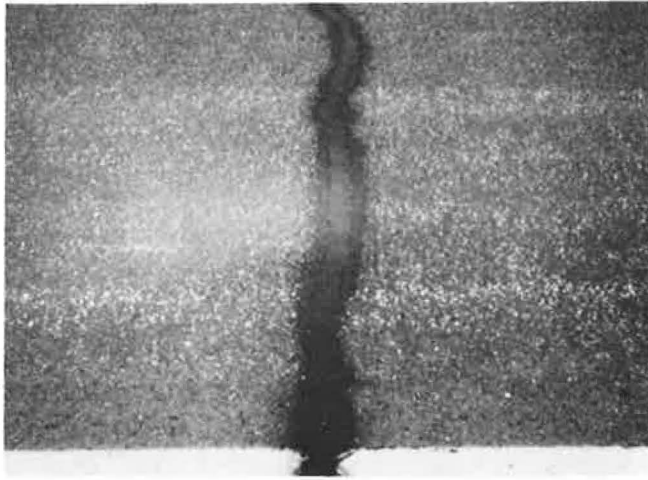
**FIGURE 9** Recommended sealant materials overfilled sufficiently to cover edges of routed crack.

rials, and snowplow shearing of excess materials (2, 6, 7). The ministry recommends that whether 19 × 19 mm or the optional 40 × 10 mm is used, sealant materials should be overfilled sufficiently to cover both edges of the routed crack, leaving the sealing materials standing slightly proud of the pavement surface (Figure 9). This additional material will provide sufficient coverage to compensate for shrinkage during the cooling process (6, 7).

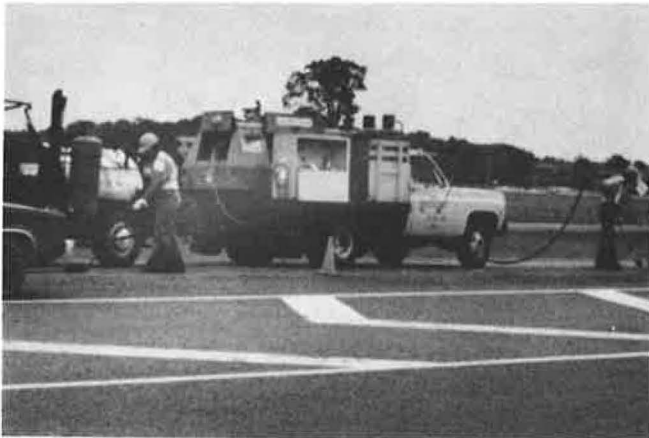
**FIGURE 10** Standard ministry equipment train for in-house rout-and-seal operations.

The most efficient and productive operation arrangement was put together by the Ottawa District Maintenance staff of the ministry. Their method is now the standard for all in-house operations (Figure 9). The train of manpower and equipment is set up as follows. Two Crafcro or Marathon routers with the operator operating ahead of the equipment train. A hot-compressed-air lance, connected to a tow-vehicle and supplied by the tow-vehicle with propane and compressed air, operates approximately 5 m (15 ft) for drying and clean-

ing the rerouted crack of dust and debris. A double-jacket oil kettle for sealant materials is towed behind the tow-vehicle; the heat is supplied by propane from the vehicle. Sealant is dispersed into routed crack by a pump-wand that maintains the sealant at a constant pouring temperature. The distance is approximately 5 m (15 ft) from the tow-vehicle. That is, the maximum distance between the cleaning and sealing phases is only about 20 to 25 m (60–80 ft), thus ensuring that no dust or debris will enter the routed crack prior to the sealant being poured.

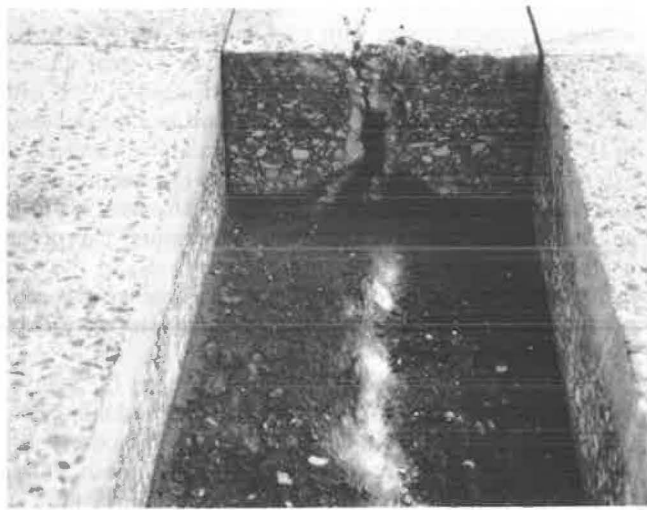
**FIGURE 12** Unsealed transverse crack deterioration continues upward unchecked on Highway 17, control section.

A summary of the findings and observations (1) follows. When transverse crack maintenance was deferred in the control section, cupping deformation occurred and progressed to the "moderate" category six service years after rehabilitation (Figure 10). Deterioration of the transverse crack continues upward from the original pavement and into the base course of the resurfacing layers after six service years (Figure 11). Also, transverse cracks began to develop multiple cracks and spalling after six service years (Figure 12).

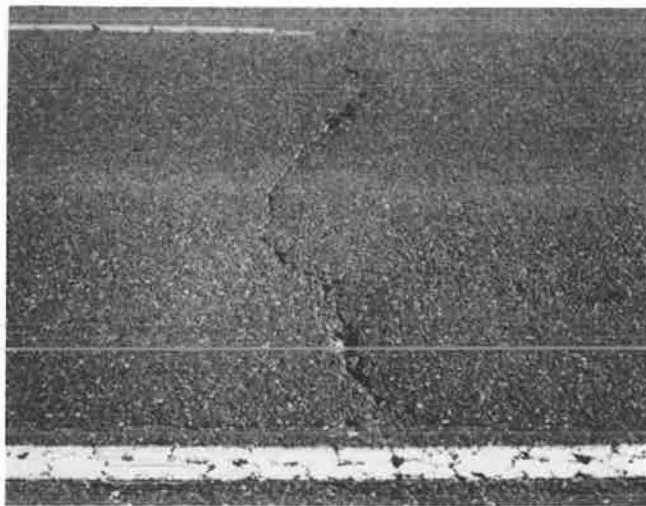
**FIGURE 13** Unsealed transverse crack develops multiple cracking and spalling on Highway 17, control section.
