# Correlation Between Corrosion of Reinforcing Steel and Voids and Cracks in Concrete Structures

B. BORGARD, C. WARREN, S. SOMAYAJI, AND R. HEIDERSBACH

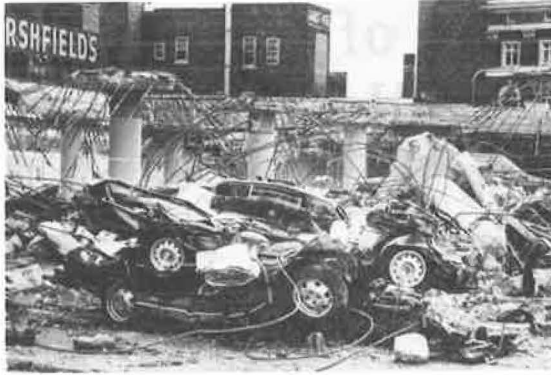
FIGURE 2 Collapse of a Minnesota parking garage due to corrosion of reinforcing steel (15).

Problems associated with concrete and masonry buildings are starting to appear in increasing numbers. The collapse of the Berlin Congress Hall (Figure 1) (13) and of a parking garage in Minnesota (Figure 2) are but two of an increasing number of instances where moisture ingress has led to the loss of structural components, roofs, or, more commonly, building facades (14,15). Much of the information associated with these problems has not been released to the general public, because lawsuits are often associated with these failures (15). To cite one example, a reported problem from the 1960s was not published until 1977 because of ongoing litigation (8).

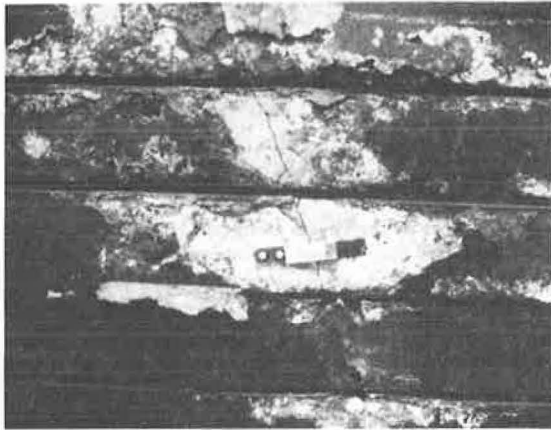
FIGURE 3 Corrosion of permanent-form decking underneath the concrete floor slab of a parking garage. Note the strain gage used to measure deflections across the crack (15).

The corrosion of reinforcing steel in parking garages is similar in many respects to the more commonly reported problems of corrosion in highway bridges. Figure 3 shows a permanent-form concrete floor slab in a parking garage in New England. The strain gage in the center of the photograph is used to measure deflection across the cracked concrete (15). The cracked concrete allowed the permanent steel forms to get wet and to corrode. Similar corrosion occurred under the cavity, formed by plastic debris, shown in Figure 4, which shows a parking garage in New York State. Corrosion in parking garages with construction of this type has been involved in several widely publicized lawsuits (8,15).

The form-in-place construction shown in Figures 3 and 4 can produce accelerated corrosion in flexible parking-garage floor slabs. The impermeable metal forms allow salty water into the slab for extended periods of time (8). The same construction technique could slow corrosion on stiff highway bridge

The corroded parking garages shown in Figures 3 and 4 were the result of a lack of protective cover on the steel. This lack of cover can be caused by structural cracking (Figure 3) or poor workmanship (Figure 4).

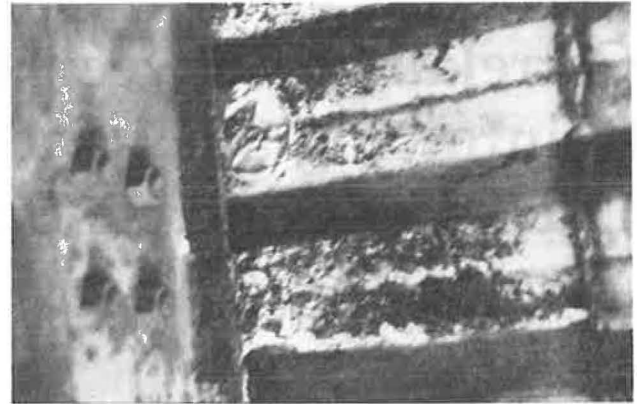
FIGURE 4 Corroded permanent-form decking on a parking garage. The cup lid made imprints in the concrete and left a void in which moisture could collect.

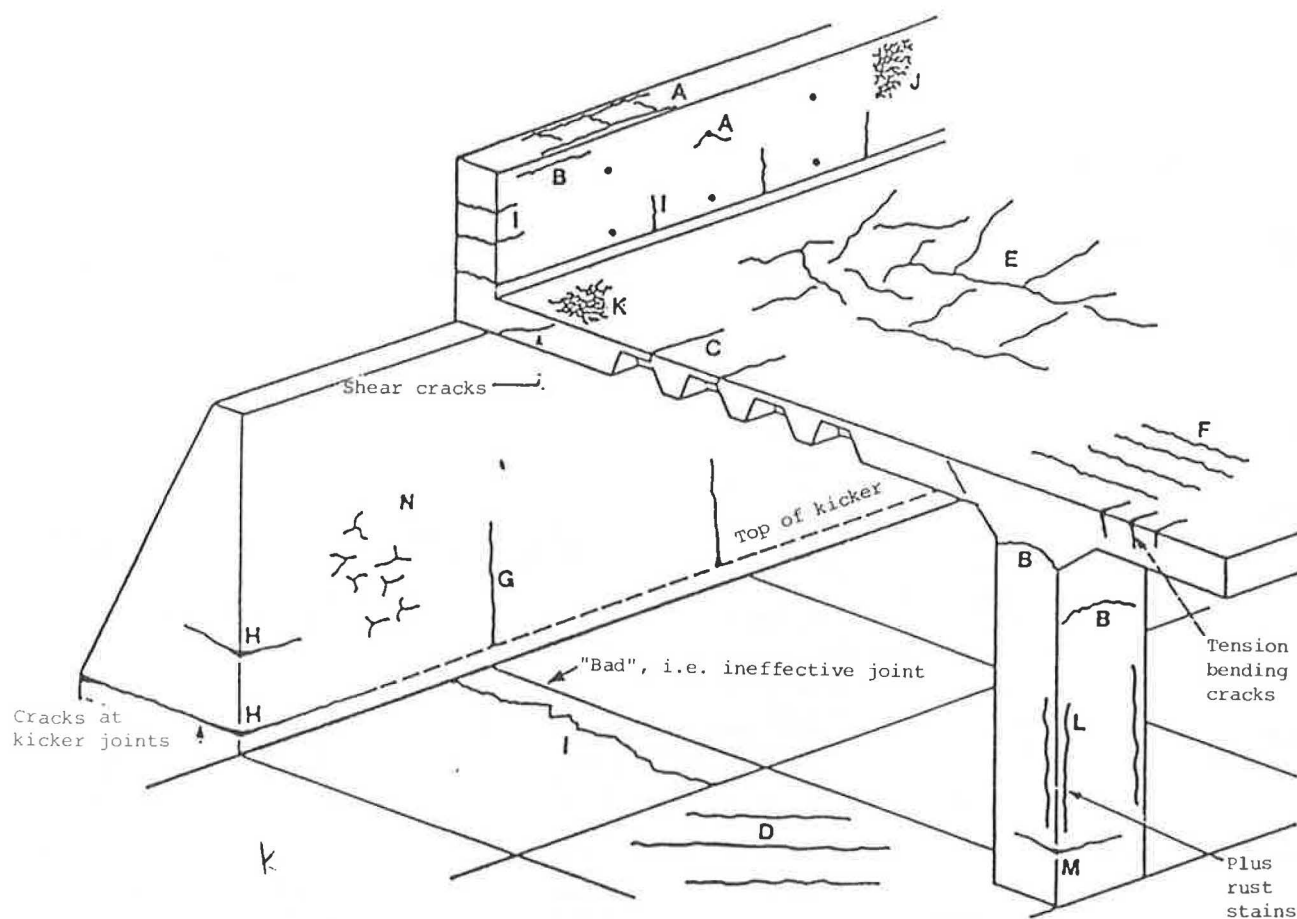
FIGURE 5 Nonstructural cracking patterns on reinforced concrete bridge (18).

Crack patterns in reinforced concrete structures can be structural, related to loading patterns on the structure, or nonstructural. Figure 5 and Table 1 explain nonstructural cracks caused primarily by concrete placement and curing practices (18). These cracks can cause corrosion if they extend to the underlying reinforcing steel (17). The corrosion will be more significant if the cracks are parallel to the reinforcing steel instead of crossing the steel (16).

Crack patterns of the type shown in Figures 5 through 7 are seldom presented in the corrosion-in-concrete literature. The need for more studies of this type is obvious, and this line of investigation is being continued in the authors' laboratory. The implication of Figure 7 is that the cracks did not come from corrosion. Although this may be true in the limited number of samples analyzed so far, it is too early to reach a conclusion. Since cracks extend beyond the plane of any cut, as is shown in Figure 7, it is important that these cracks be analyzed in three dimensions whenever possible.

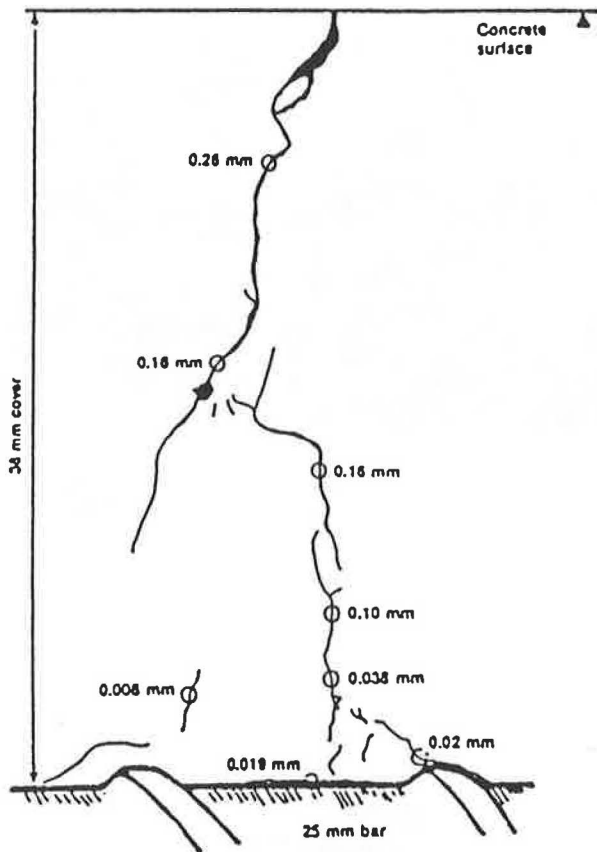
FIGURE 6 Variation of crack width with depth (19).

Figure 6 shows how many cracks may not reach down to embedded steel and, thus, do not cause corrosion (19). Even if they do extend this deep, autogenous healing (20) may occur and prevent corrosion. Studies such as the one that produced Figure 6 are often cited to support the contention that corrosion is more likely to cause cracking than to be a result of cracking (16). Unfortunately, the crack pattern shown in Figure 6 was taken from a research project that studied unloaded or statically loaded concrete. Dynamically loaded concrete, such as that found on such actual structures as bridge decks, may behave differently.

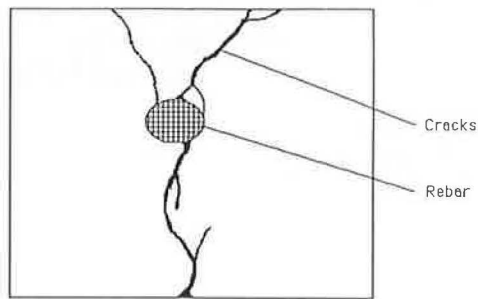
FIGURE 7 Crack pattern on core removed from reinforced concrete fence wall on a beach in California.

Figure 7 shows the crack pattern on a core removed from a concrete wall in coastal California. Note that the cracks are narrower at the reinforcing steel than at the surface. This crack pattern, with cracks near the steel being smaller than those farther away from the steel, is common in research on cores removed from building walls, marine piers, and highway bridge decks. If corrosion had caused these cracks, they would

be wider near the metal. Since the cracks are narrower at the steel than at the surface, they must be due to other causes. Guidance is available on how these cracks form. Unfortunately, there is no nondestructive method presently available for determining crack widths except where they intersect the concrete surface (18).

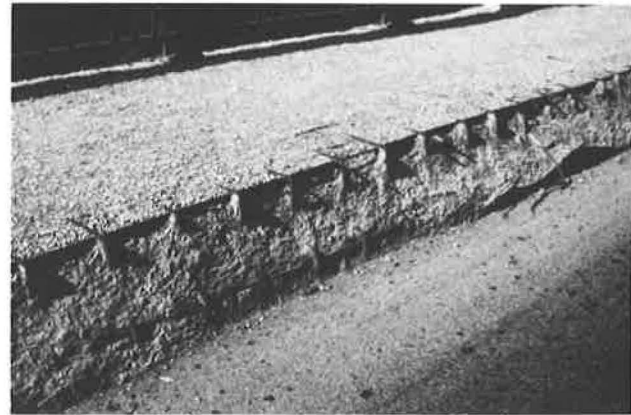
FIGURE 9 Salt-accelerated freeze-thaw damage on highway bridge in Kansas City, Missouri.

The effects of salt in causing the type of cracking shown in Figures 9 and 10 seem to have gone virtually unnoticed in the corrosion literature, even when they are reported at conferences (24) or in journals (32) that should be known to the research community.

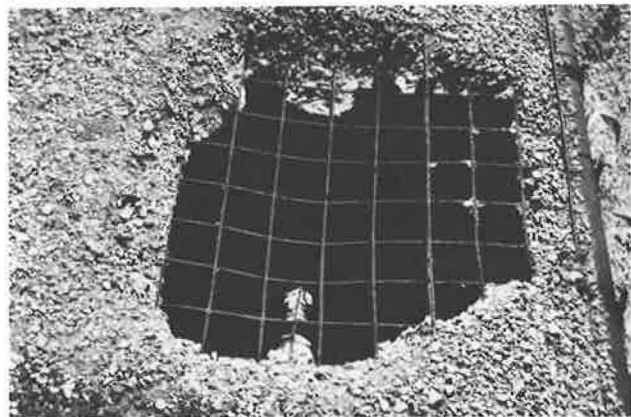
FIGURE 10 Complete separation of concrete from reinforcing steel on walkway of bridge shown in Figure 9.

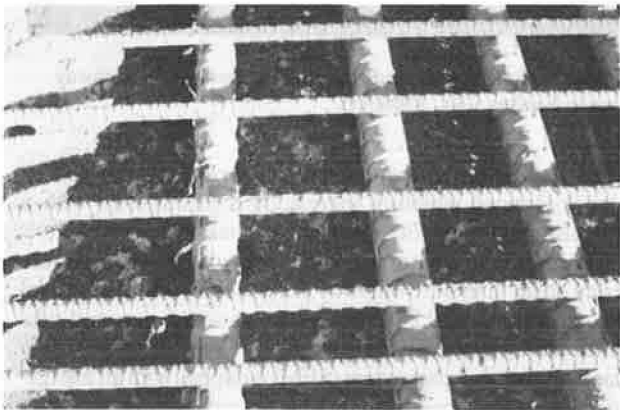
FIGURE 12 Condition of reinforcing steel on bridge shown in Figure 11.

Figure 11 shows a spalling pattern on an interstate highway bridge under repair in 1986. The spalling pattern is similar to that shown by Cady (11) and many others. The locations of spalls on this stiff bridge can roughly be correlated with heavy traffic patterns (less damage near the curbs) and is somewhat different from the patterns (shown in Figure 8) on a more flexible bridge. The corrosion pattern shown in Figure 12 reveals that most of the steel in these spall locations has little

or no corrosion. This is consistent with corrosion being caused by crack-induced moisture ingress. It is inconsistent with a mechanism whereby corrosion causes spalls.

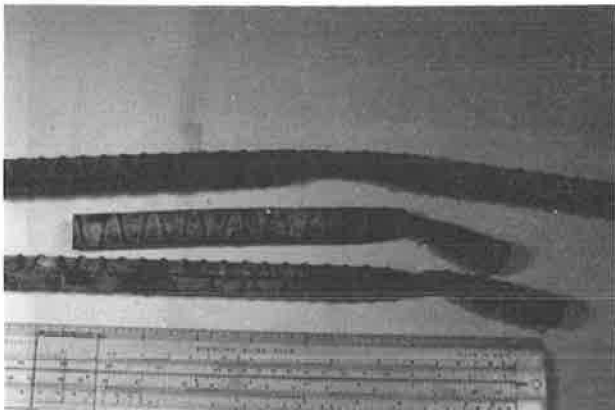
FIGURE 13 Localized corrosion due to crack in pavement overlay on I-90 in New York State (July 1982) (25).

Figure 13 shows reinforcing steel removed from a pavement overlay on an interstate highway in New York State. The steel has corroded at a crack in the overlay caused by ground subsidence (25). The steel shown in Figure 13 was analyzed using a scanning electron microscope (SEM) equipped with an energy-dispersive, X-ray spectrometer. This equipment is similar to that used to determine the cause of failure on the post-tensioned building shown in Figure 1 (13). The cement paste adjacent to the corrosion shown in Figure 12 had high chlorine levels, showing that deicing salts had penetrated to the metal surface in this location. Minimal chlorine was detected in the

The SEM was used to analyze the steel in Figure 15 the same way the steel in Figure 13 was analyzed. Adherent cementitious material on the reinforcing steel had virtually no chlorine, as did the uncorroded steel. The only location where chlorine was present in significant amounts was where corrosion had occurred.

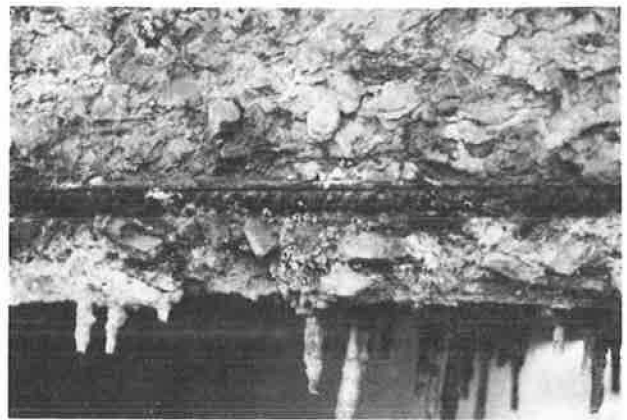
FIGURE 14 Stalactites formed from water runoff from reinforced highway bridge in Edmond, Oklahoma (January 1985).

Stalactite formations indicate locations where relatively large amounts of water have permeated a concrete structure (Figure 14). Figure 15 shows the corrosion pattern found on the reinforcing steel removed from the Oklahoma highway bridge shown in Figure 14. The bottom of the steel, as it was located in the bridge, appears as the extensively corroded, or pitted, top of the steel in Figure 15. Portions of the steel are extensively corroded, while other portions of the same steel are uncorroded.

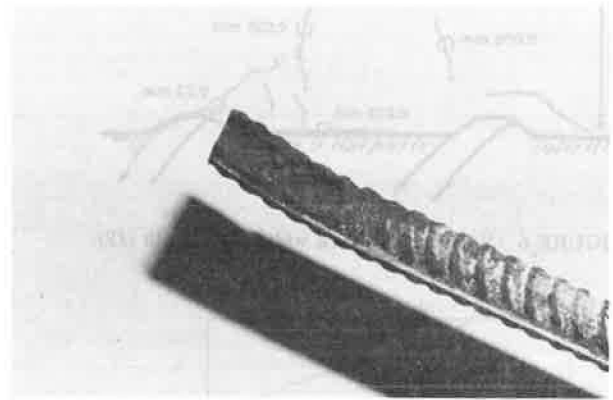
FIGURE 15 Closeup of steel removed from bridge shown in Figure 14. Note localized corrosion and absence of corrosion at other locations on the same steel. Extensive corrosion was at bottom of steel as it was located in the bridge.

The fact that the corrosion on the Oklahoma bridge (Figure 15) occurred on the bottom of the reinforcing steel supports the idea that corrosion occurred on this steel at locations where a protective cementitious cover was lacking, probably because of the presence of unconsolidated voids. Figure 16, from a 1960s report by Verbeck and Monfore (5), shows rust filling a cavity in concrete. This macrophotograph has many similarities to the voluminous rust found on cracked, metal-fiber reinforced concrete (Figure 17) (34). Thus the idea that corrosion occurs in cracks and voids is not new, and there is experimental evidence to support the idea.

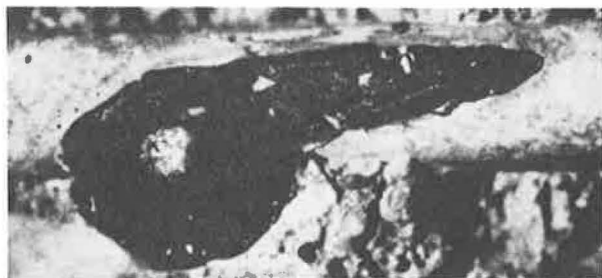
FIGURE 16 Rust filling void in concrete (5).

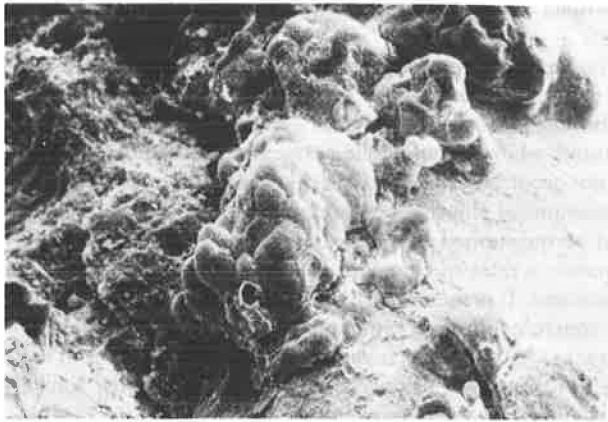
**FIGURE 17** Rust as seen by scanning electron microscope on metal-fiber reinforced concrete exposed to a marine environment (34).

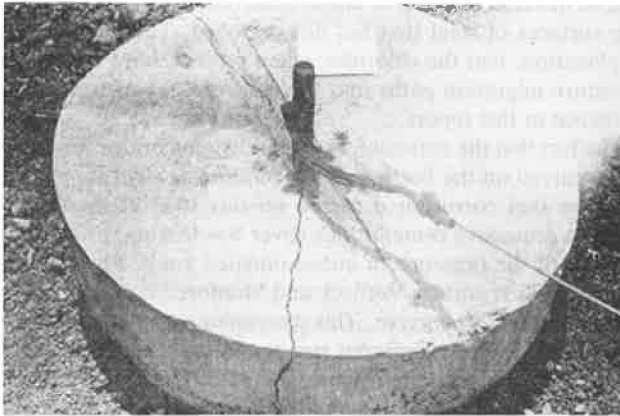
**FIGURE 18** Cracking caused by anodic currents used to simulate stray currents on electric railway structure (35).

Figure 18 shows an early (1940s) experiment in which excess anodic current caused corrosion and cracking on a reinforced concrete laboratory sample (35). A careful review of the literature has failed to identify any laboratory or field investigations in which cracking due to the corrosion of embedded steel has occurred in the absence of externally applied electric currents. Figure 19 shows corroded steel protruding from concrete in a marine environment. Although the steel is extensively corroded, no cracking has occurred in the adjacent concrete. Most marine concrete locations can produce dozens of examples similar to that in Figure 19.

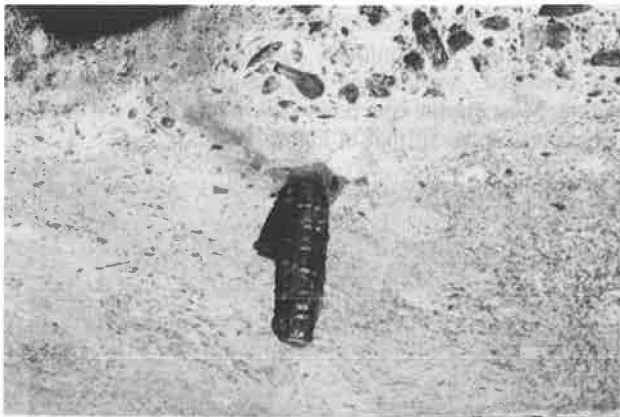
**FIGURE 19** Corroded reinforcing steel stud protruding from concrete at Humboldt Harbor breakwater (July 1988).

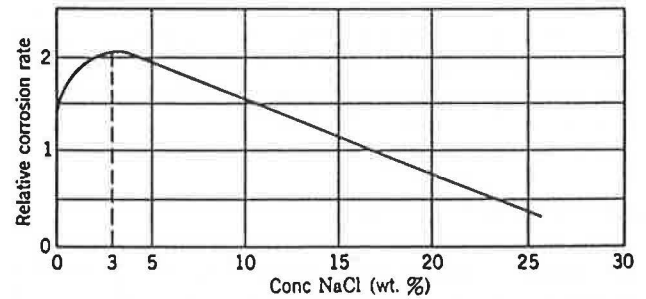
**FIGURE 20** Effect of salt concentration on corrosion rate of steel immersed in brines (37).

rosion rate by limiting the amount of oxygen available for the reduction reaction that must accompany any oxidation of metal. Figure 20 is remarkably similar to Figure 21, which shows how increasing the amount of chloride-containing admixtures can lower the corrosion rate of steel embedded in concrete (33). This figure may help explain why Australian research was successful in finding chloride-based corrosion inhibitors to use as concrete set accelerators when concerns were expressed about the suitability of using calcium chloride for this purpose (39).
