TRANSPORTATION RESEARCH RECORD

*Concrete Bridge Design  
and Maintenance: Steel  
Corrosion in Concrete*

# Correlation Between Corrosion of Reinforcing Steel and Voids and Cracks in Concrete Structures

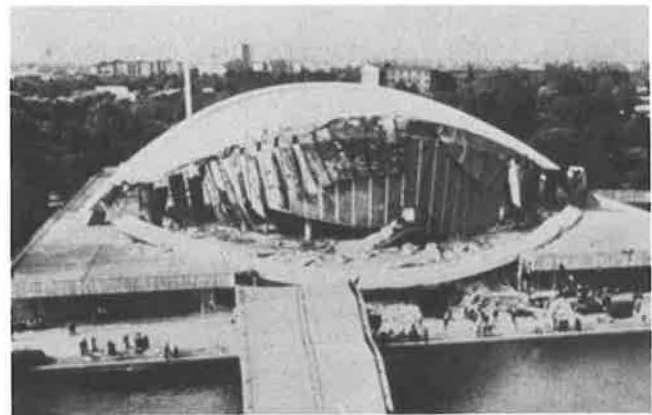
FIGURE 1 Collapse of the Berlin Congress Hall due to hydrogen-assisted cracking of post-tensioning cable.

Problems associated with concrete and masonry buildings are starting to appear in increasing numbers. The collapse of the Berlin Congress Hall (Figure 1) (13) and of a parking garage in Minnesota (Figure 2) are but two of an increasing number of instances where moisture ingress has led to the loss of structural components, roofs, or, more commonly, building facades (14,15). Much of the information associated with these problems has not been released to the general public, because lawsuits are often associated with these failures (15). To cite one example, a reported problem from the 1960s was not published until 1977 because of ongoing litigation (8).

Figure 1 showed a widely publicized concrete structure that collapsed in the absence of chlorides. If this can happen, it then becomes necessary to explain what role chlorides, or other salts, play in altering corrosion rates. Figure 20 shows how variations in salt content affect the corrosion rate of steel in water. This figure, reproduced from a standard corrosion textbook (37-38) and based on research first reported in the 1930s, can be explained by the effect of dissolved salts on oxygen's solubility in brines. Too much salt limits the cor-

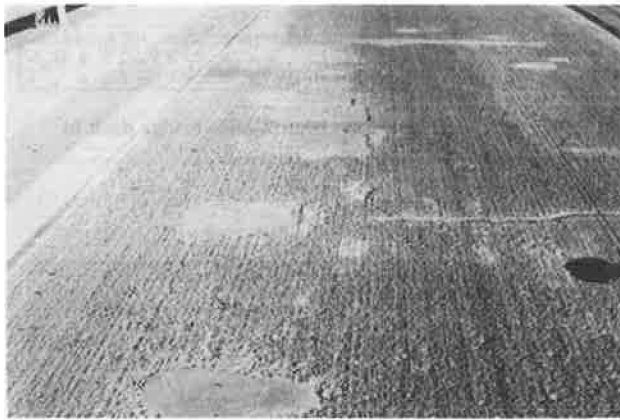
FIGURE 11 Spalling pattern on bridge under repair on I-90 in central Washington State (September 1986).

Figure 11 shows a spalling pattern on an interstate highway bridge under repair in 1986. The spalling pattern is similar to that shown by Cady (11) and many others. The locations of spalls on this stiff bridge can roughly be correlated with heavy traffic patterns (less damage near the curbs) and is somewhat different from the patterns (shown in Figure 8) on a more flexible bridge. The corrosion pattern shown in Figure 12 reveals that most of the steel in these spall locations has little

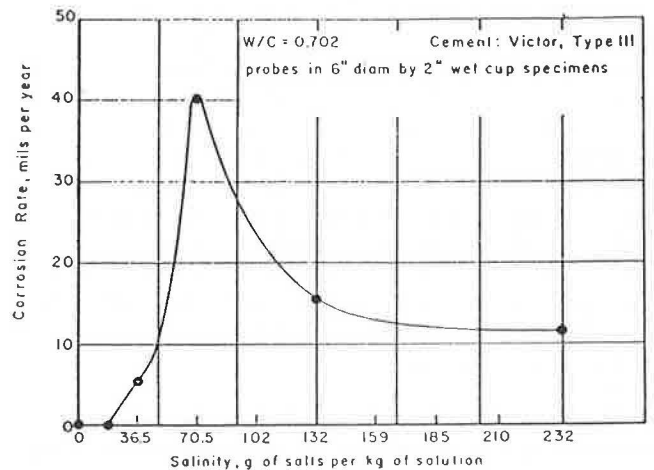
**FIGURE 21** Effect of salt admixture concentration on corrosion rates of embedded steel (33).

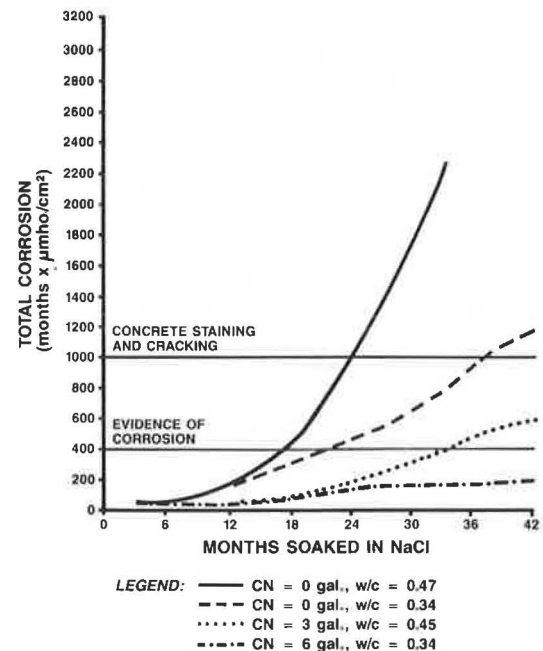
FIGURE 2 Total corrosion vs. time in 3 percent NaCl as a function of w:c ratio and calcium nitrite content.

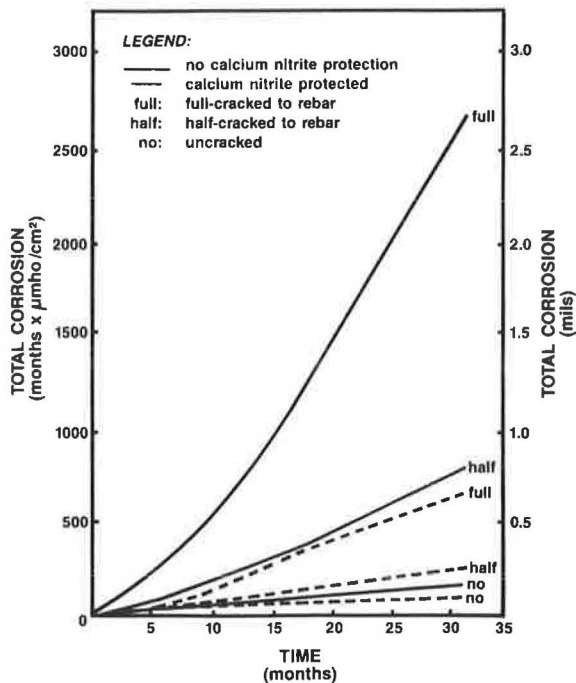
FIGURE 3 Total corrosion vs. time for precracked beams with and without calcium nitrite.

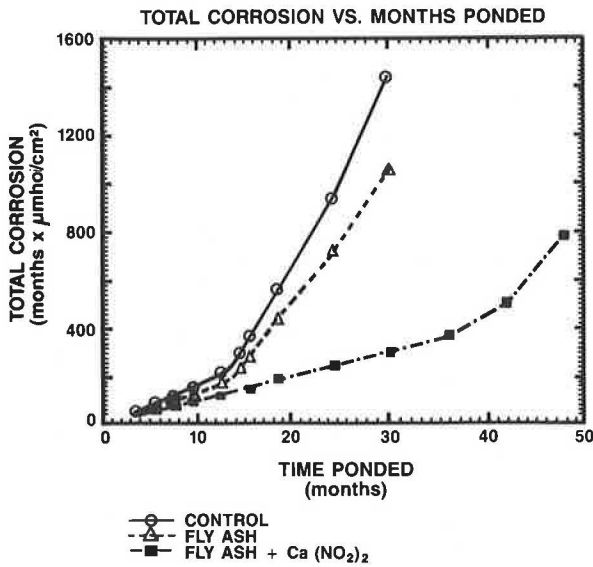
FIGURE 4 Effect of fly ash and fly ash + calcium nitrite on the total corrosion of concrete rebars ponded in 3 percent NaCl.

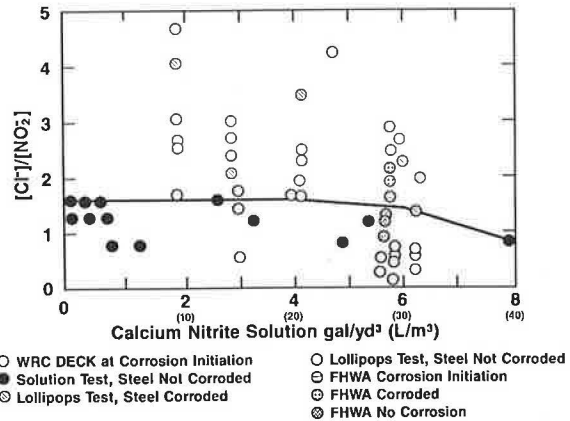
FIGURE 5 Chloride:nitrite ratios at which corrosion occurs based on testing in solutions and concrete.

If one can estimate the amount of chloride that will reach the steel at the design life of a structure, an estimate of the calcium nitrite needed to protect the structure can be given. Chloride levels can be estimated from experience and con-

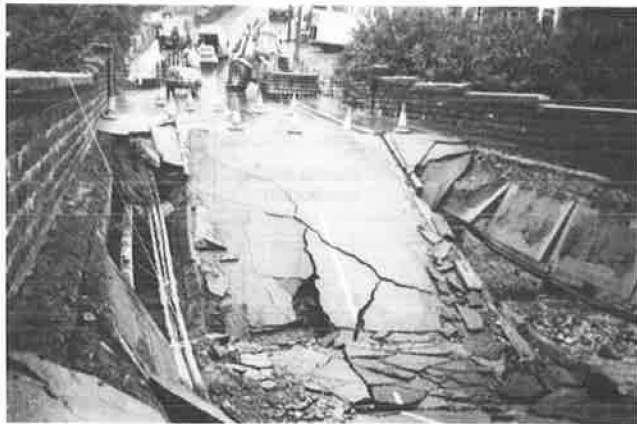
FIGURE 2 Ynys-y-Gwas bridge after collapse (photographs courtesy West Glamorgan County Council).

The deck collapsed when there was no traffic on the bridge; all nine internal beams failed (Figure 2). The line of failure is shown in Figure 3. The edge beams and blockwork parapets remained standing and apparently unaffected, despite the inward and downward forces exerted by the top transverse, prestressing tendons as the central deck collapsed. Some of the slabs that spanned the gap between the I-beams and the edge beams were left hanging from the edge beams.

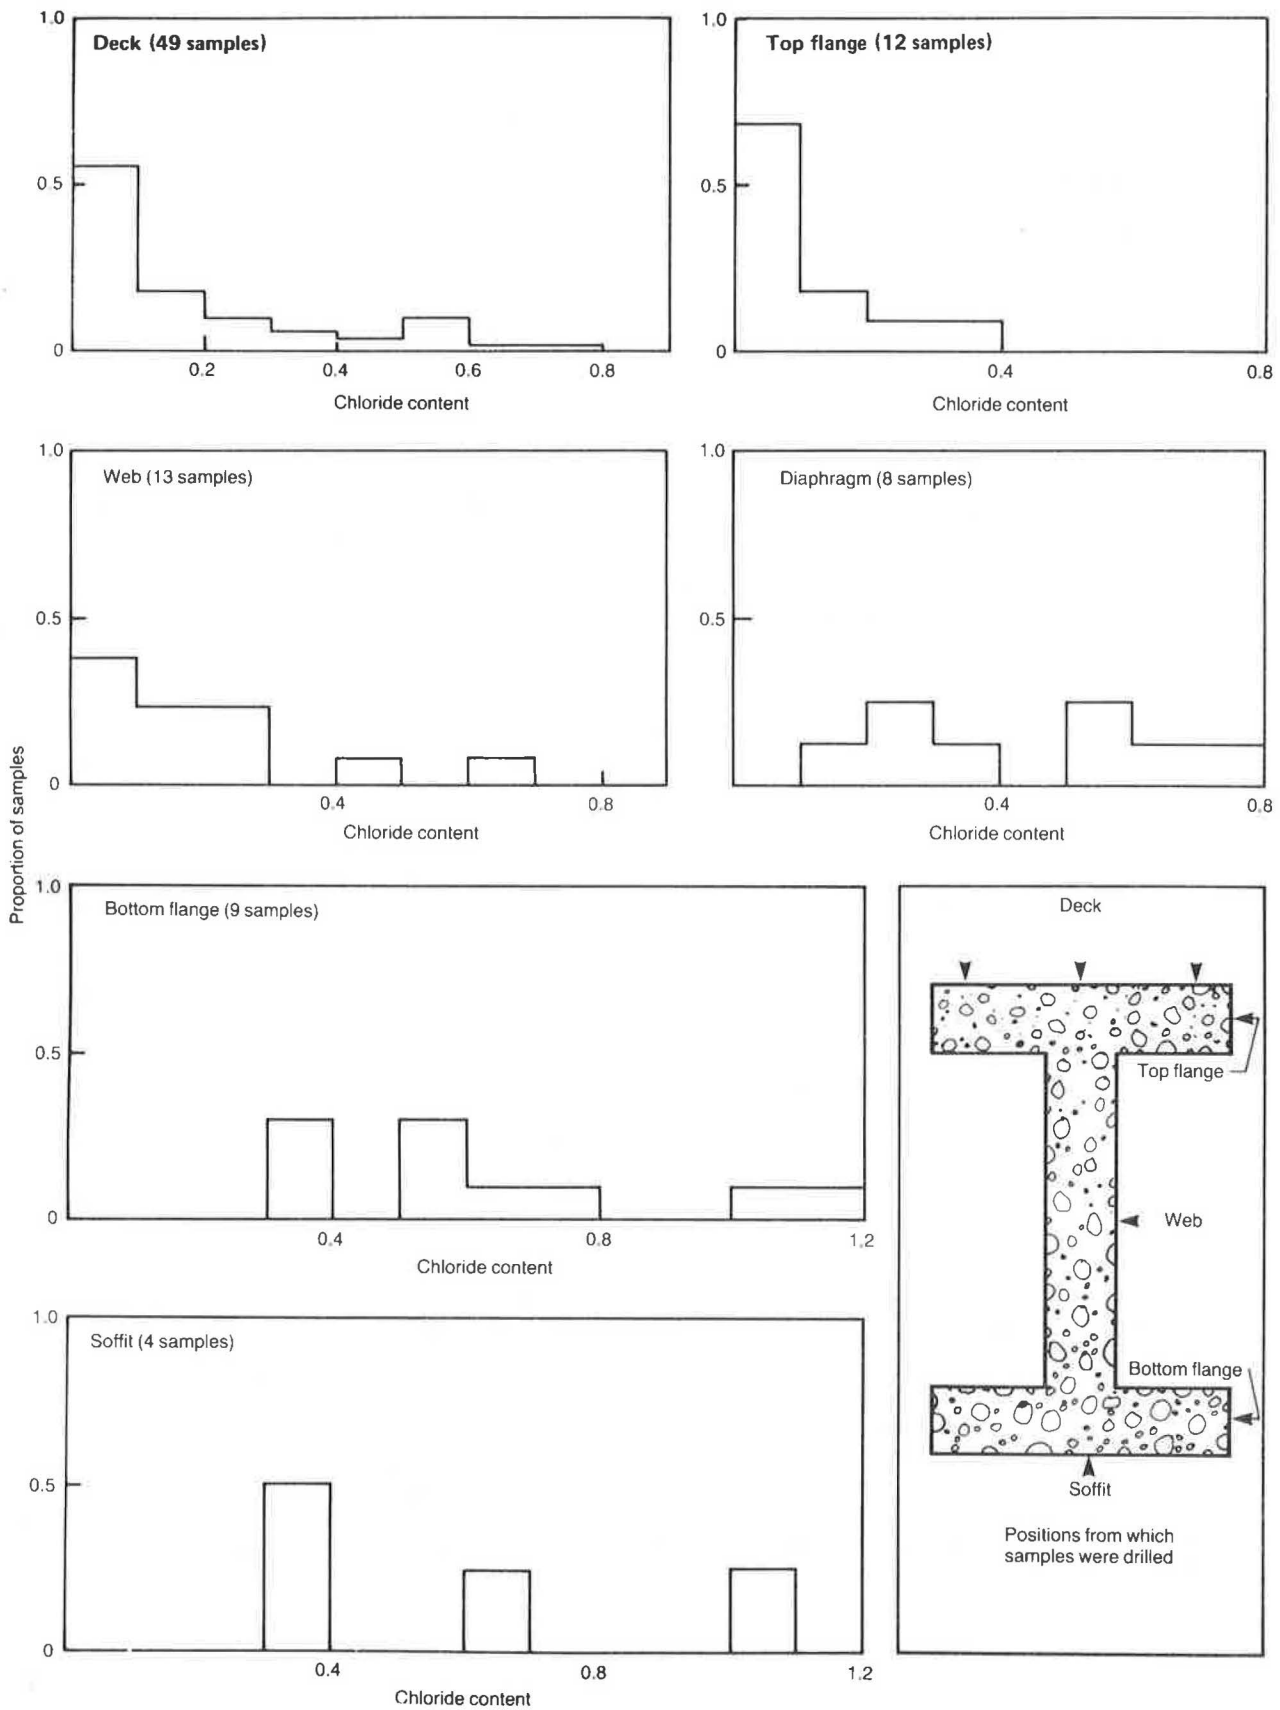
**FIGURE 10** Normalized frequency distributions of chloride content (percent by weight of cement)—I-beam surface concrete.

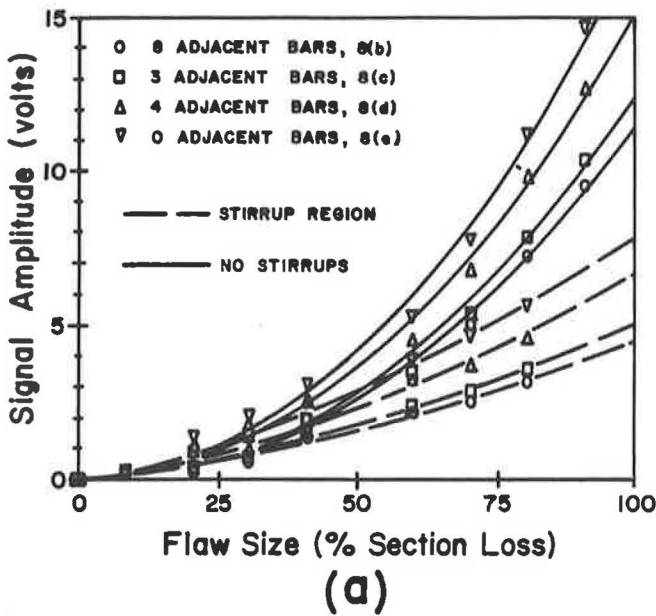
FIGURE 12 Correlation values with respect to amount of adjacent steel.

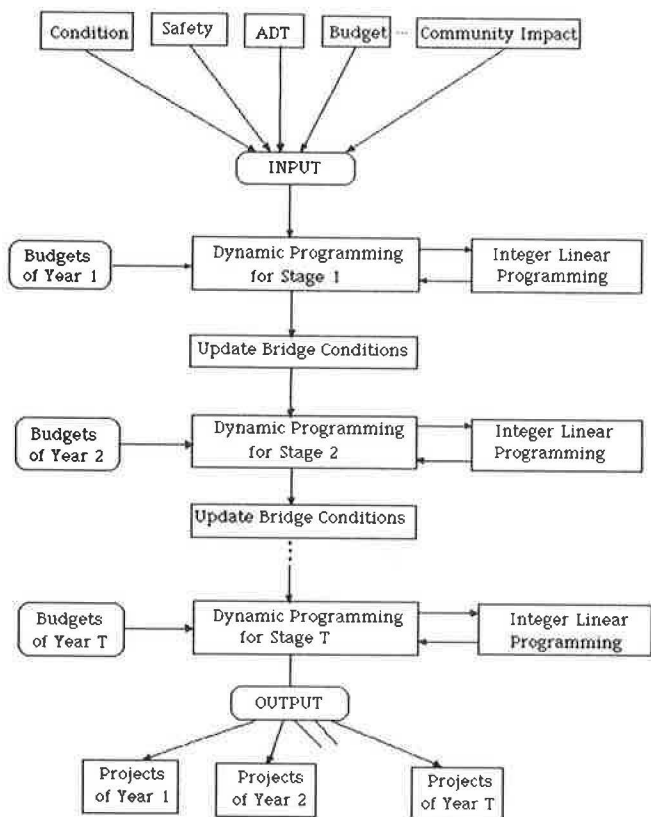
FIGURE 2 Flowchart of the optimization model.
