# Toward an Integrated Nondestructive Pavement Testing Management Information System Using Infrared Thermography

GARY J. WEIL AND LONNIE E. HAEFNER

**This paper describes the theoretical basis and practical procedures for use of thermography in detection of pavement distress. It also illustrates the field use of thermography with some recent applications on airport taxiways, bridge decks, and parking garage slabs. It provides an overview of a staged research process under way by the authors to integrate nondestructive pavement testing using infrared thermography with evaluation models that form the basis for an integrated pavement testing, management information system.**

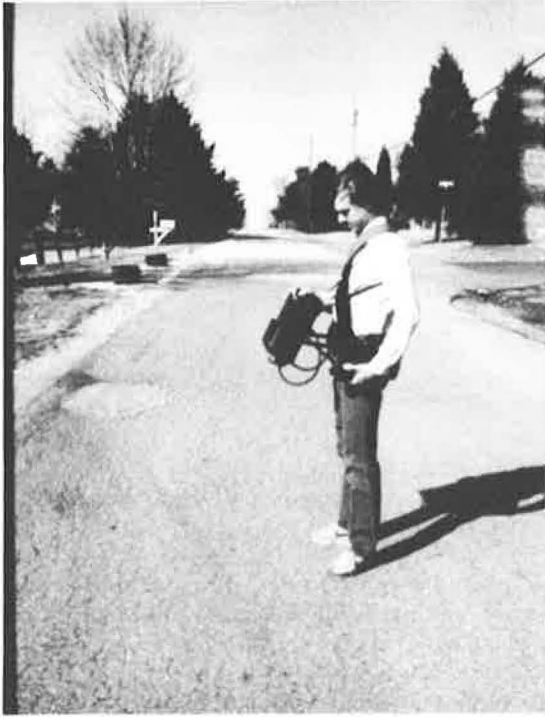
**FIGURE 3** Infrared scanner mounted on portable body harness.

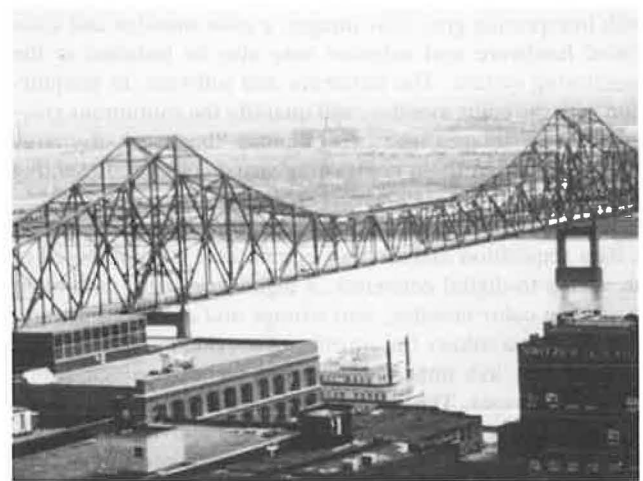
**FIGURE 6** Martin Luther King Jr. Memorial Bridge spanning the Mississippi River between St. Louis, Missouri, and East St. Louis, Illinois.

The first case history reviews the 1985 inspection of a concrete deck on the Martin Luther King Jr. Memorial Bridge spanning the Mississippi River at St. Louis, Missouri (see Figure 6). In this location, weather conditions can quickly change, and conditions can alter from clear sky to fog and rain in a matter of minutes. Therefore it was decided to perform the field inspection in one 8-hour period or less. The deck and its associated ramps were four lanes wide and almost a mile long, and included various sections with and without an overhead superstructure. It was determined to use a mobile lift platform capable of constant movement at up to ¾ mph while simultaneously lifting the infrared equipment, an operator/engineer, and a vehicle driver to heights sufficient to view all four lanes in a single pass (see Figure 7).
