TRANSPORTATION RESEARCH RECORD

*Pavement Management
and Rehabilitation*

TRANSPORTATION RESEARCH BOARD
NATIONAL RESEARCH COUNCIL
WASHINGTON, D.C. 1989

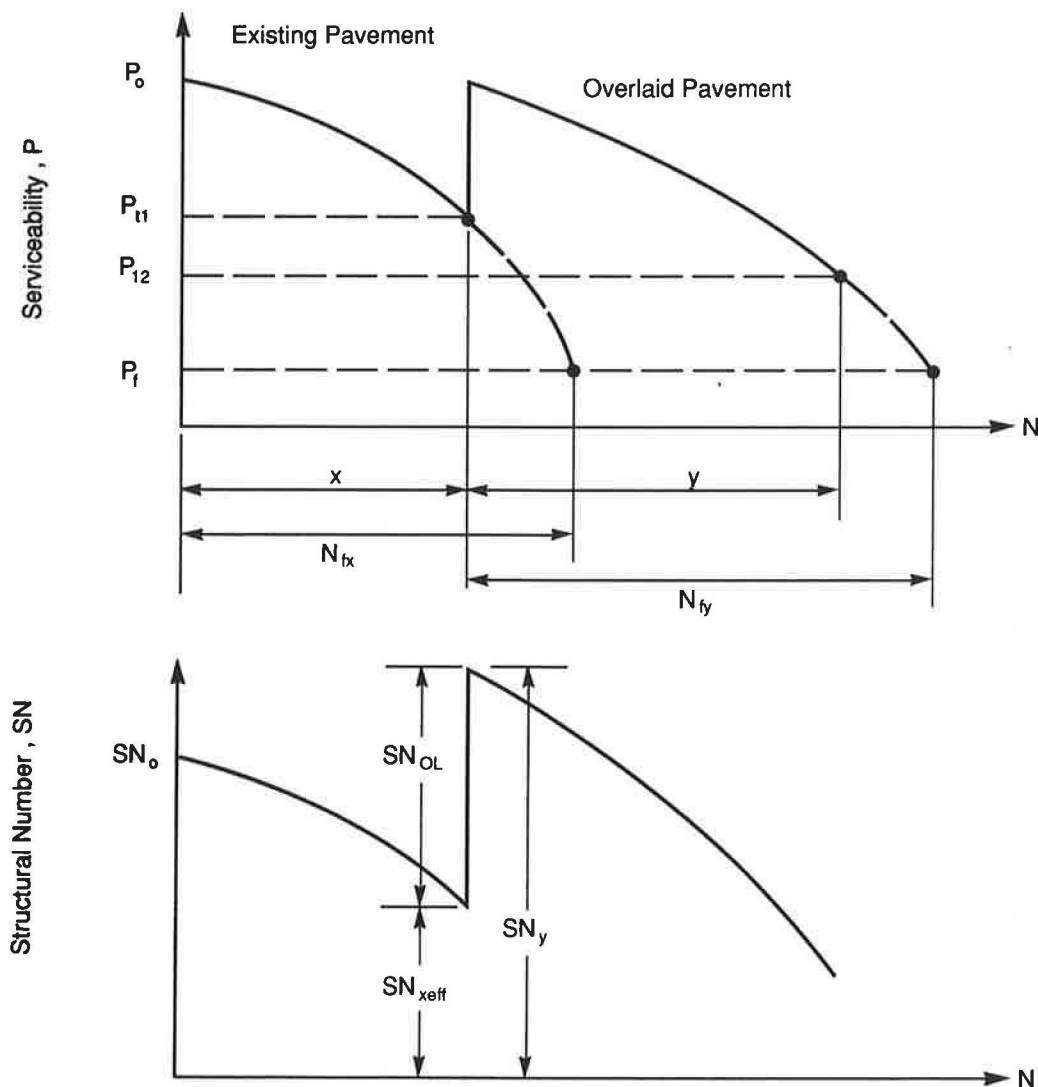
FIGURE 5 Relationship between serviceability-structural number and traffic (AASHTO, Fig. III, 5.1).

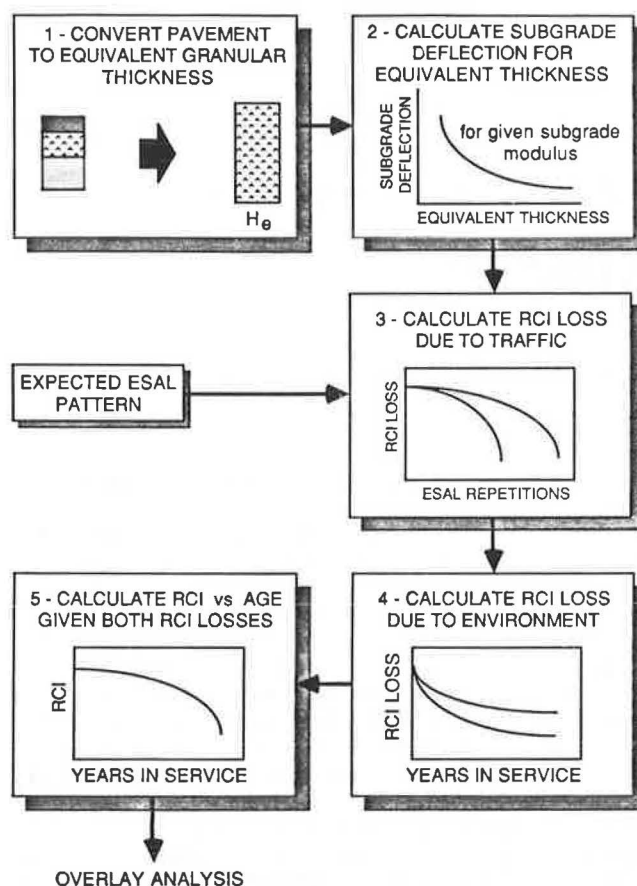
FIGURE 1 Ontario flexible pavement deterioration model.

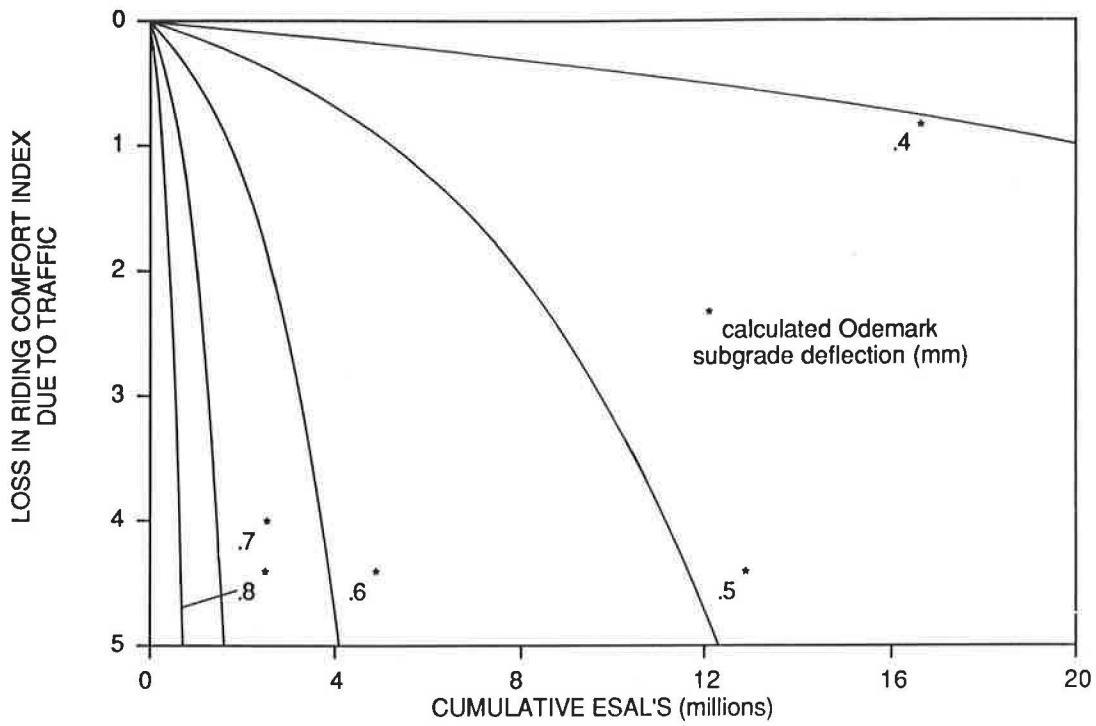
FIGURE 2 Load-associated RCI loss versus cumulative ESALs.

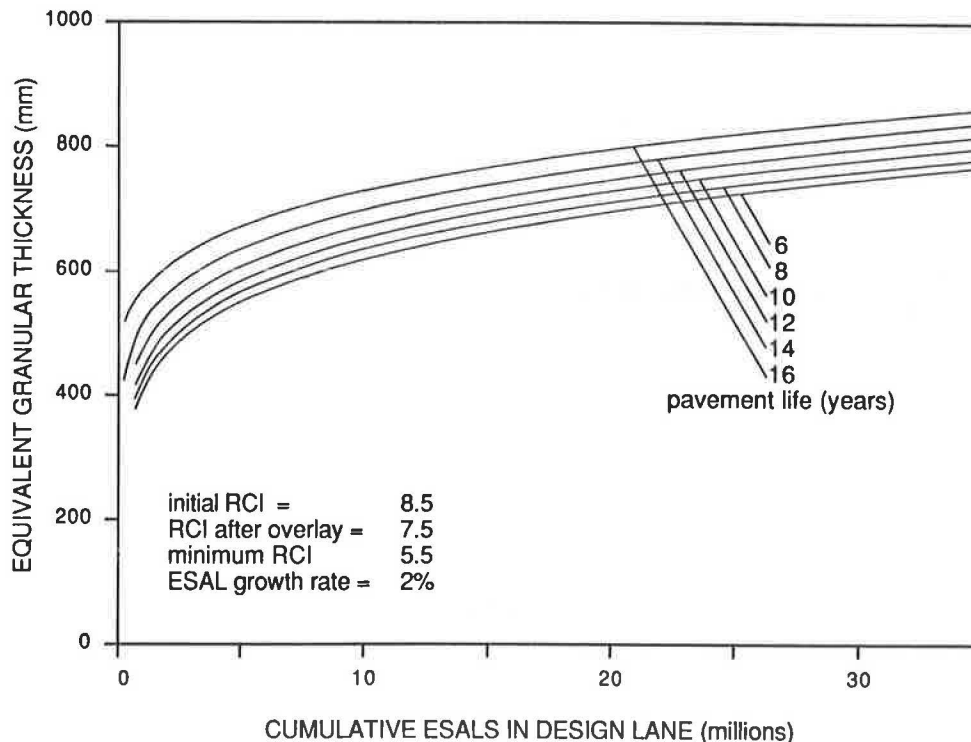
FIGURE 5 Equivalent granular thickness versus design ESALs for different pavement lives.

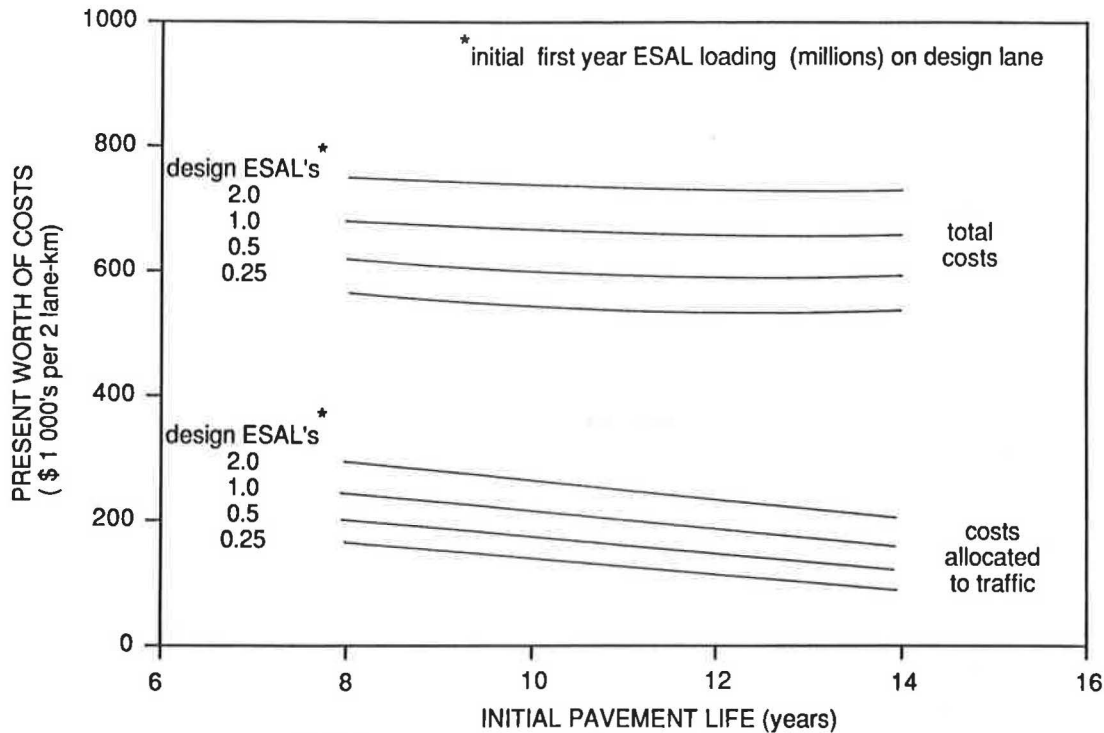
FIGURE 9 Present worth of initial pavement plus overlay costs.

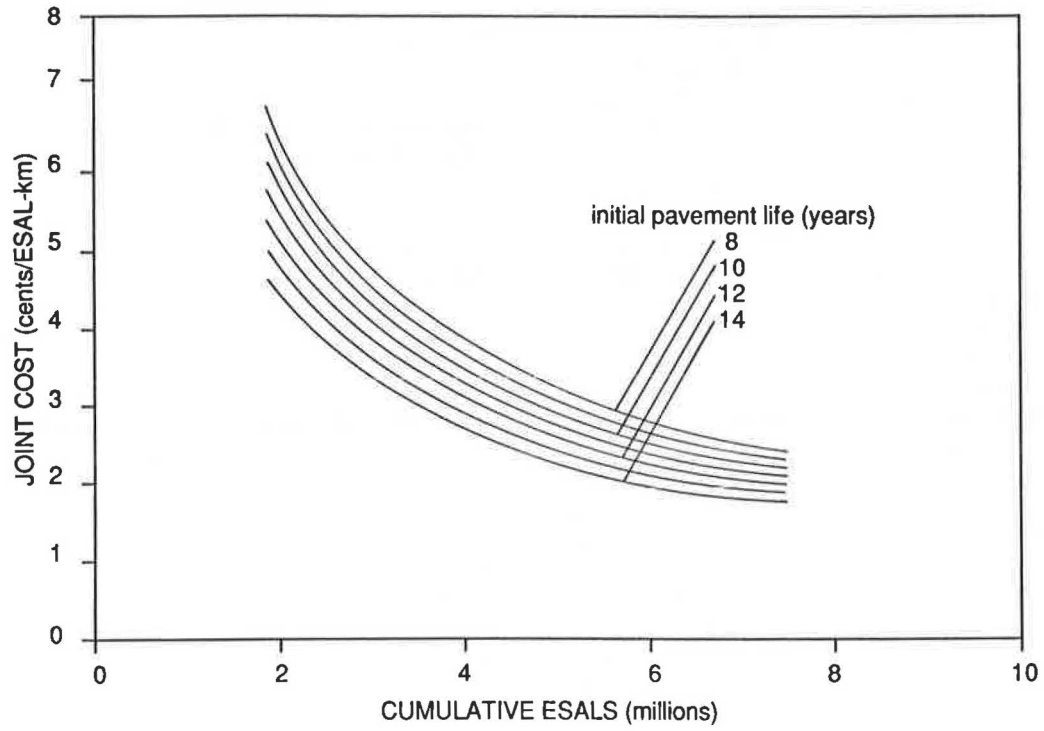
FIGURE 11 Joint costs for a secondary highway.

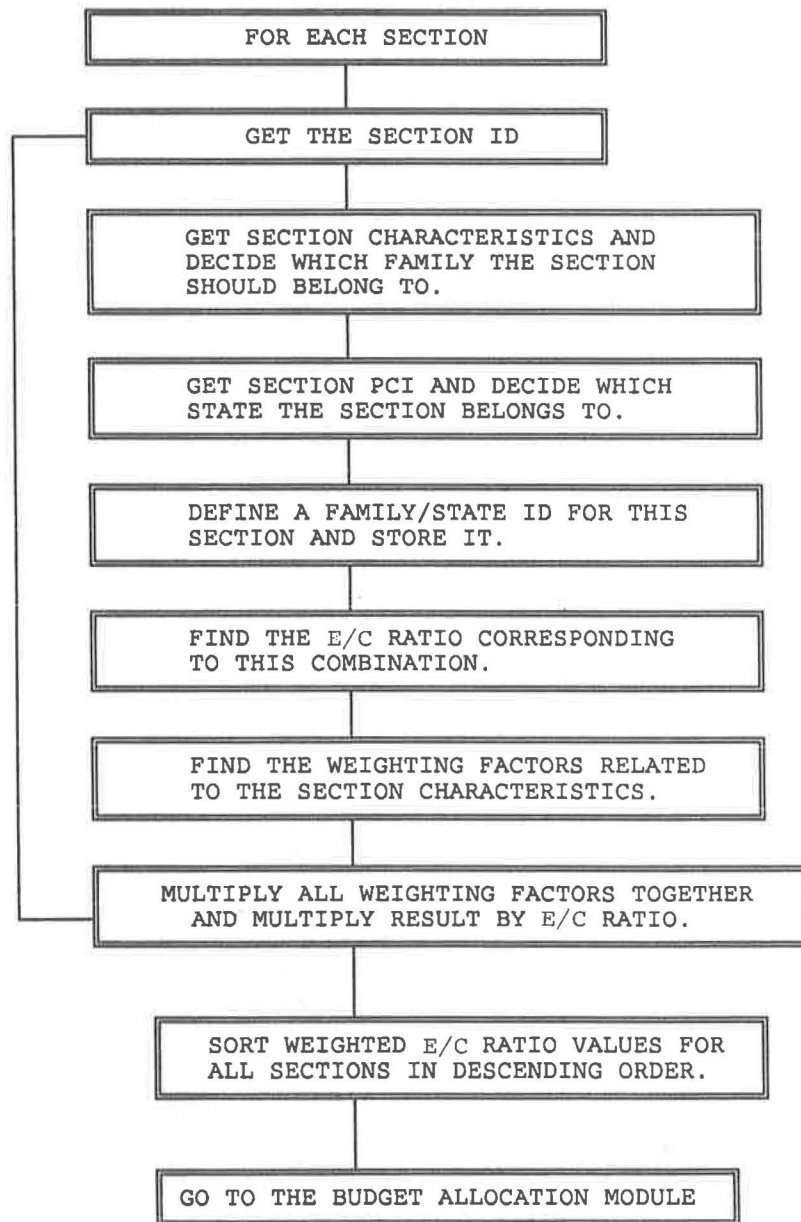
FIGURE 2 Prioritization module.

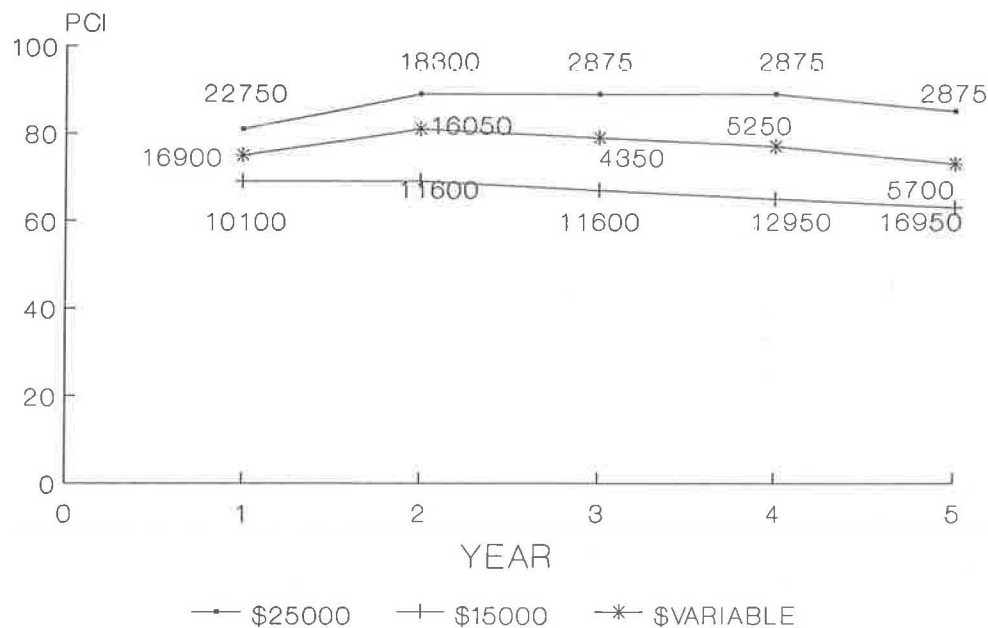
FIGURE 9 Network performance.

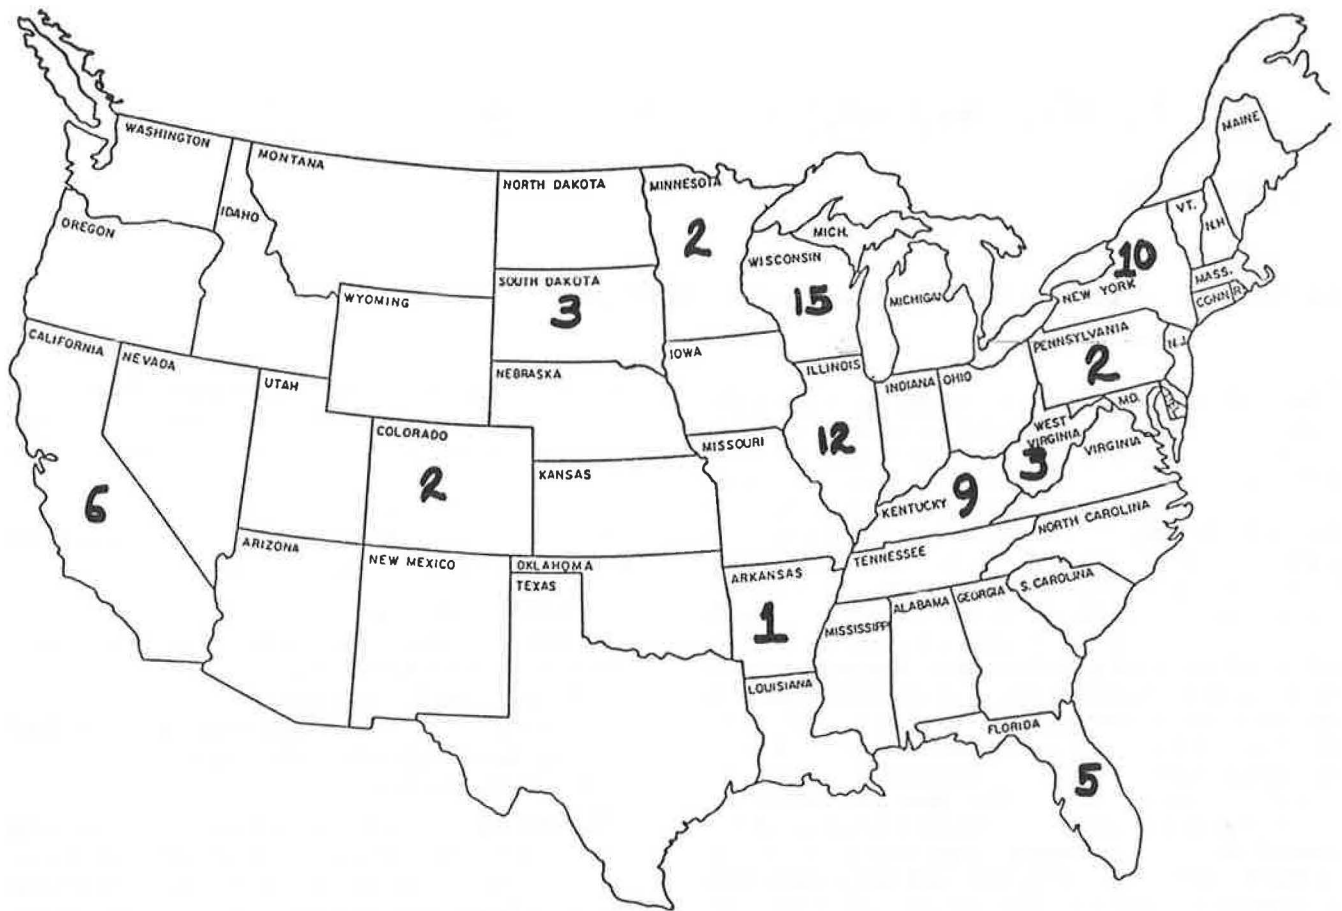
FIGURE 1 Distribution of crack and seat projects in the United States.

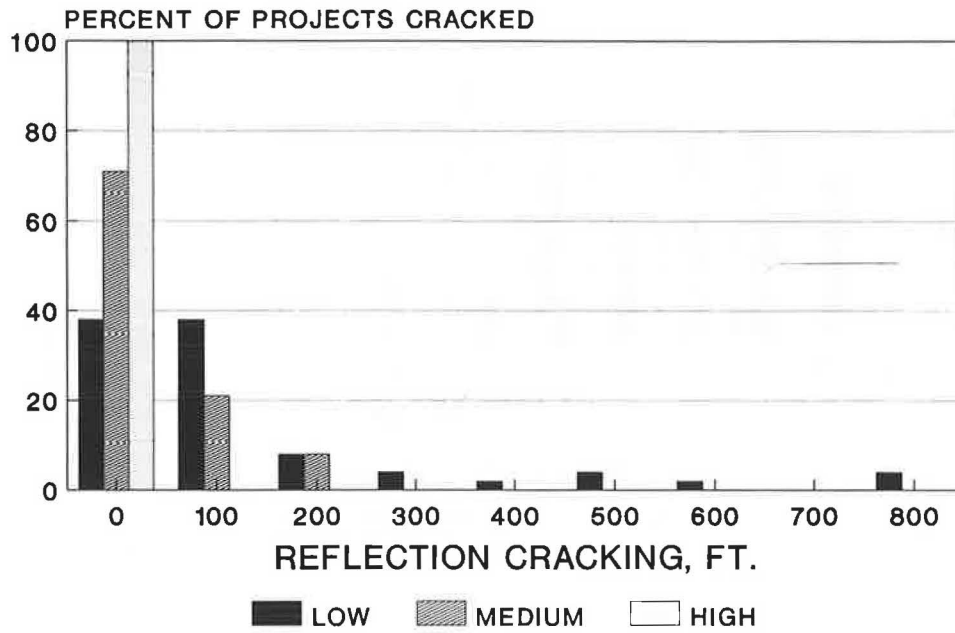
FIGURE 4 Amount and severity of reflection cracking present on crack and seat projects with no reinforcing steel.

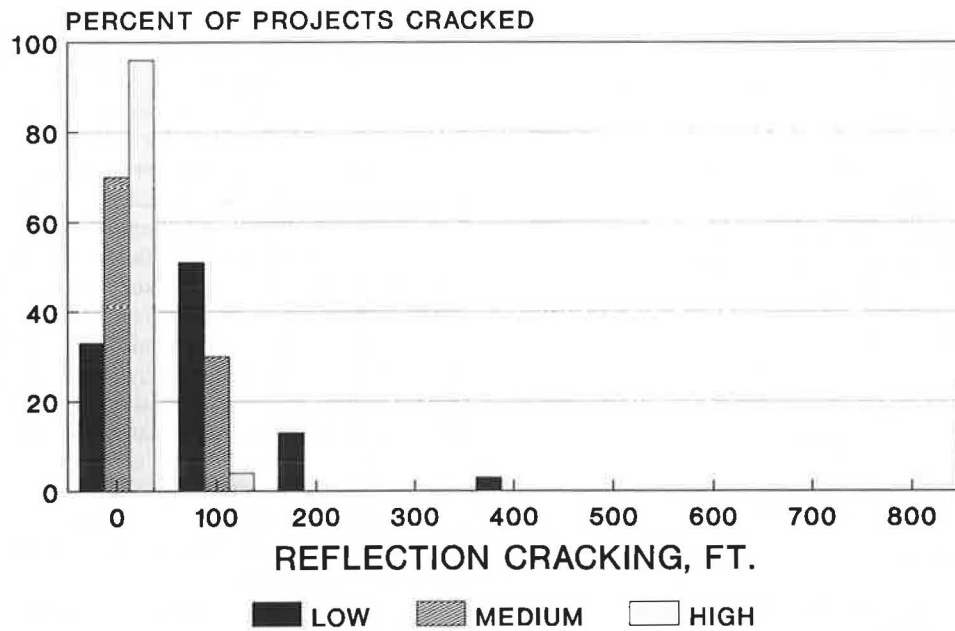
FIGURE 5 Amount and severity of reflection cracking present on crack and seat projects with reinforcing steel.

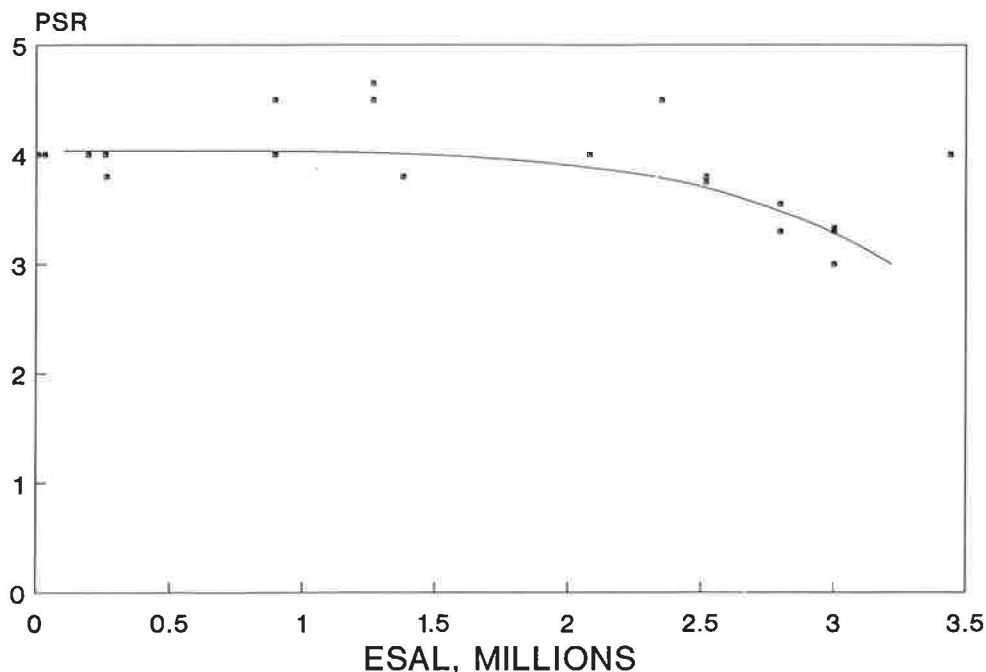
FIGURE 6 Serviceability rating (PSR) for the crack and seat projects.

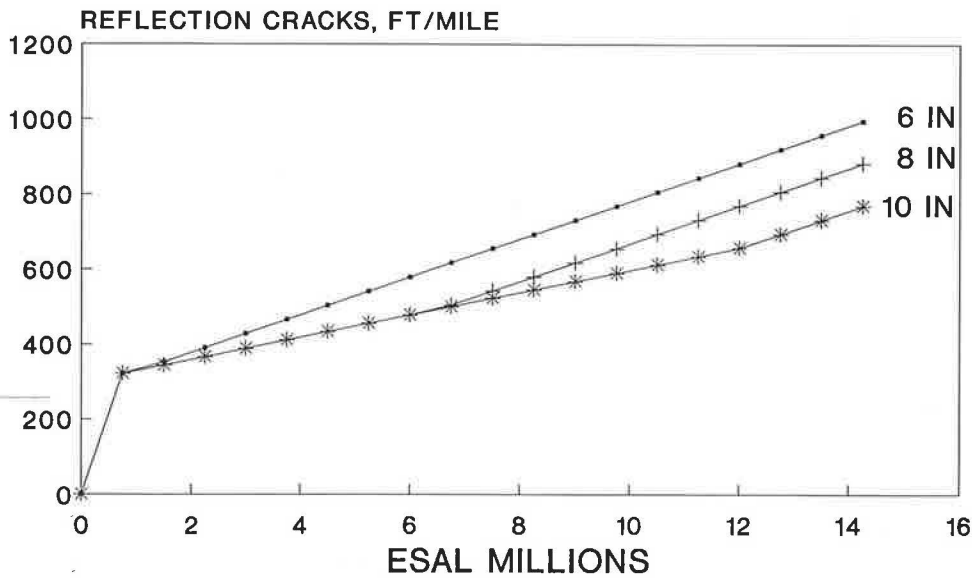
FIGURE 9 Influence of original concrete pavement thickness on reflection cracking.

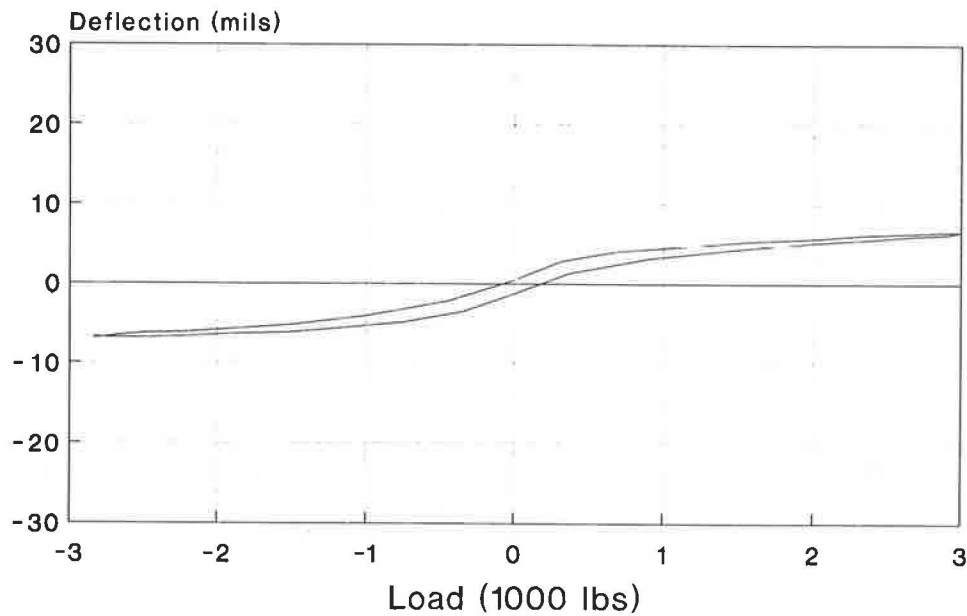
FIGURE 12 Load-deflection profile for cast-in-place specimen after 300,000 load cycles (1-in. dowel).

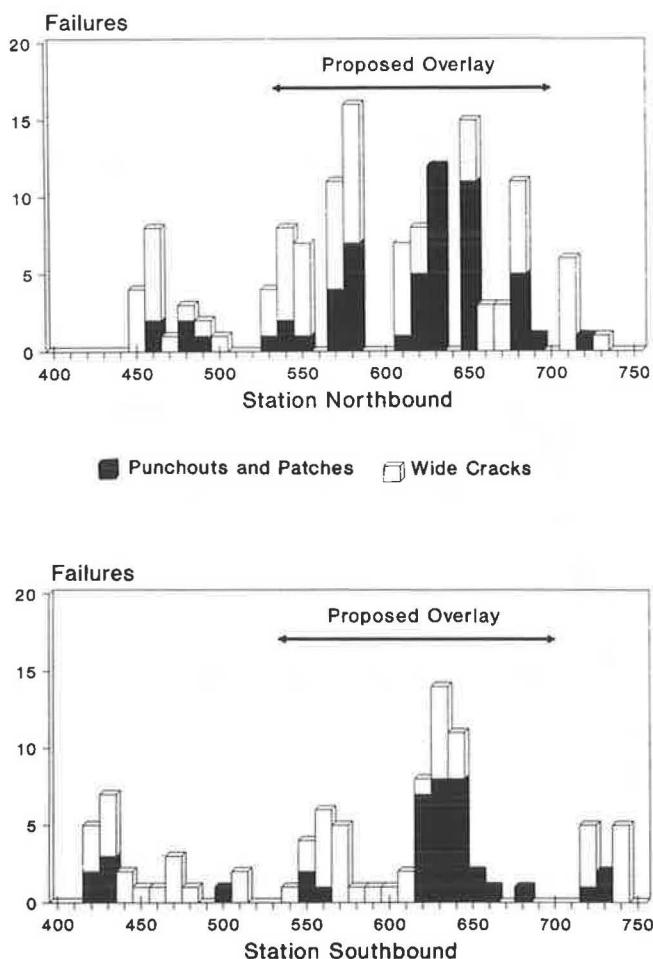
FIGURE 2 Distribution of distress along length of I-57 Manteno project.

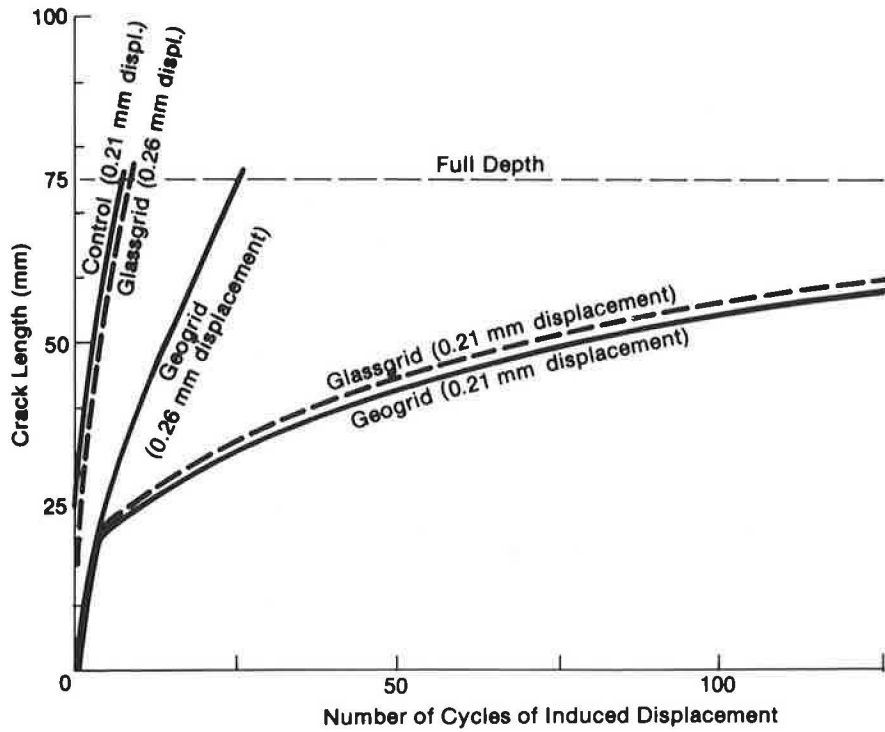
FIGURE 12 Crack growth curves for various overlay treatments.
