# Investigation of a Shoreline Enhancement Technique for Wetlands Impact Mitigation

FRED K. PARRISH

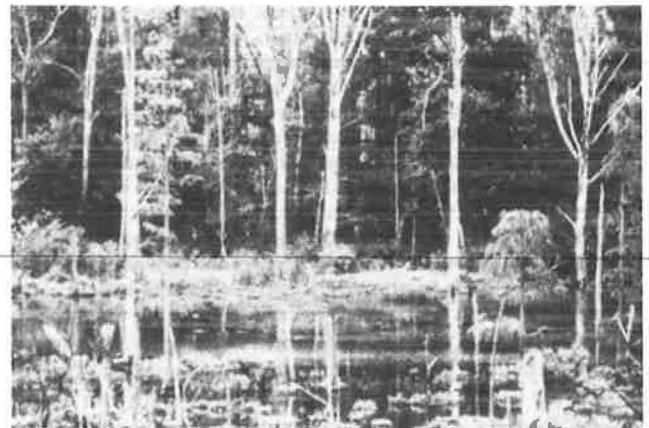
**FIGURE 3** Telephoto view across pond. C 3 is visible. Note the four baldcypress trees. The specimen on the left is about 30 ft high, suggesting that the pond has a history of wet and dry periods, and that the pond is several years old.

The wetland chosen for this study was a beaver pond lying along Powder Springs Creek in the southern part of Cobb County, Georgia (Figures 2 and 3). The pond was separated from the creek by a low island, approximately 25 to 100 ft wide, which extended upstream about 2,200 ft (Figure 4). The island was covered with a mature stand of bottomland trees (red maple, *Acer rubrum*, predominated), shrubs, and vines. Privet (*Ligustrum* sp.) was abundant and provided food for the beavers.

The pond varied from about 400 to 500 ft wide, covering 25 acres when the beaver dam was at its highest and after rainfall. The maximum depth was about 8 ft. Because of the number and condition of dead trees that were observed standing in the water, the pond was estimated to be about 20 years old. Figure 1 is an aerial view of the pond and fingers taken in 1985 immediately after construction of the roadbed and mitigation fill fingers. Figures 2 and 3 are views of the pond from the roadfill taken in 1987.

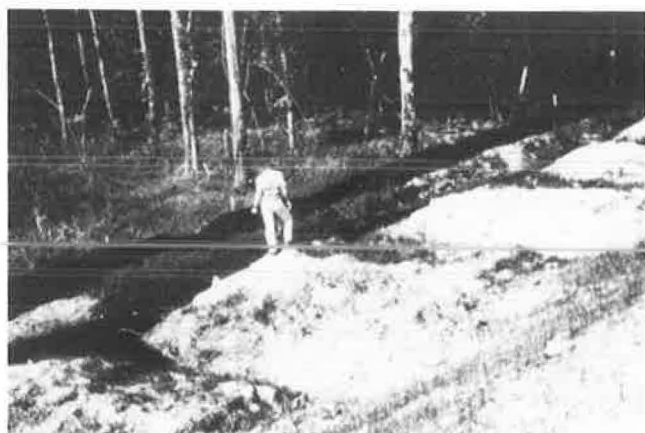
**FIGURE 6** Fingers in early March 1985. Weeping love grass is just coming up. B. Pruitt is standing on finger to the left of I 7. Note low water in slough, only about one-fourth of which is submerged. By end of March, when this study began, water was about 18 in. deep.

making the water shallower and the width of the water narrower in the sloughs, and extending the length and width of the fingers (Figure 6). Sediment from the roadfill and finger edges was up to 32 in. deep in the sloughs. Thus, when the water level in the pond was down by 14 in., many sloughs were dry and most had only a few inches of water for less than one-fourth of their length.

The roadfill and fingers were seeded with weeping love grass (*Eragrostis* sp.) and interstate lespedeza (*Lespedeza stipulacea*) shortly after construction. These plants were just in evidence (Figure 6) when this study began in March 1985. The roadfill and finger banks had not yet completely stabilized.
