TRANSPORTATION RESEARCH RECORD

*Rest Areas, Wetlands,  
and Hydrology*

TRANSPORTATION RESEARCH BOARD  
NATIONAL RESEARCH COUNCIL  
WASHINGTON, D.C. 1989

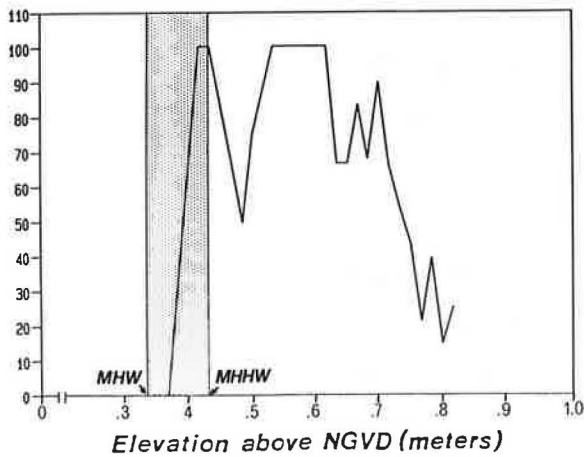
FIGURE 3 Percent survival of planted *Scirpus americanus* as a function of elevation above NGVD (July 1987).

Measurements of percent survival for *Scirpus americanus* (Figure 3) suggest that planting elevation may have affected its potential success in getting established in the constructed marsh. *Scirpus americanus* is not present in the natural marsh; therefore there was no basis for comparison within the study

area to determine its normal elevation range under natural conditions. With the exception of a low value around 0.45 NGVD, the *Scirpus* generally maintained 100 percent survival between 0.40 and 0.60 NGVD and then followed a pattern of increased mortality with increased elevation. The low value at 0.45 NGVD appears to reflect the soil conditions in one

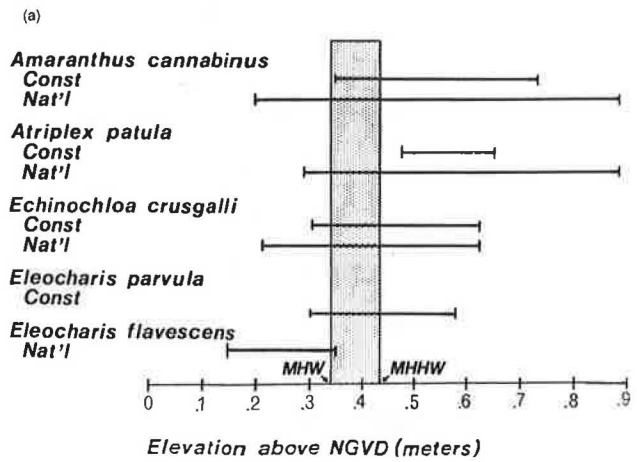
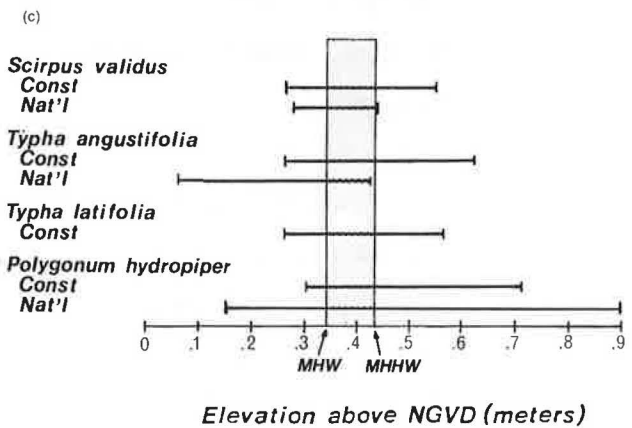
FIGURE 4 Elevation of plant species at Marley Creek constructed (Const) and natural (Nat'l) marshes. (a) *Amaranthus cannabinus*, *Atriplex patula*, *Echinochloa crusgalli*, *Eleocharis parvula*, *Eleocharis flavescens*; (b) *Leersia oryzoides*, *Pluchea purpurescens*, *Peltandra virginica*, *Scirpus americanus*, *Carex* spp.; (c) *Scirpus validus*, *Typha angustifolia*, *Typha latifolia*, *Polygonum hydropiper*.

*Leersia oryzoides* was planted within elevation ranges for which it was found in the natural marsh (Figure 4), yet it suffered the greatest mortality of all the species. The high mortality of *Leersia oryzoides* cannot be attributed to planting

In addition to the planted species, the elevation ranges of major invading species were also recorded and compared with distributions at the natural marsh (Figure 4a–c). With the exception of *Scirpus validus*, plant species invading the constructed marsh occupied a more narrow range. This narrow range may reflect the germination requirements of the individual species; that is, the seeds germinated where the moisture and temperature conditions were most suitable. If this is the case, then during the following growing season one might expect a shift in distribution as determined by differences in storm events, tide cycle, and temperature at seed set. The recorded distributions may also be more permanent and represent the realized niche breadth under various sediment conditions. In providing more saturated conditions, the silt substrate of the natural marsh may widen the potential elevation distribution range.

Included in Figure 4 is a comparison of *Scirpus americanus* and *Carex* species. The purpose of this comparison is to demonstrate that the natural marsh surface extends well above the MHHW level of the tides and yet it is still a wetland. Although the constructed wetland was graded, in part, higher than the design grade, the distribution of *Scirpus americanus* illustrates that these elevations are within the range found under natural conditions. Table 1 provides a list of all 28 plant species that colonized the constructed wetland within the first growing season.

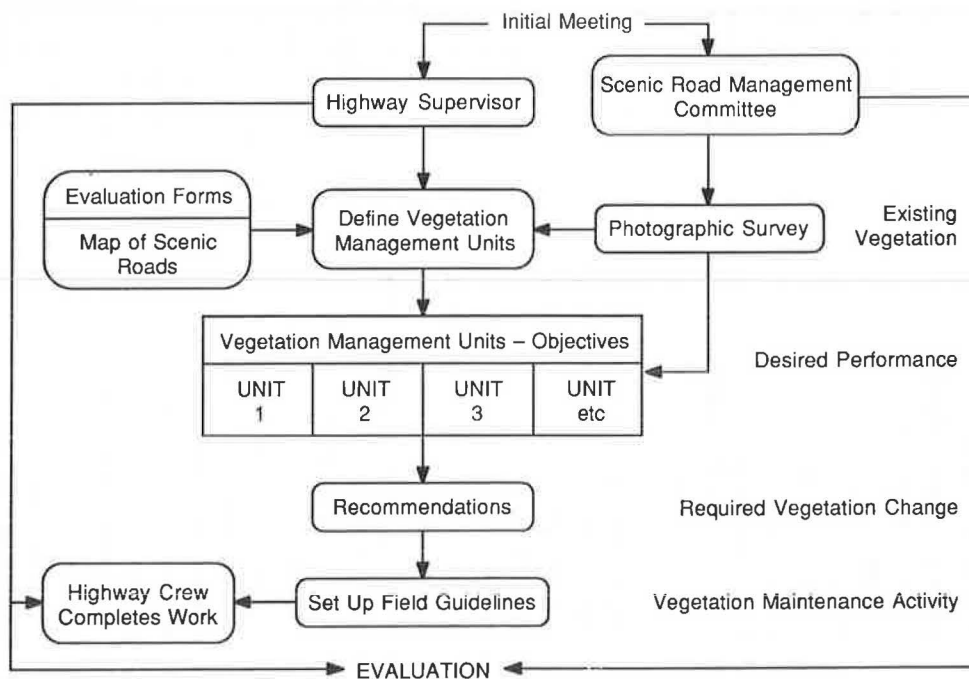
FIGURE 3 Vegetation management process.

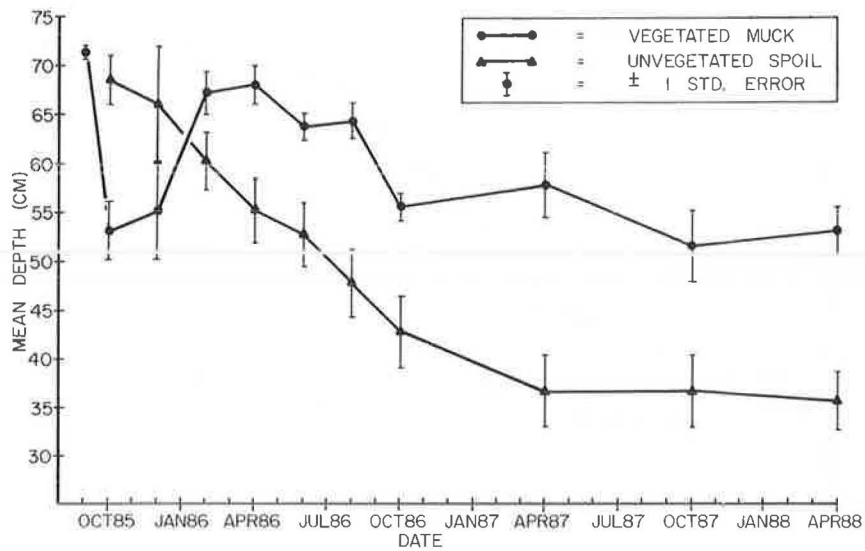
FIGURE 7 Mean channel depth in vegetated muck and unvegetated spoil.

Figures 5–7 compare arithmetic mean width and depth values of the MRC in vegetated muck (along the west connector) with unvegetated spoil. In Figure 5, ratios of mean width to depth ( $W:D$ ) are plotted to illustrate an overall indication of erosion or deposition of the MRC, or both. An increase in the ratio can occur as a result of an increase in MRC width, a decrease in MRC depth (indicates deposition), or both. Between October 1985 and April 1987, mean  $W:D$  increased significantly in the spoil zone in unvegetated areas. A comparison of Figures 6 and 7 shows that the initial instability of the west connector MRC (vegetated muck) was not caused by an increase in MRC width, but instead was because of a decrease in MRC depth (note sharp decrease in mean depth between September and October 1985). Dense *S. alterniflora* rhizomes are responsible for soil stability and the retention

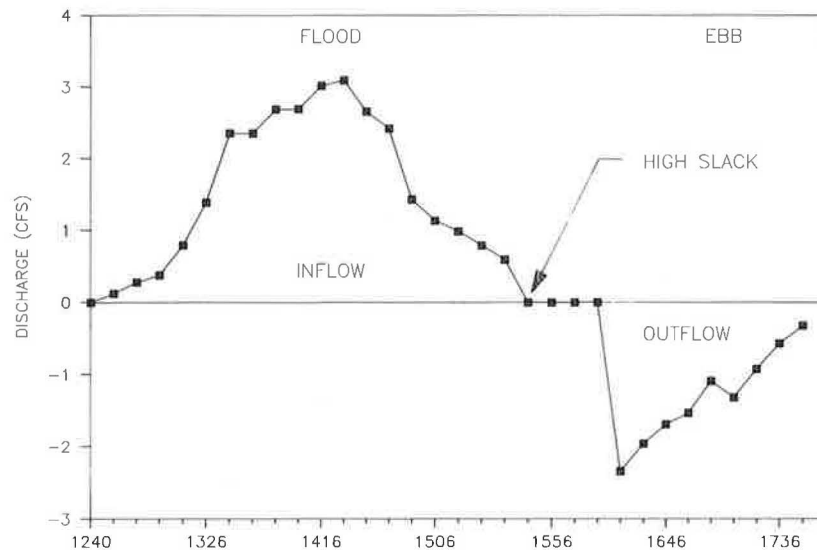
**FIGURE 9** Tide cycle hydrograph from the west connector gauging station on October 30, 1987.

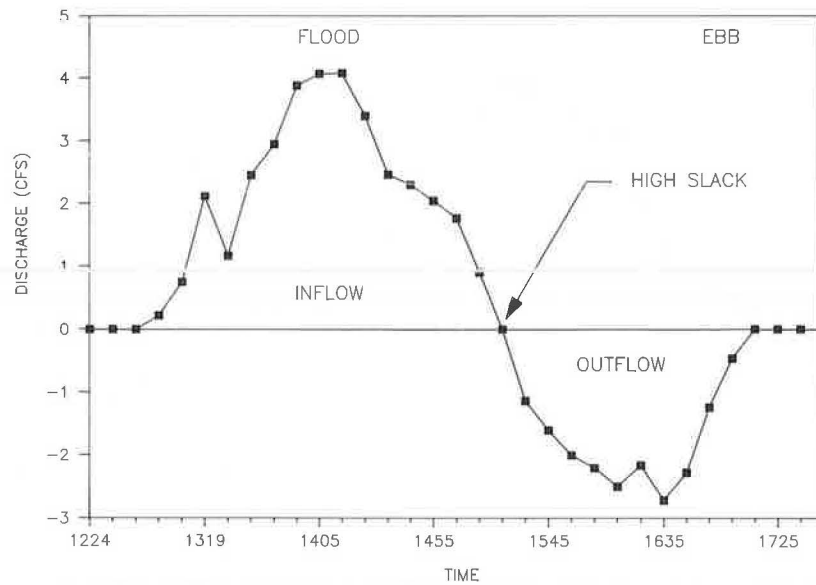
**FIGURE 10** Tide cycle hydrograph from the east connector gauging station on October 30, 1987.

The east end of the spoil zone represents a much more complicated hydrologic regime. Between 12:24 and 15:15, approximately 155,000 gallons of seawater flowed during flood tide past the east connector gauging site onto the spoil zone (Figure 10). During this period, only 8,000 gal of seawater was introduced through the intermediate connector from the natural tidal meander adjacent to the east connector (Figure 11). However, 31,000 gal of seawater was lost during flood tide out the intermediate connector for a net loss of 23,000 gal from the MRC into the natural tidal meander. The direction of flow in the intermediate connector changed twice during the flood tide: from northwest (into the MRC) to southeast (into the natural tidal meander) to northwest again. High slack tide occurred at 15:25 at the east gauging sites.

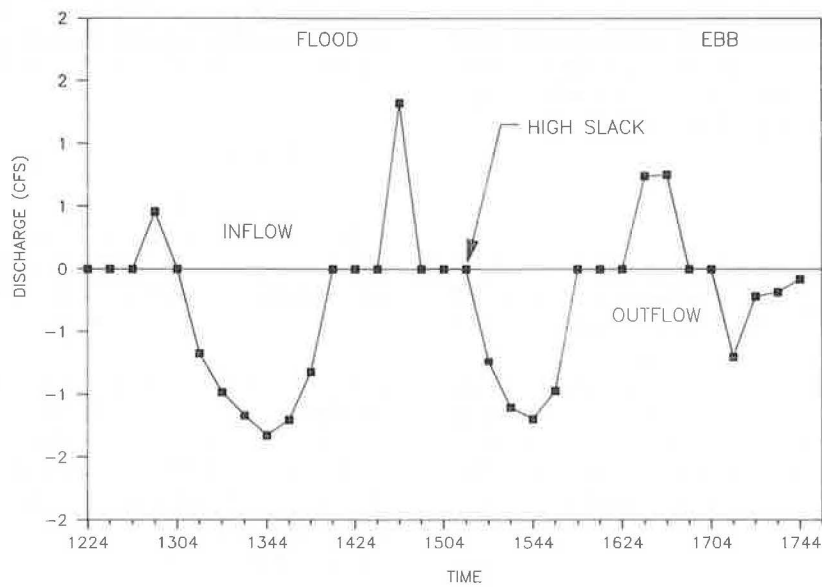
**FIGURE 11** Tide cycle hydrograph from the intermediate connector gauging station on October 30, 1987.

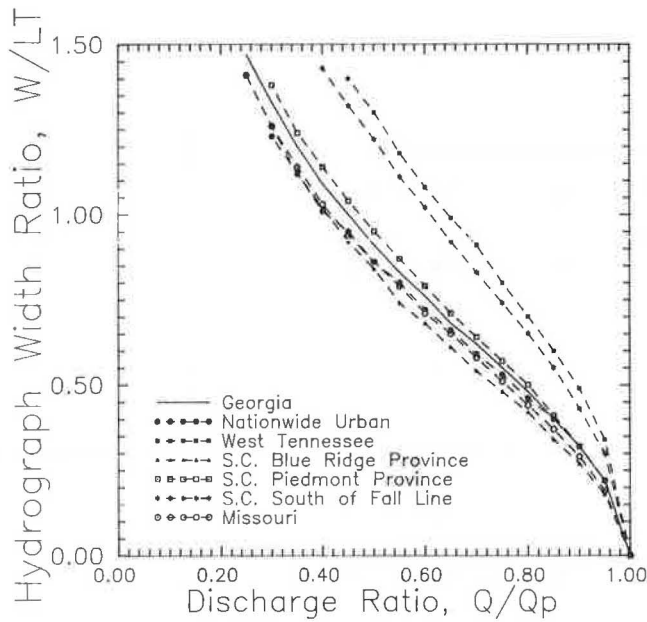
FIGURE 8 Hydrograph width relations.

Area	$a$
Georgia	0.00169
Nationwide urban	0.00159
West Tennessee	0.00218
South Carolina	
Blue Ridge	0.00166
Piedmont	0.00176
South of fall line	0.00202
Missouri	0.00161
